Performance of One- and Two-Family Dwellings

Mitigation Assessment Team Summary Report and
Recommendations

Commonwealth of the Northern Mariana Islands
Super Typhoon Yutu

FEMA P-2178

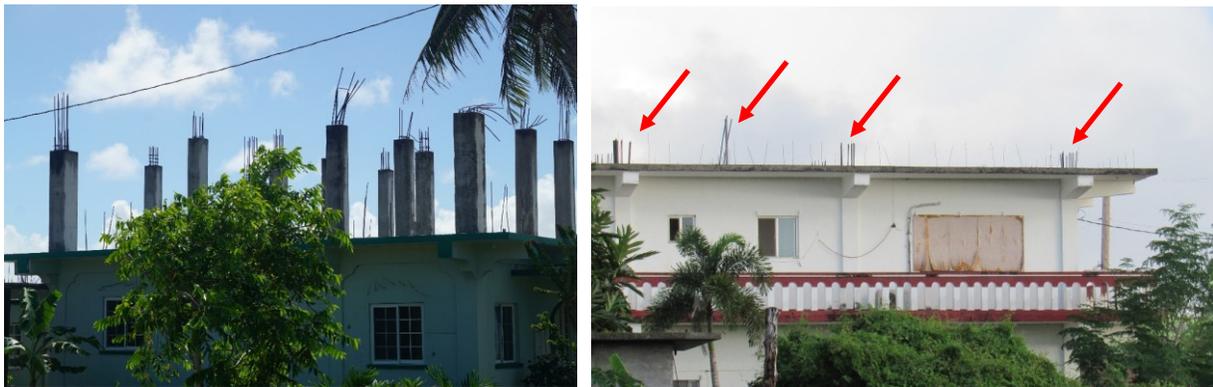
Staged or phased construction allows homeowners to use the home while they plan for future expansion. Many times, these future additions are built on top of the initial home construction with provisions made to grow vertically through the use of exposed rebar splices. “Hope sticks” or reinforcement extended above current construction in anticipation of future construction was some indication of reinforcement use (Figure 2). This practice, however, can lead to deterioration of the existing concrete caused by corrosion of the exposed reinforcement, which then will allow water and corrosion to move into the base structure.

Figure 2: Red arrows indicate “Hope sticks” extending out from base home construction. These unprotected reinforcing bars will lead to damage of the base structure as they experience harmful corrosion.

DPW should institute time limits on permits for staged or phased construction that is left incomplete (i.e., rebar extended through roof sections for future second stories, partially completed additions, etc.).

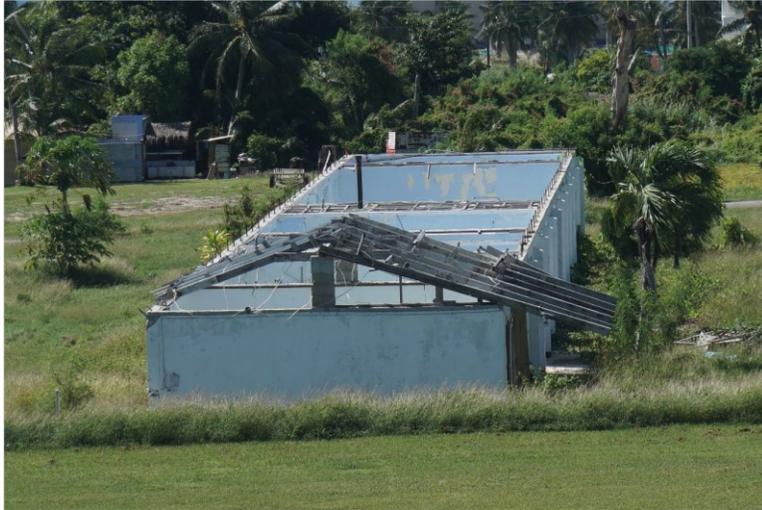
There were widespread failures of wood-framed roof systems during Super Typhoon Yutu. Typical failures were caused by metal roof panels blowing off the underlying nailers or the nailers separating from the beams and joists. Many traditional homes with corrugated metal roofs lost large sections of the roof. For some houses, entire assemblies—roof structure and covering—were missing, indicating that the high wind speeds separated the roofs at their connections to the walls. This suggests that connections between the roof panels and/or decking and the rafters were stronger than the connection between the rafters and the walls (Figure 3). The connection from the roof structure to the top of the wall is a critical connection in the load path and was observed to be poorly addressed in most homes with wood-framed roof systems.

Figure 3: Building with entire roof blown off.

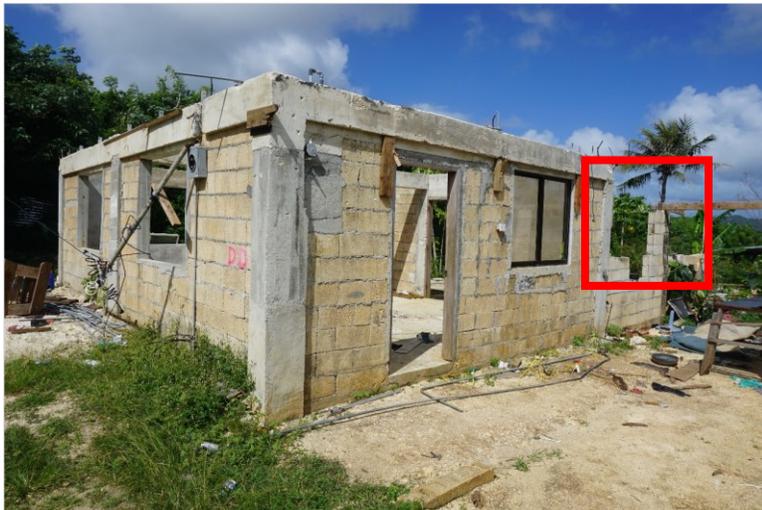
CMU homes did sustain some wall damage, often at the top of the wall near damaged rooflines. In many cases, CMUs were pulled off with the roof structure. Adequate wall reinforcement in the horizontal and vertical direction was not evident, and the lack of reinforcement likely contributed to the wall-to-roof connection failures when subjected to the winds from Yutu (Figure 4).

Figure 4: Home with concrete frame with CMU in-fill wall construction. The CMUs have variable joint spacing down to no joint spacing. Rafter connectors are informal and spaced far apart. The back-right wall of the house (in red box) has been blown off with the roof and is separated from the home.

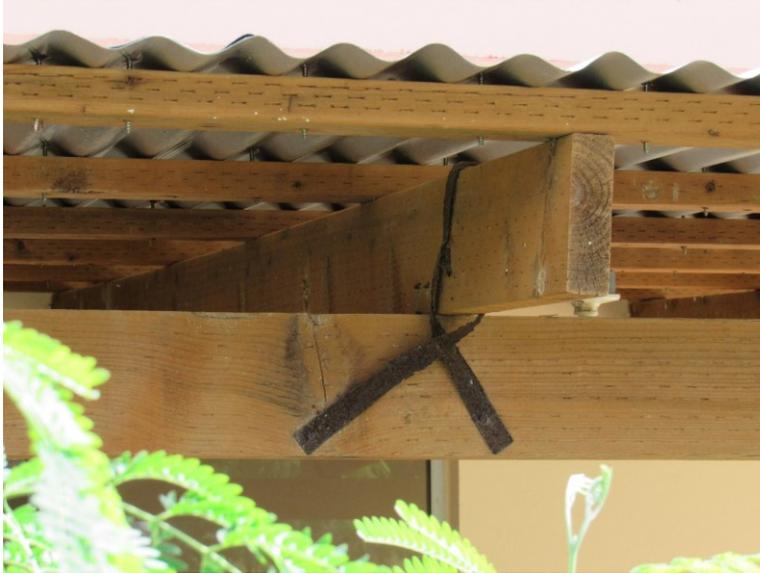
Figure 5: Wood-framed roof-to-beam construction. Connection is an informal method that is not an engineered solution.

DPW should require proper connectors between the roof framing and the walls. Professional design of the connectors is recommended. Homeowners and builders should connect wood structural members to the top of the walls, creating a continuous load path from the roof framing to the wall. Homeowners will need to retrofit the connections to framing already in place. Metal bars and straps bent over wood roof framing members at the top of the wall are not code-compliant connections. CNMI Recovery Advisory 1, *Code-Based Wind-Resistant Roofing for Homes: Reducing Wind Damage in the CNMI*, includes guidance for these connections.

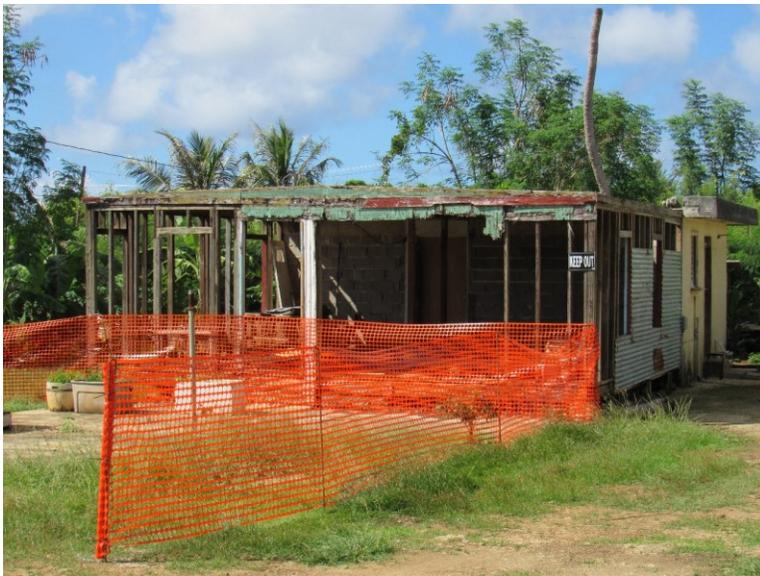
Figure 6: Wood-framed home that suffered near complete damage.

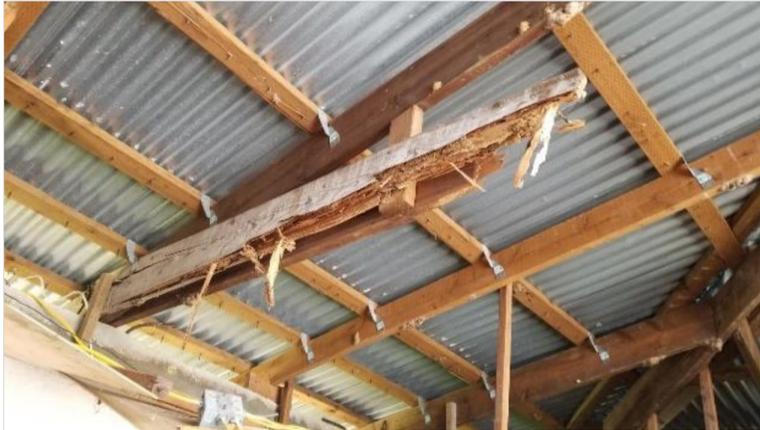
In addition to the issues noted above, many metal roofs did not have the required structural roof deck or diaphragm under the metal panels needed to resist and transfer the lateral loads to the walls. Often the rafter-to-wall connection was inadequate to resist the intense uplift loads from the high winds.

Wood roof framing was subject to decay and damage from environmental factors, especially termites (Figure 7). The MAT observed many instances where termite damage had compromised already marginal framing. The further weakened structural members then were stressed by Yutu to the point of complete failure. Extensive termite damage and decay of roof structural members—rafters, purlins, nailers, top plates—further compromised the continuous load path for wind loads.

Figure 7: Roof framing showing lack of structural roof deck under corrugated metal roof, rafters spaced too far apart, informal connectors from rafters to walls, and extensive termite damage to most roof structural members.

Homeowners and builders should use alternative materials, such as cold-formed metal framing (16 gauge) or wood members treated to resist termite damage and organic decay.

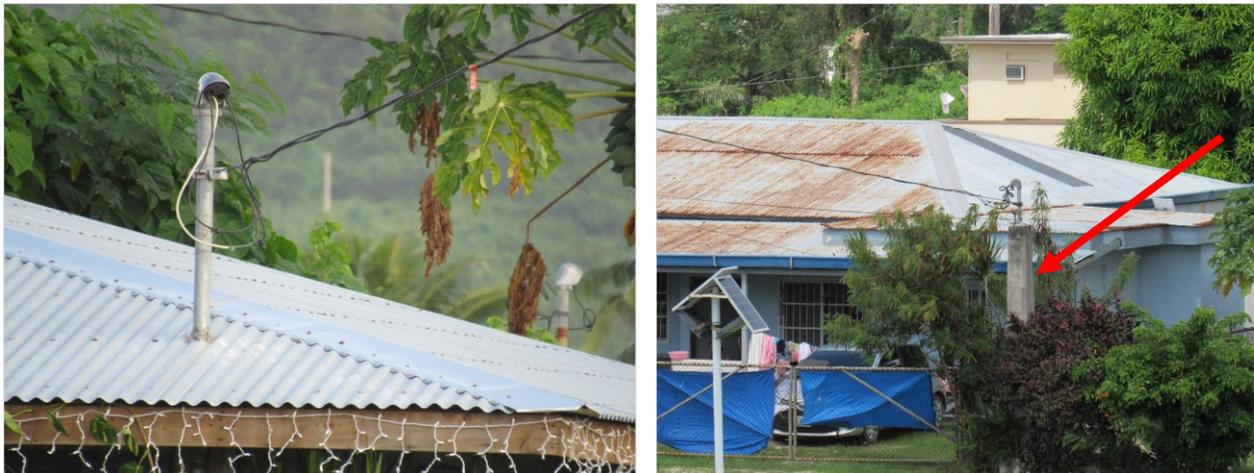
There were several instances where electrical service masts penetrated the roof, creating potential problems for the roof (Figure 8). The weather seal at this interface between the electrical mast and the roof was difficult to maintain. This junction between the mast and the roof also provided a point of initiation for roof failure when electrical lines became overstressed from wind and debris impact and loaded the roofing. Additionally, when trees and power poles fell, they pulled the mast, which damaged the roof.

Figure 8: Left—Electric service mast going through roof; Right—Electric service on separate pedestal.

Where service masts penetrated the existing roofs, localized roof failure and water intrusion damage often occurred. Because many roofs have overhangs or porches, when the power feed is extended up from the wall (where the meter is located), the mast typically is extended up through the roof covering.

Homeowners and builders should avoid penetrating roof coverings with utility service masts, including porches and overhangs. New construction and most major renovations are required to install new meter pedestals at homes for power and utility connections. Where existing homes are being repaired or renovated, installation of a new meter pedestal will prevent the need to penetrate the roof with a utility service mast.

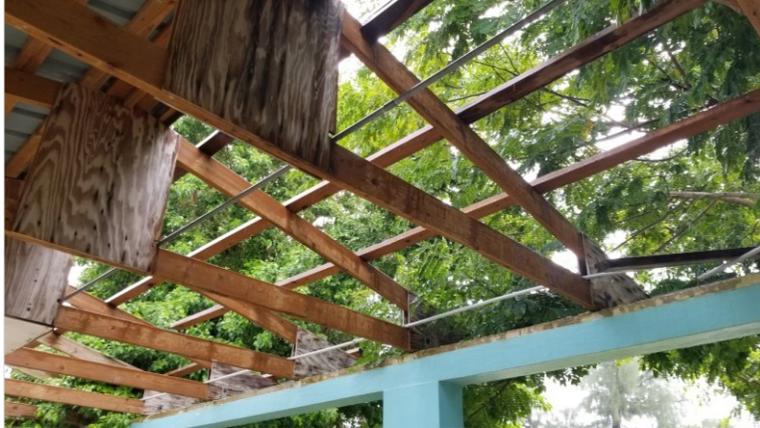
Numerous metal panel roofs were only lightly secured and did not use adequate numbers and types of fasteners. While some roofs remained in place during the storm, several roofs experienced partial or complete blow-off. Many metal roof panels were attached to wood purlins with nails, which provided inadequate wind uplift resistance (Figure 9). Screws provide a better alternative to nails when securing metal roof panels to the roof structure since it is much more difficult for high winds to pull screws loose.

Figure 9: Roof panel blew off purlin nailers.

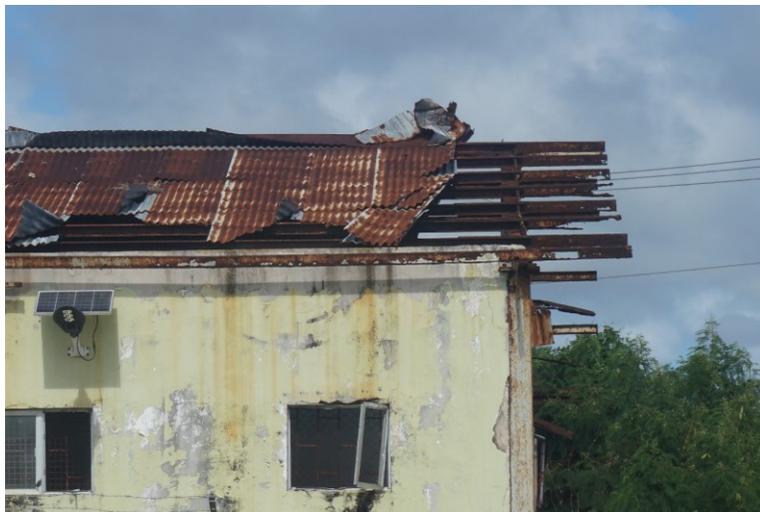
Maintenance of roof systems often was lacking, resulting in lost roofing and severe damage. Galvanized metal roof panels consume the zinc protective layer throughout their life. When the zinc layer is gone, corrosion of the base metal begins. Metal roofs can be recoated with special metallic paints to extend their life many decades. Loss of the initial zinc layer and lack of recoating with protective paint allowed corrosion to become established on the roof panels. Consumed and corroded metal roof panels failed and allowed water intrusion (Figure 10). Many roofs failed due to corroded and missing fasteners.

Figure 10: Corroded roof panel with zinc galvanizing consumed.

Homeowners should apply corrosion-inhibiting coatings to metal roof panels that have had the zinc coating consumed. Application of special metalized paints can extend the life of metal roof panels by inhibiting corrosion.

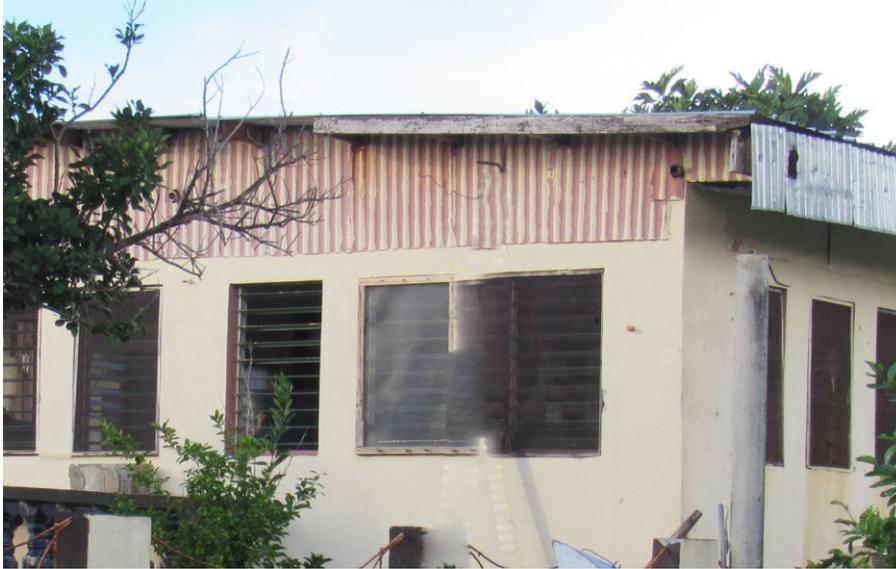
Houses in the CNMI have many window types, including glass jalousie, casement, and sliding pane glass windows. Accordion shutters are the primary tools used to protect the various openings. Numerous windows and shutters suffered damage from wind-borne debris. Water seeped around and through jalousie windows and door gaps, causing minor interior water damage, including damage to some contents (Figure 11). The use of concrete walls and floors limited the impact of water intrusion as these materials are water resistant.

Figure 11: Home with jalousie windows.

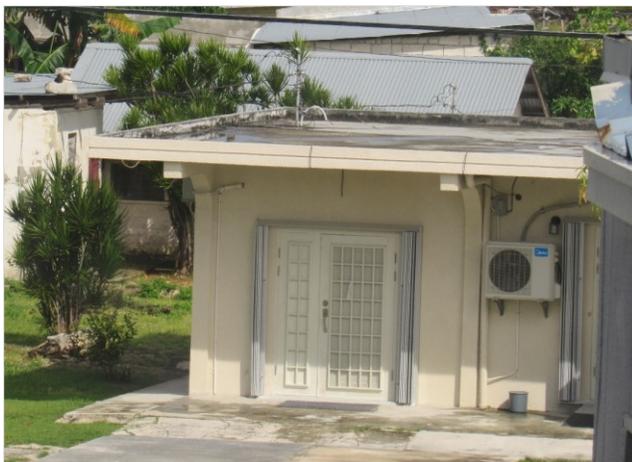
The MAT also observed shutters on doors and windows that remained attached to the structure and appeared to have provided adequate protection. An accordion shutter that is commonly used in the islands and is manufactured in the CNMI performed well and withstood impacts from wind-borne debris. Some shutters were damaged while still protecting the glazing or doors behind them. The accordion shutters used a folding panel arrangement permanently mounted in place with the tracks and hardware (Figure 12). This prevented loss of the hardware, but it lacked the ability to close from the inside.

Figure 12: Home with accordion shutter door protection (shutter not deployed in this photo).

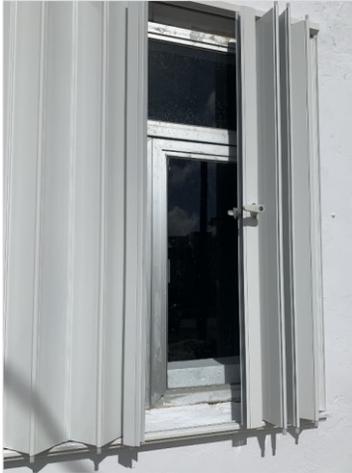
Some of the accordion shutters had a handle-style twist lock closing mechanism (Figure 13) that, when deployed, created a single point of connection that became inoperable after being struck and broken by debris impact. Shutters in several applications were not operable due to debris, corrosion, and roller or track damage. Shutters typically were not cleaned or maintained.

Figure 13: Residential window with typical accordion shutter with handle-style lock located in the center of the shutter.

Many shutters were not operating properly due to debris, rust, or roller damage. Many residential uses of shutters with handle-type closing mechanisms and single-point connections were broken by wind-borne debris and became inoperable after the storm event.

Homeowners should check shutters regularly and ensure they are properly maintained and serviced. Annual maintenance for shutters will include cleaning, lubrication, and repairs. Homeowners should wash and clean the shutters to remove accumulated dirt or materials

from the surfaces. The tracks that rollers move in should be cleared of grit and debris that will prevent movement of the rollers. The rollers, hinges, and joints need to be lubricated to assure they are free to move and are not corrosion bound. Lastly, any components that are found to be broken, damaged, or compromised should be replaced or repaired.
