# Performance of Public Buildings and Critical Facilities

Mitigation Assessment Team Summary Report and Recommendations

Commonwealth of the Northern Mariana Islands  
Super Typhoon Yutu

P-2179

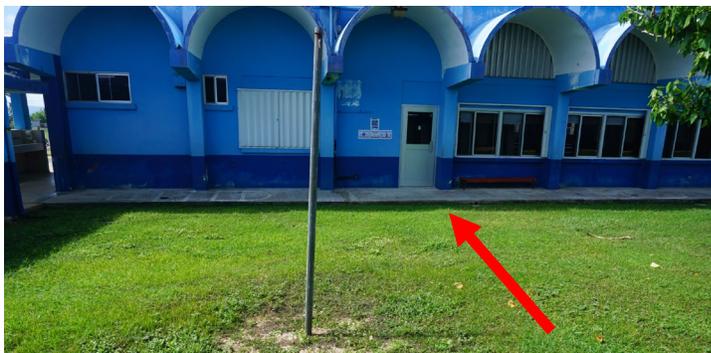
At schools, the MAT noted water came in through doors as it flowed from areas of high ground toward lower ground, where buildings such as cafeterias were located. The cafeterias were used as refuge areas during the storm, and some had standing water 1 inch to 3 inches deep while occupants slept on cots inside (Figure 2).

**Figure 2: Tinian Elementary School Cafeteria, where surface runoff flowed across the ground and into the building (red arrow), which was used as a refuge.**

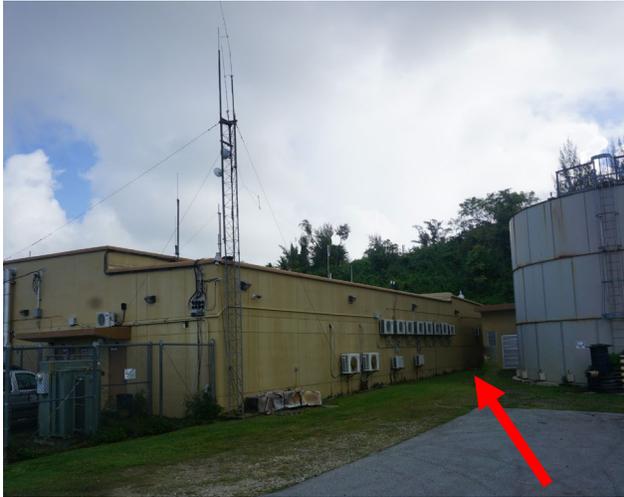
and the slab-to-wall interface was not watertight. Additionally, the water's flow path followed a narrow space between the emergency generator and the building. The water from the EOC roof, the generator roof, and the sloping terrain behind the EOC was constrained to flow through this narrow area that was originally designed as a shallow swale. The red arrow in Figure 3 indicates the area of constriction and the higher grade.

**Figure 3: The architectural reveal along the side of the EOC (yellow building) is approximately 1 to 2 feet above the interior finished floor. The narrow area where drainage flows is indicated by a red arrow.**

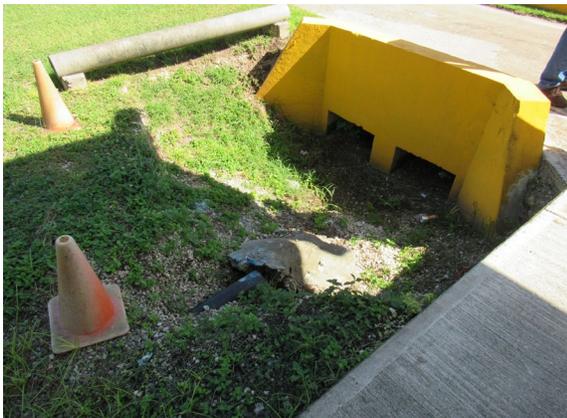
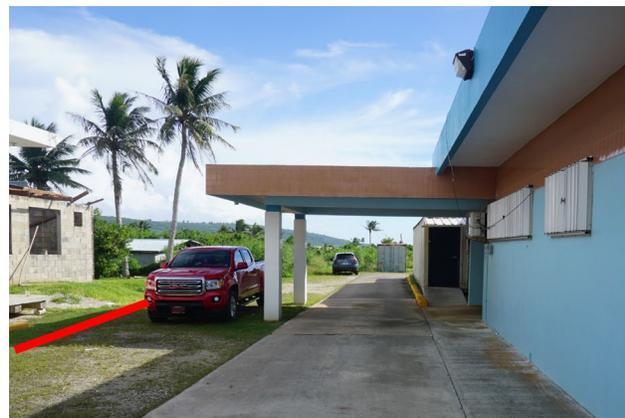
At the Tinian Fire Station and the Tinian Hospital (Figure 4), a surface water conveyance had become filled with debris as a result of a lack of maintenance, blocking the flow of water between the buildings. This caused water to flow above ground across the driveways that served the emergency room access doors. The runoff also overwhelmed the sanitary drains and septic fields, causing water to upwell through a service port located in front of the emergency room entrance.

**Figure 4: Left—Culvert between Tinian Fire Station and Hospital blocked by accumulated soil. Right—Hospital Emergency Entrance with canopy where surface water flowed. Design conveyance swale has filled in (red line).**

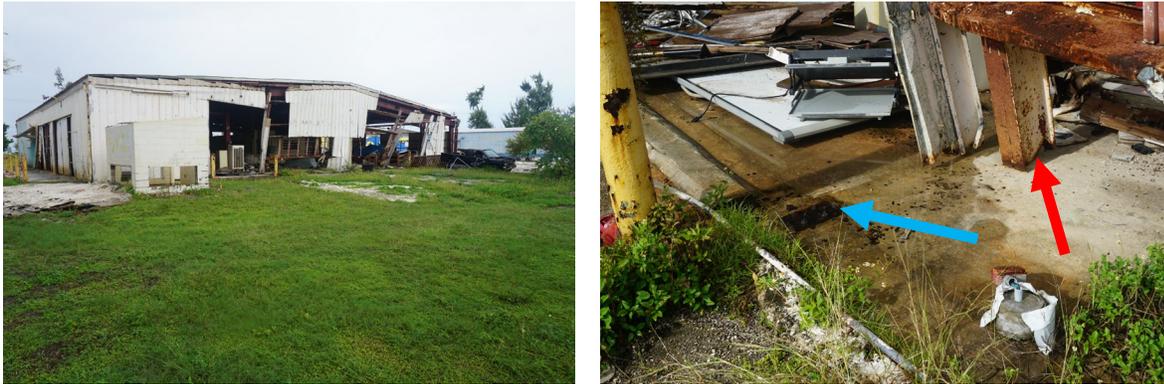
MBSs performed at differing levels, depending on the age and condition of the building and components. Several MBSs had initial design features that led to degradation of important elements, including lack of building pads under column bases, which caused corrosion of anchor bolts and base plates. The building pads frequently were very low, thus exacerbating the problem by allowing water to accumulate and stand at the important load transfer interface at the column base (Figure 5).

**Figure 5: Left—MBS showing displaced wall. Right—Column (red arrow) at displaced wall showing corrosion of column base plate (blue arrow) and lack of housekeeping pad. Also, the building pad elevation is at grade, aggravating conditions.**

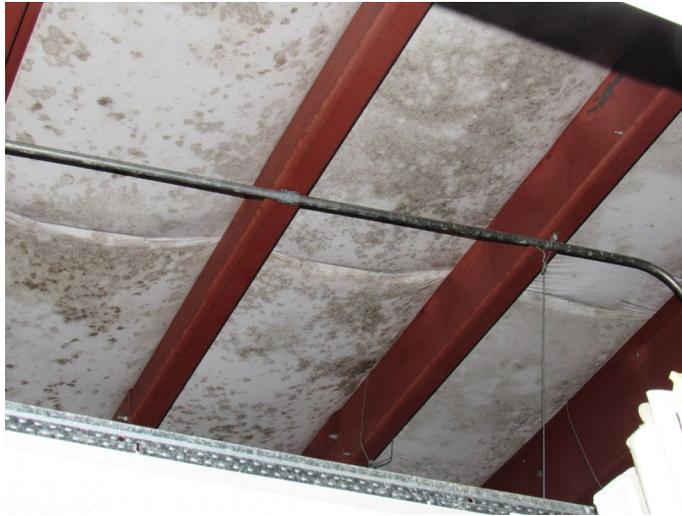
MBSs that were newer and less deteriorated in condition seemed to perform better, further indicating that corrosion was a main cause of performance issues. Some MBSs had wind bracing that was undersized or past its service life. MBSs also had a problem with water intruding into plastic-wrapped blanket insulation layers. The plastic held the water and provided a favorable environment for organic growth (Figure 6).

**Figure 6: MBS plastic-wrapped blanket insulation showing organic growth due to inability to remove water from interior layers of insulation.**

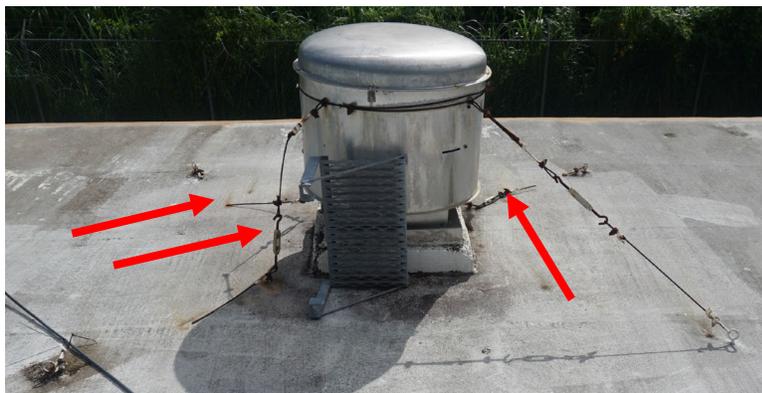
Poor maintenance resulted in building components that had reduced capacity compared to when they were placed into service. The effects could be seen in the anchorages of rooftop equipment, where anchors were severed at corrosion points (Figure 7). This lack of proper anchorage leaves rooftop equipment vulnerable to blowing off, creating a direct opening in the roof to rainfall entry during a storm.

**Figure 7: Rooftop fan unit where three of four cable anchors failed because of corrosion (red arrows).**

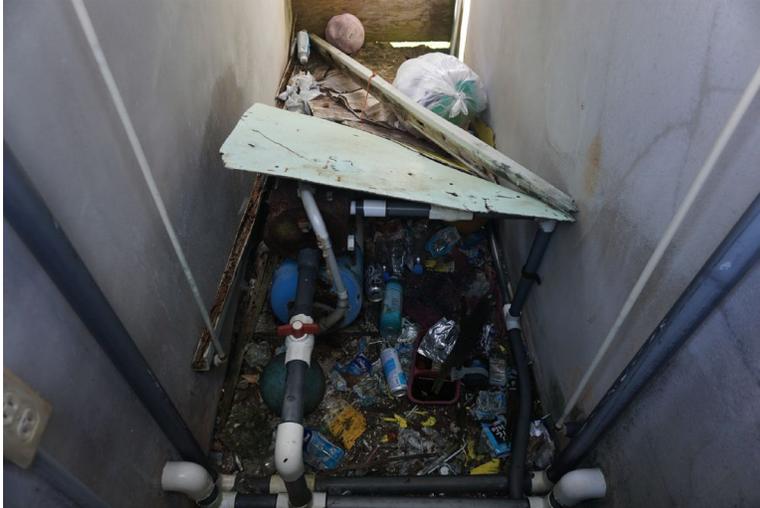
Several school complexes had water pumps for non-potable functions that were not in secure and weather-tight enclosures. The pumps were subject to debris and weathering that degraded the pump life and service. The electrical outlets that were observed in use in the pump enclosures were not appropriate for wet weather use, but instead were made for dry interior use (Figure 8).

**Figure 8: School water pump in building enclosure that did not provide adequate weather protection.**

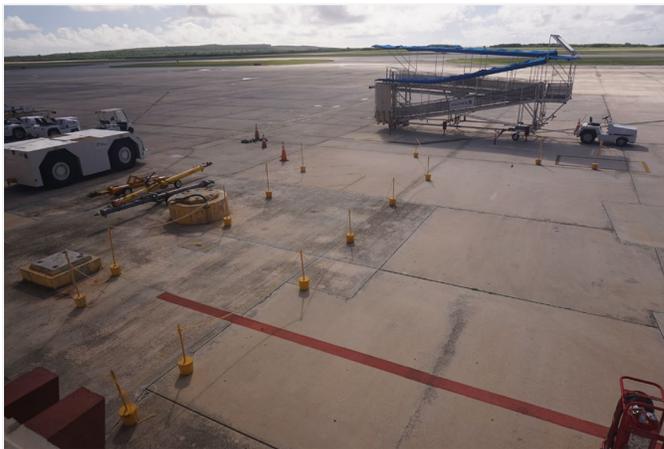
The Saipan Airport suffered damage to the movable aircraft passenger boarding bridges that allow passengers to embark and disembark aircraft directly to the upper level of the terminal. The passenger boarding bridges have storm moorings that lock them into place, preventing damaging movement. During Super Typhoon Yutu, the storm moorings failed, allowing several passenger boarding bridges to swivel and move with the extreme winds, damaging the terminal building and the passenger boarding bridges (Figure 9). The MAT observed new storm moorings at several locations are already being installed at several passenger boarding bridge locations to address this issue.

**Figure 9: View of damaged passenger boarding bridge location. Original storm mooring foundations are painted yellow (left side).**

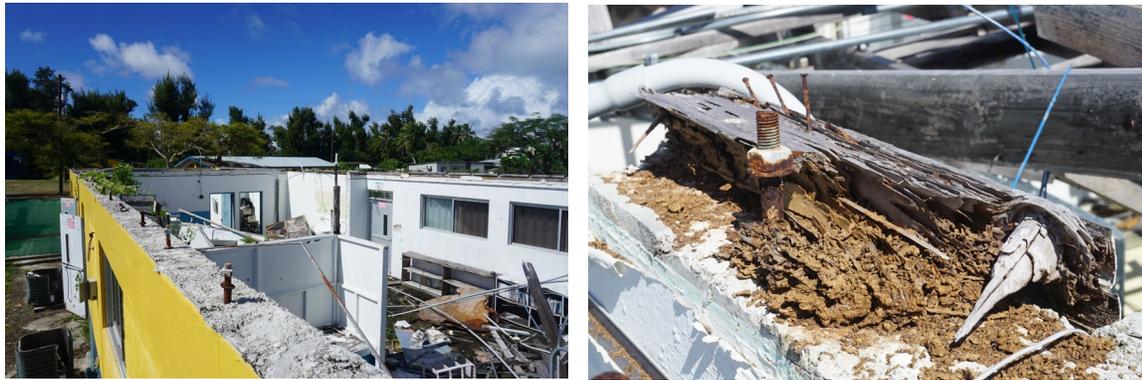
Termite damage and decay were seen in buildings with wooden trusses and frames. Schools that had wooden trusses for roof framing had catastrophic losses when the compromised trusses failed to provide the necessary strength to resist storm winds, resulting in complete loss of the roof (Figure 10).

**Figure 10: Left—School with compromised wooden roof trusses that caused the entire roof structure to be blown away by high winds. Right—Same school roof trusses revealing termite damage that weakened the roof-to-wall anchorage.**

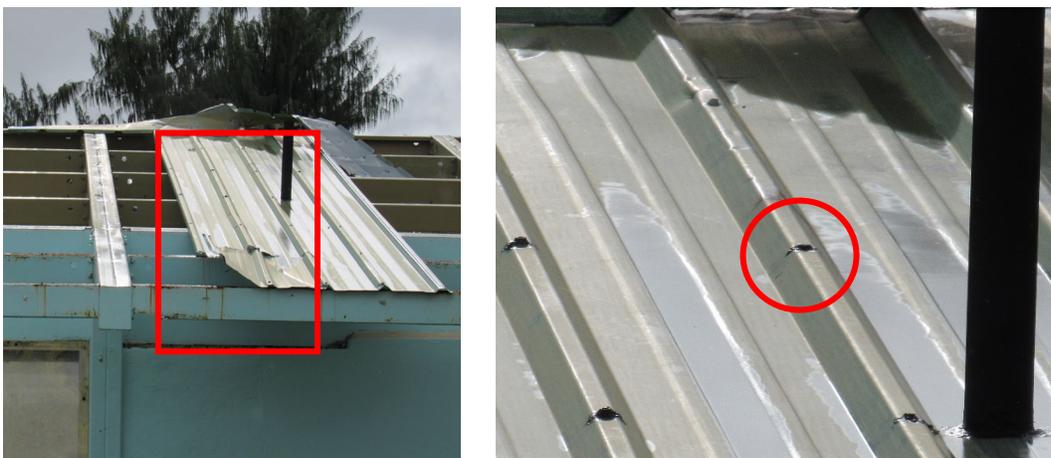
A number of metal panel roof coverings (mostly at schools, but also at other public buildings) were only lightly secured and did not use adequate numbers and types of fasteners (Figure 12). While some roof coverings remained in place during the storm, many roofs experienced partial or complete roof covering blow-off. Many metal roof panels were attached to wood purlins with nails, which provide inadequate wind uplift resistance (Figure 12). Nails should never be used to secure metal roof panels to the structure. Screws provide a much stronger connection to resist wind uplift and are much less susceptible to dynamic loading.

**Figure 11: Left—Wind damage to metal roof with inadequate numbers and size of fasteners, Marianas High School in Saipan; Right—Closer view showing the metal roof pulled through the head of the fastener with the fastener head no longer visible.**

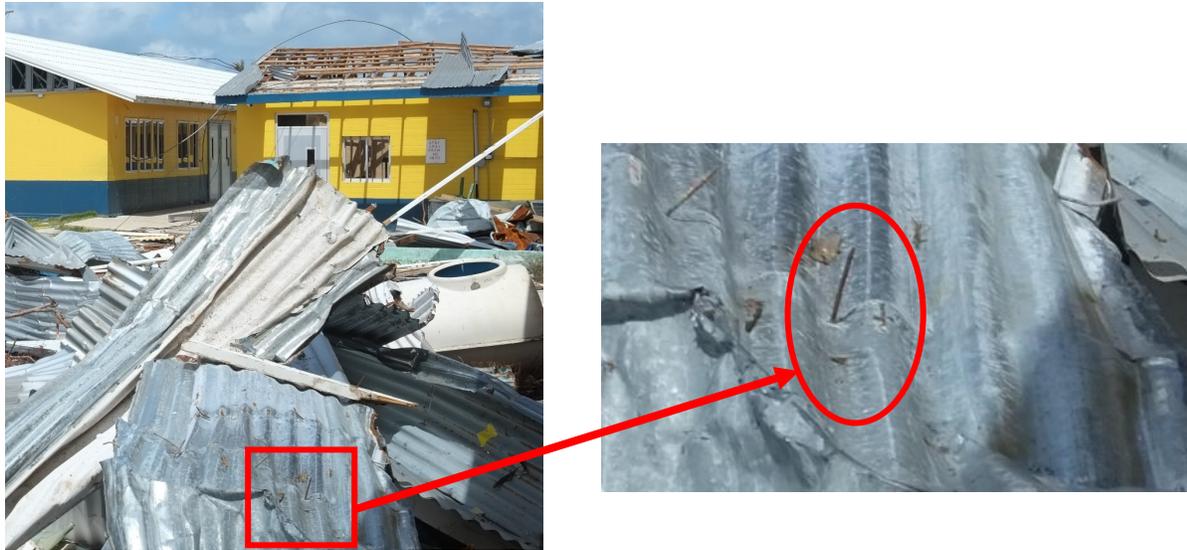
**Figure 12: Left—Wind damage to Hopwood Middle School in Saipan; Right—Inadequate fasteners, such as nails, led to much of the damage. [Image credit: Forrest Lanning, FEMA]**

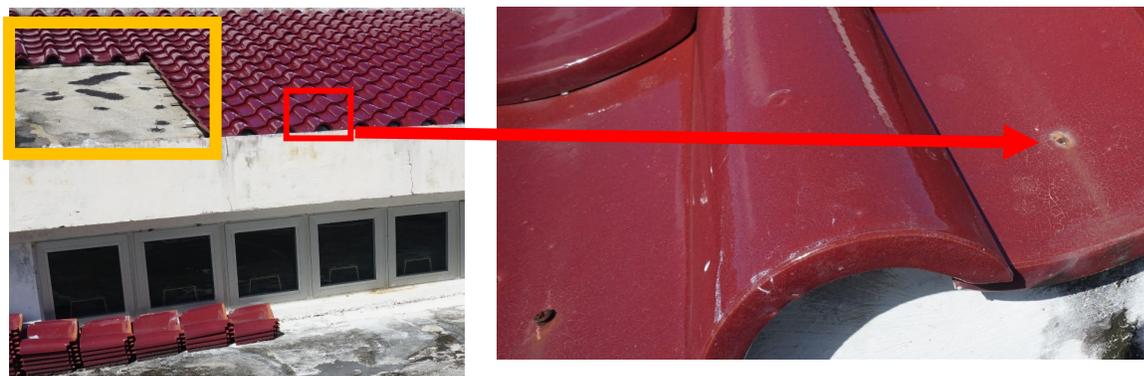
Tile roofs exhibited poor performance from the high winds of Super Typhoon Yutu. At the Office of Aging building, the corrosion of tile fasteners significantly contributed to failure (Figure 13). When these roof coverings fail during high-wind events, they become wind-borne debris. The blow-off of one roofing element can lead to the failure of others and can result in a large portion of the roof being lost.

**Figure 13: Left—Tile roof damaged by strong winds at the Office of Aging; Right—Corrosion of fasteners contributed to the failure.**

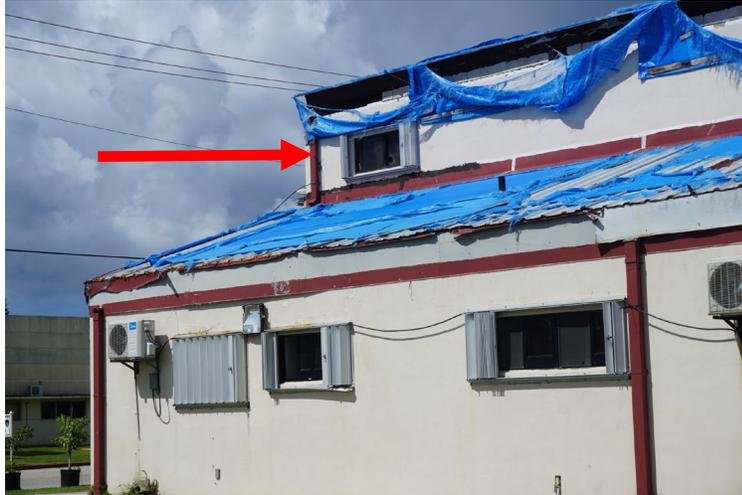
permanently mounted in place with tracks and hardware. These systems prevent loss of the hardware, but they lack the ability to be closed from the inside. This can be an issue when the staff has limited preparation time or the openings on the building are high off the ground, requiring personnel to use lifts or ladders to deploy the protection (Figure 14).

**Figure 14: High window with accordion shutter that was not closed during Super Typhoon Yutu, resulting in window damage (red arrow).**

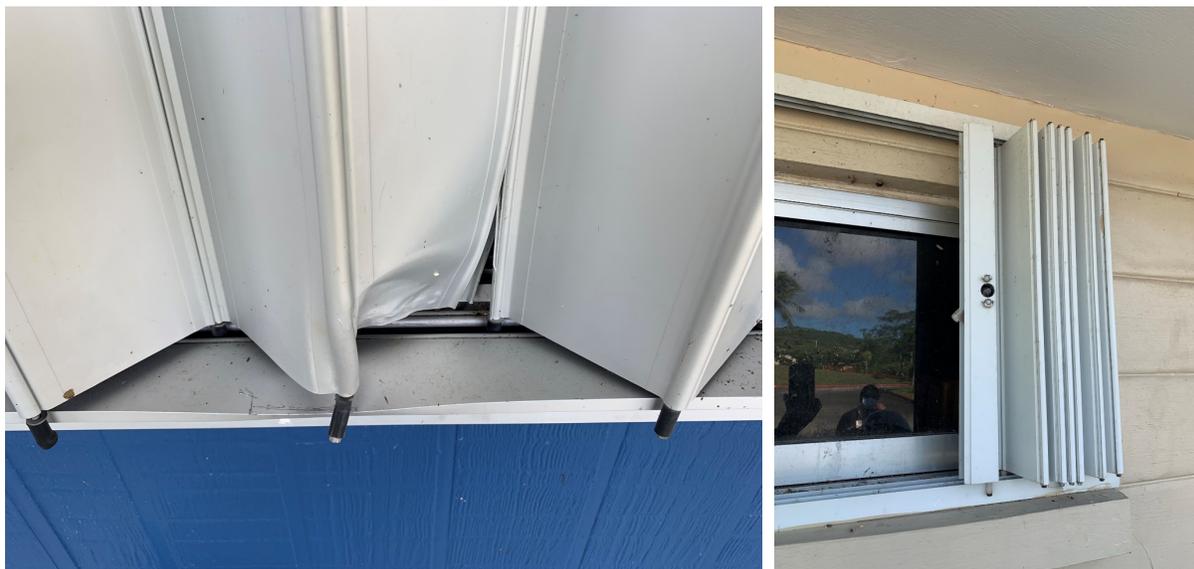
In several instances, shutters were not operable because of debris, corrosion, roller damage, or track damage (Figure 15). It was observed that shutters with handle-type closing mechanisms and single-point connections were damaged prior to this event on some systems and others became inoperable after this event (likely broken or damaged by wind-borne debris). The team observed that shutters with twist lock handle systems to lock the two halves together when deployed created a single point of connection that became inoperable after being struck and broken by debris impact.

**Figure 15: Left—Impact damage of non-rated, non-labeled shutter. Right—Single twist lock handle on shutters.**

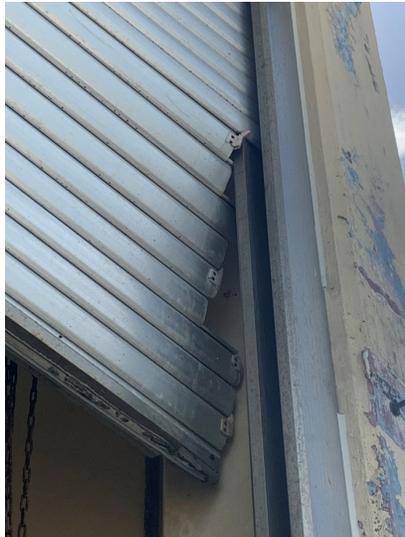
Large apparatus bay doors for fire stations generally performed poorly. The MAT observed that wind forces and wind-borne debris damaged large rolling doors that were intended to protect apparatus

bays and vehicles at several fire stations. Damage occurred to the doors themselves, resulting in door failures that left the doors unusable, thus also preventing equipment from being deployed from the facilities (Figure 16). In other instances, the failure of the large doors resulted in damage to the buildings themselves and vehicles housed inside the buildings.

**Figure 16: Damage to large, rolling door at fire station apparatus bay at Fire Station 2.**

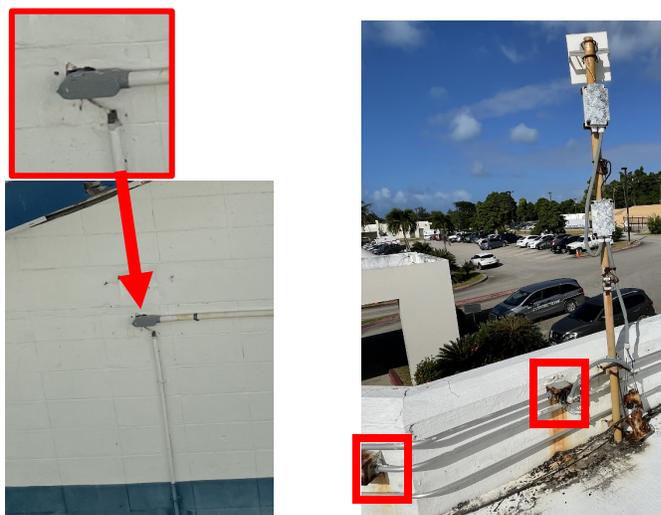
Electrical conduit enclosures were not properly sealed. Many electrical systems and sub-systems were water soaked, including at the weather heads where systems enter the building envelope. Open panel enclosures, junction boxes, and conduit were corroded, missing gaskets, or missing covers (Figure 17). The unsealed enclosures potentially led to corrosion and damage to conductors.

**Figure 17: Left—Conduit not connected to junction; Right—Corroded junction boxes on roof of CHC.**

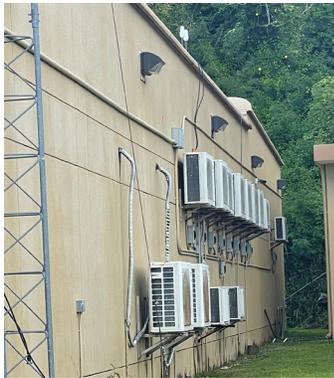
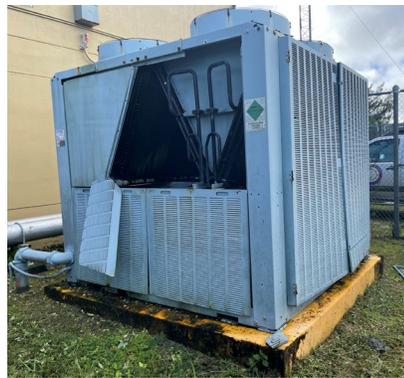
Mini-split HVAC systems were used as a common replacement for larger or complex systems damaged during the storm. The MAT observed that installing the new mini-split systems was a cost-effective and time-sensitive approach versus repairing the original systems (Figure 18). Improperly decommissioned HVAC systems also were observed and needed to be abandoned. Facility managers often were unable to get replacement parts or find a certified technician to make the repairs to the larger systems. HVAC ducts left in place from abandoned units allowed additional damage from water infiltration.

**Figure 18: Emergency Operations Center, Left—Replacement mini-split units; Right—Abandoned condenser.**

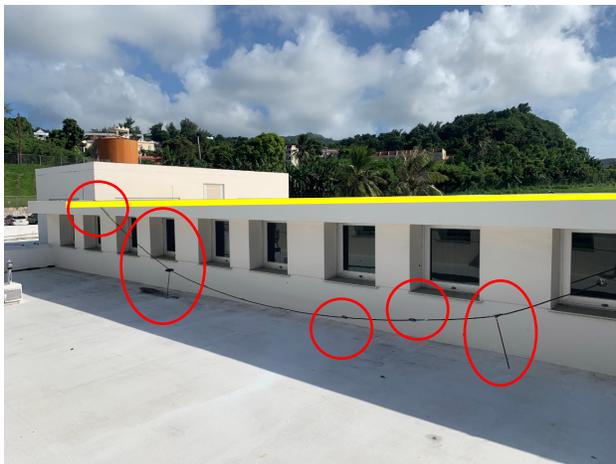
The hospital lightning protection system was not anchored well and caused damage when it became dislodged. It was observed that inadequate anchorage, maintenance, and corrosion were the sources of failure for many of these elements. Figure 19 shows where the connectors and air terminals (circled in red) have been displaced from the roof top edge (yellow line) and not been reinstalled to protect the facility. The resulting damage can include punctures in the roof and destruction of other rooftop equipment, and it can leave the building unable to ground lightning strikes.

**Figure 19: Failed connectors from lightning protection system. Air terminals were displaced when the system connectors failed.**

National Fire Protection Association (NFPA) 780, *Standard for the Installation of Lightning Protection Systems*, 2008 Edition, advocates performing a visual inspection every year to make sure exposed components are in good working order and performing a comprehensive testing inspection every five years for any system. Additional recommendations for anchoring in high-wind conditions can be found in FEMA P-424, *Design Guide for Improving School Safety in Earthquakes, Floods, and High Winds*.

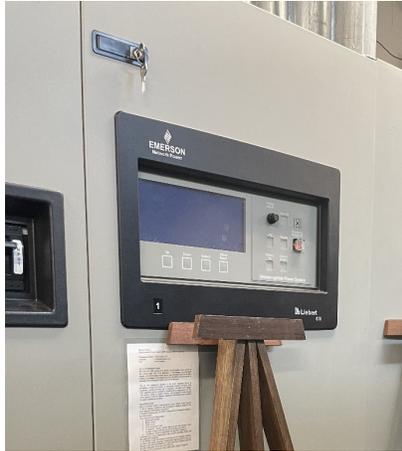
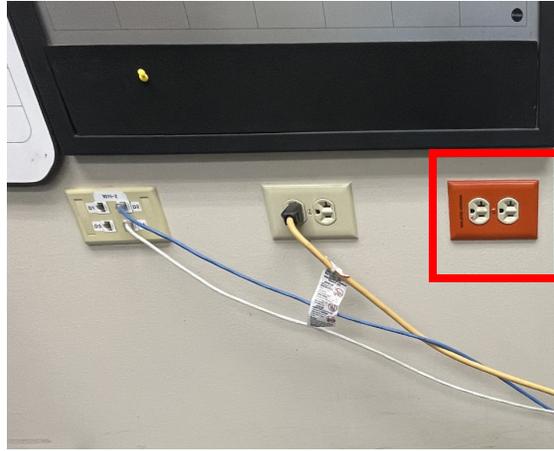
Emergency and backup power systems failed to provide service to several public facilities as needed during and after Yutu. At the EOC, the facility's Uninterruptible Power Supply (UPS) and generator were not functional during the MAT visit, two years after the event (Figure 20). The loss of emergency power during Yutu forced personnel to relocate all functions of the EOC to a less well-equipped location due to lack of communications. Currently, the EOC communications systems are dependent on smaller, individual UPS systems located at each device to operate under all situations (i.e., during a power outage).

**Figure 20: Left—UPS not functioning at EOC; Right—Emergency power outlet not in use.**

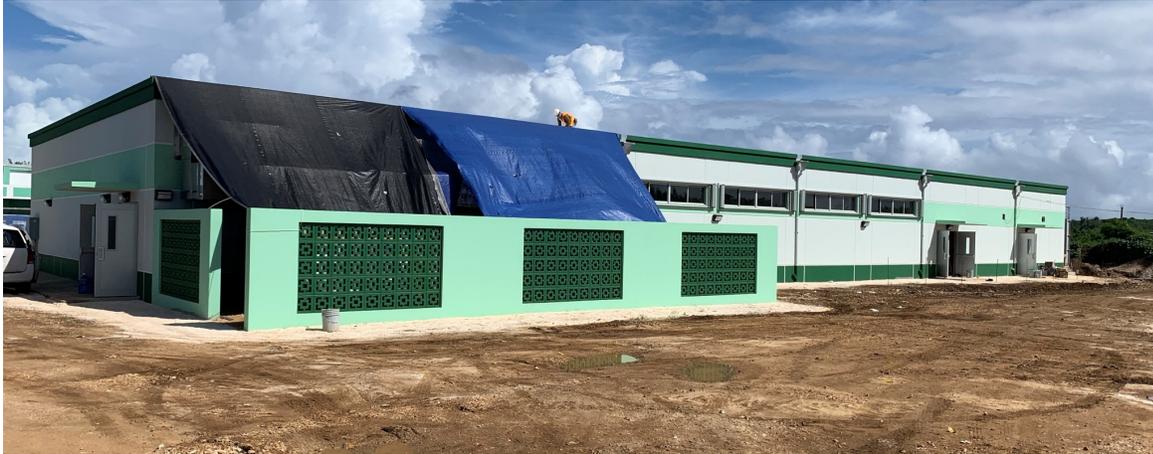
requirements). Recent construction projects, such as the new cafeteria building at Koblerville Elementary School (see Figure 22), could have met the FEMA safe room or ICC 500 storm shelter criteria if doors and windows compliant with ICC 500 requirements had been installed, if bathroom facilities had been provided within the building (per criteria), and if emergency power systems had been provided.

**Figure 22: New cafeteria at Koblerville Elementary School identified for use as an emergency shelter, but was not designed to meet FEMA or ICC life safety protection criteria.**

HS&EM and PSS should modify the design and construction of new facilities at schools to include bathroom facilities and rated doors to comply with ICC 500 storm shelter criteria (as current roof and wall construction appear to meet wind and wind-borne debris protection
