ROTA WEST HARBOR MASTER PLAN

Commonwealth Ports Authority

April 2018

Prepared By | Moffatt & Nichol, Honolulu, Hawaii
In Association With | PEGS and Micronesian Environmental Services, Inc.

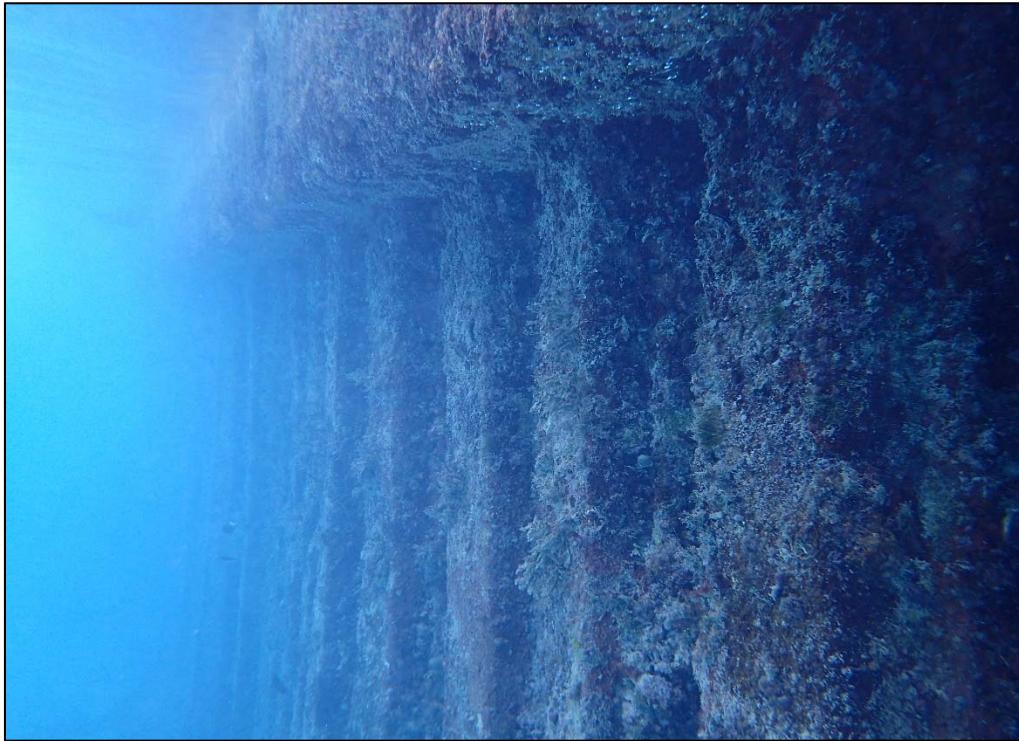
The sheet piles are in satisfactory condition. Typical corrosion losses were estimated to range between 4%-20%. Heavy pitting and higher levels of corrosion were typically noted just below the cap. The most significant amount of section loss was noted at Berth 2 (Station 0+05 North face) just under the concrete pile cap encasement where 57% of the original thickness remains. At this location an additional reading was taken two feet below the top reading where 89% of the original thickness remains. The inspection team found no evidence that any sort of cathodic protection has been installed. Inspection data from Berths 1 and 2 are summarized in Table 1. No manufacturer's data for the thickness of the flange could be found and was therefore estimated to determine remaining thickness.

Photo 3. Berth 2 front face sheet pile elevation below water. The pile cap can be seen at the top of the sheet piles.

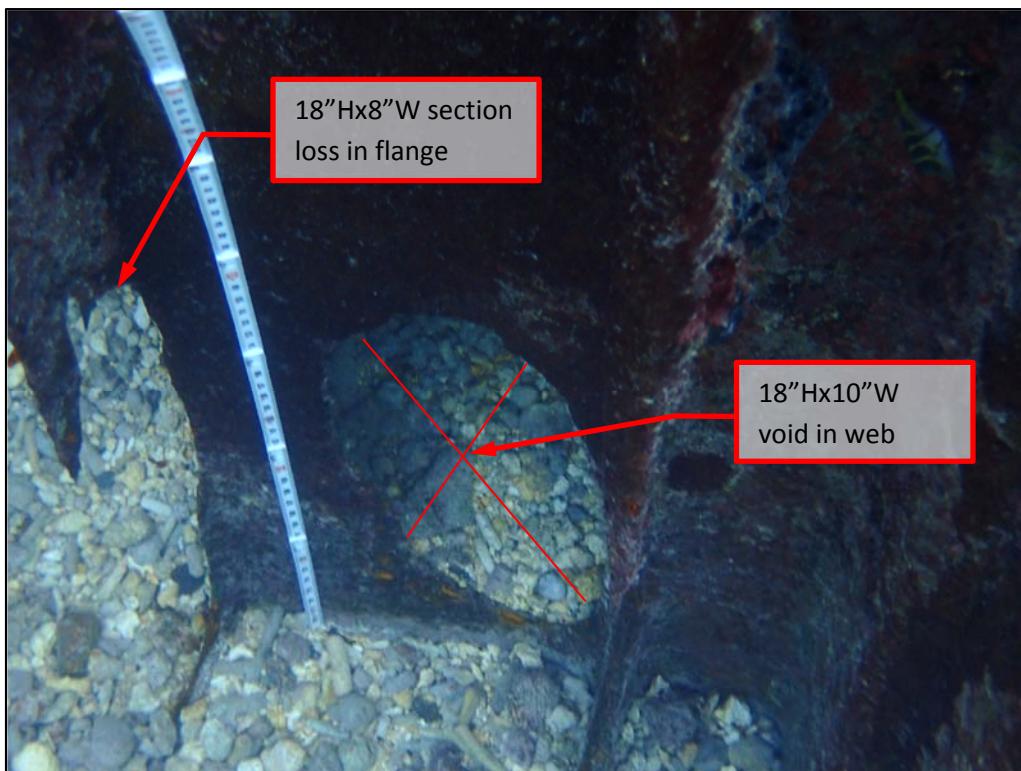
Photo 6. Berth 1. An oval shaped opening in the web of the H-pile and section loss in the flange at the northwest corner.

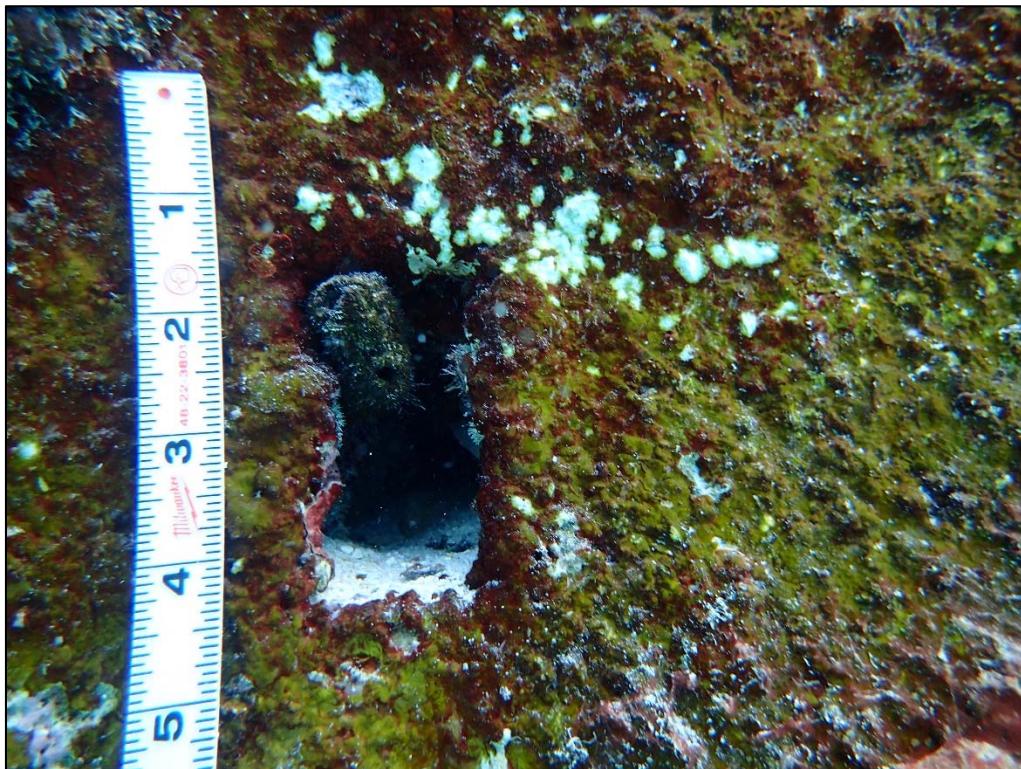
Photo 8. Typical manmade hole found at Berth 1.

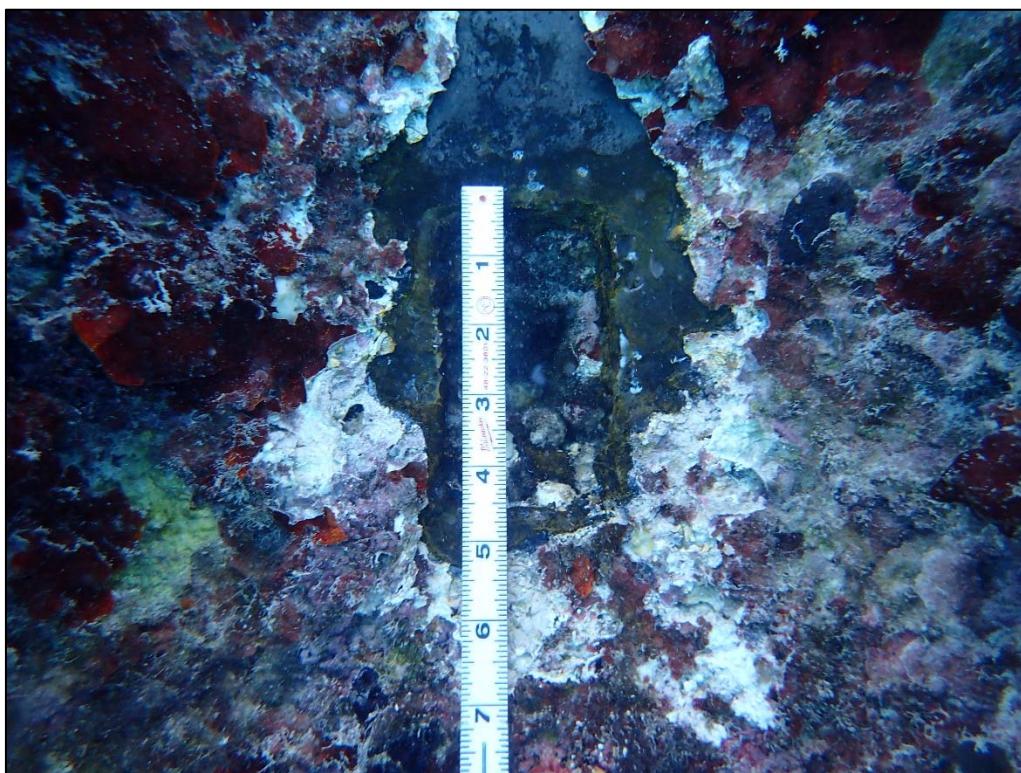
Photo 9. Typical manmade hole found at Berth 2 where the marine growth has been removed.

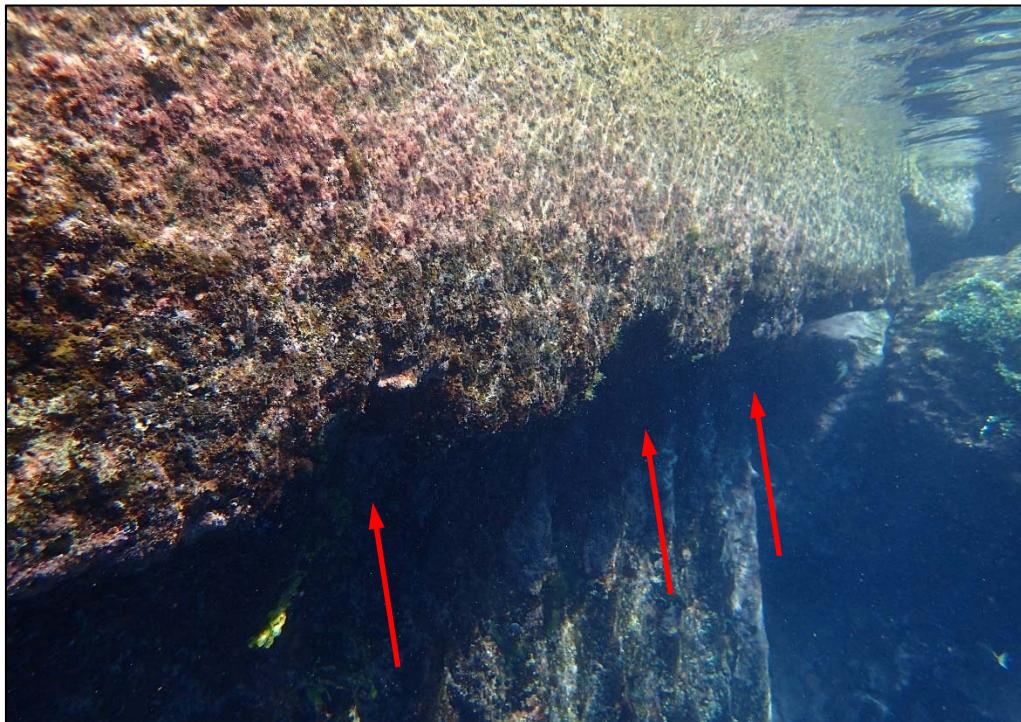
Photo 10. Bottom of concrete cap, south face of Berth 1. Poorly consolidated concrete at the bottom of the cap was noted throughout Berth 1. See Attachment B for further discussion of concrete deterioration.

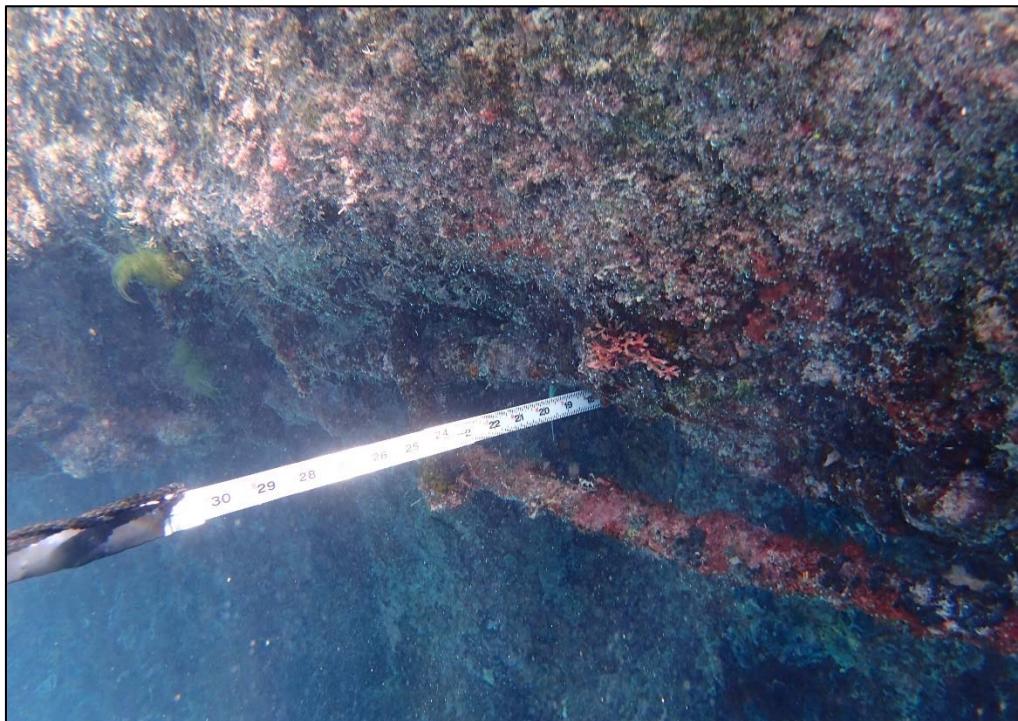
Photo 11. Berth 1 concrete cap. Poorly placed and poorly consolidated concrete at Station 0+96 exposes three longitudinal bars, with up to 100% section loss, and six vertical bars. The section of concrete loss is 4-ft long, 2-ft deep and 1-ft high. See Attachment B for further discussion of concrete deterioration.

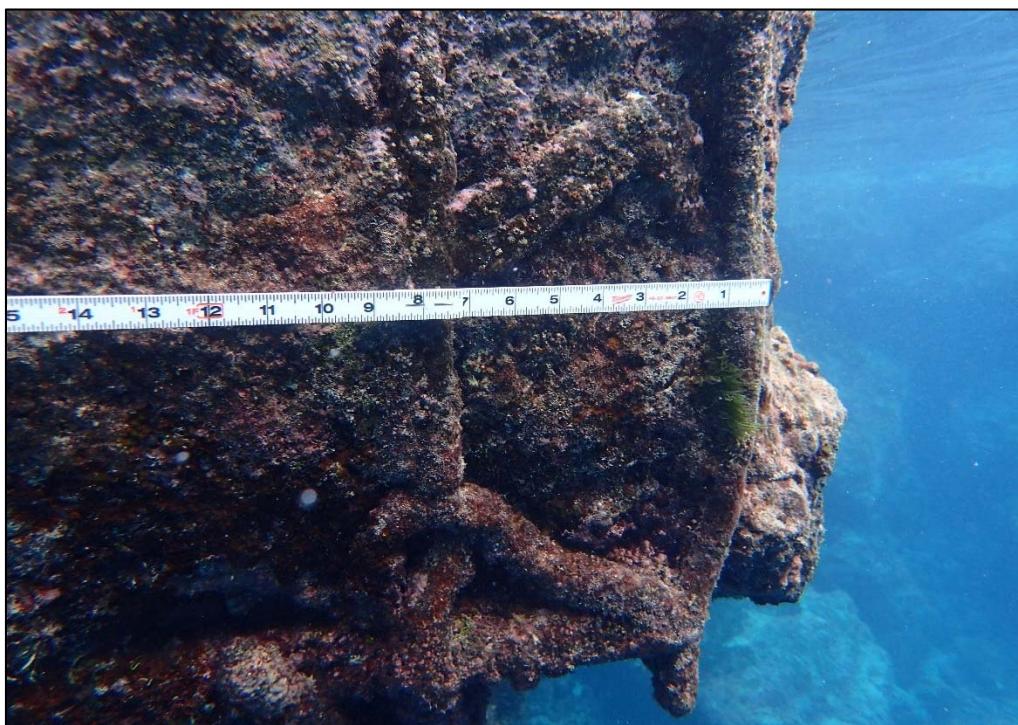
Photo 12. Berth 1 concrete cap. Damage found at the southwest corner seen from below water. Two vertical and one horizontal bars are exposed with minor steel section loss observed.

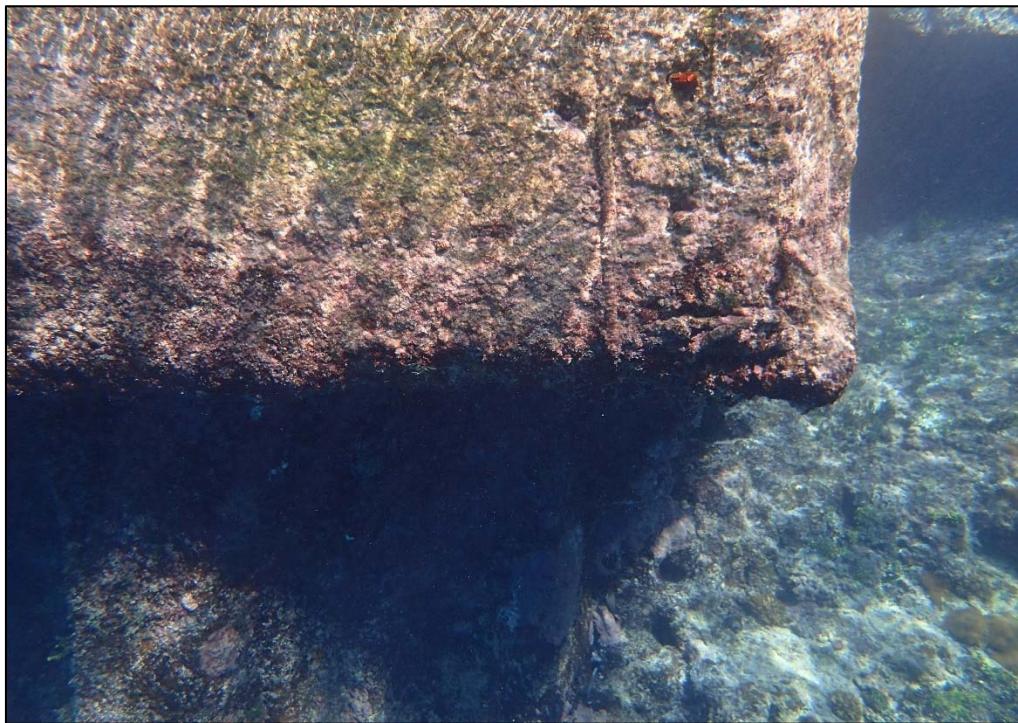
Photo 13. Berth 2 concrete cap. Erosion damage coupled with insufficient concrete cover over the reinforcing steel found at Station 0+00 seen from below water. This damage is typical of north and south corners on each berth.

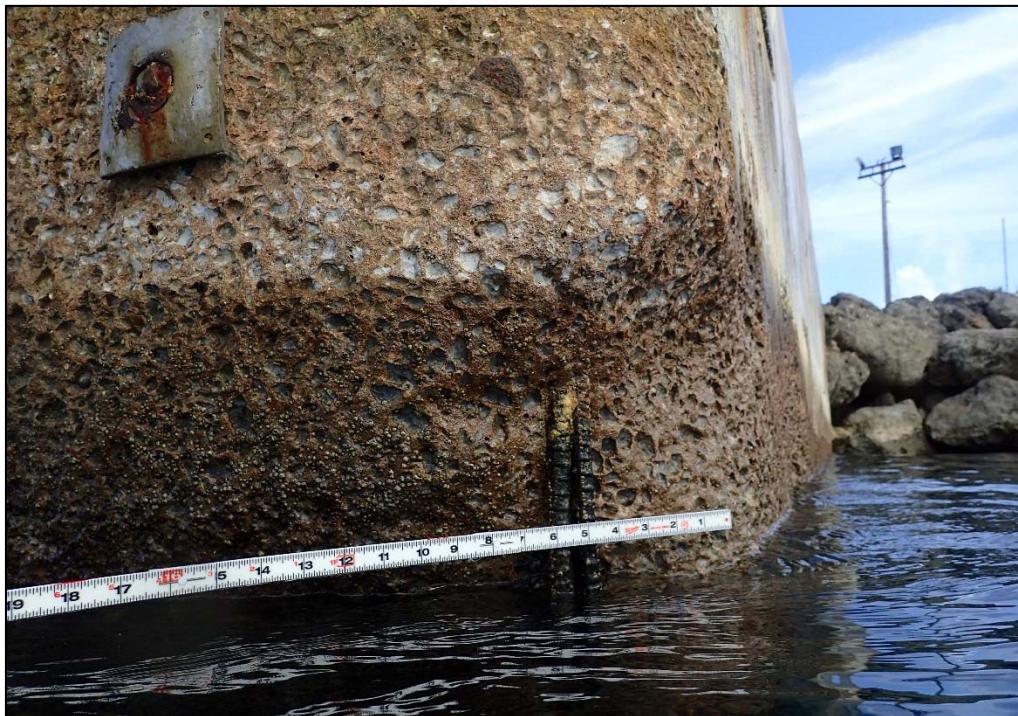
Photo 14. Berth 1 concrete cap. Typical erosion damage where the aggregate has "raveled" away over time leaving rock pockets, found at the southwest corner above the damage seen in Photo 11. This damage is typical of north and south corners on each berth.

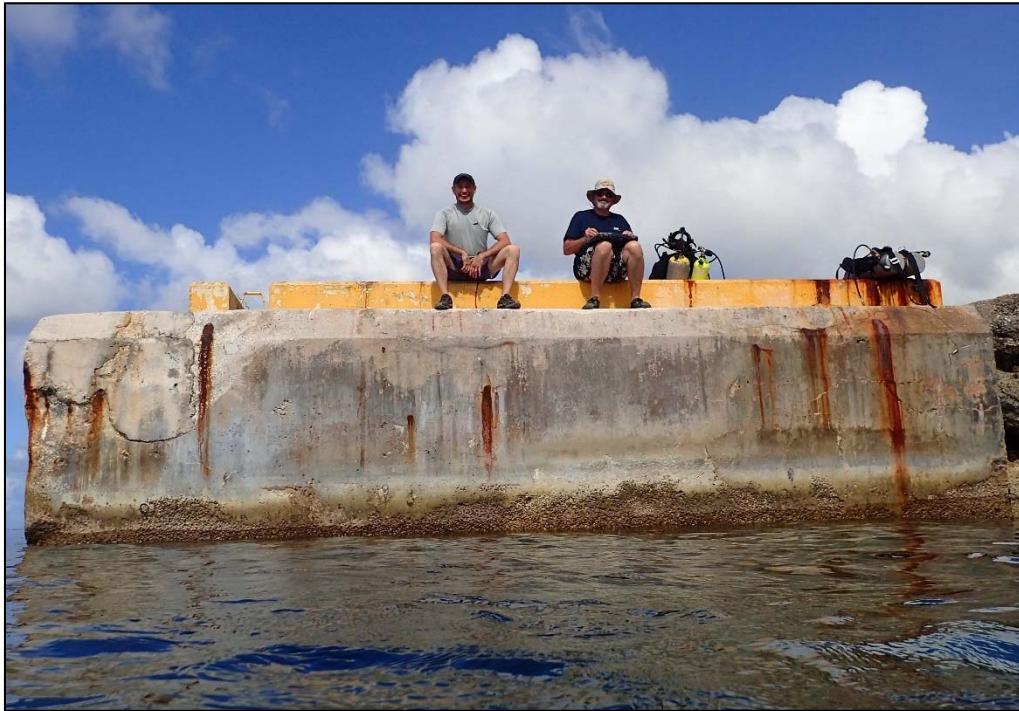
Photo 15. Berth 1 concrete cap. Corrosion spalling and bleeding noted throughout the south face. See Attachment B for further discussion of concrete deterioration.

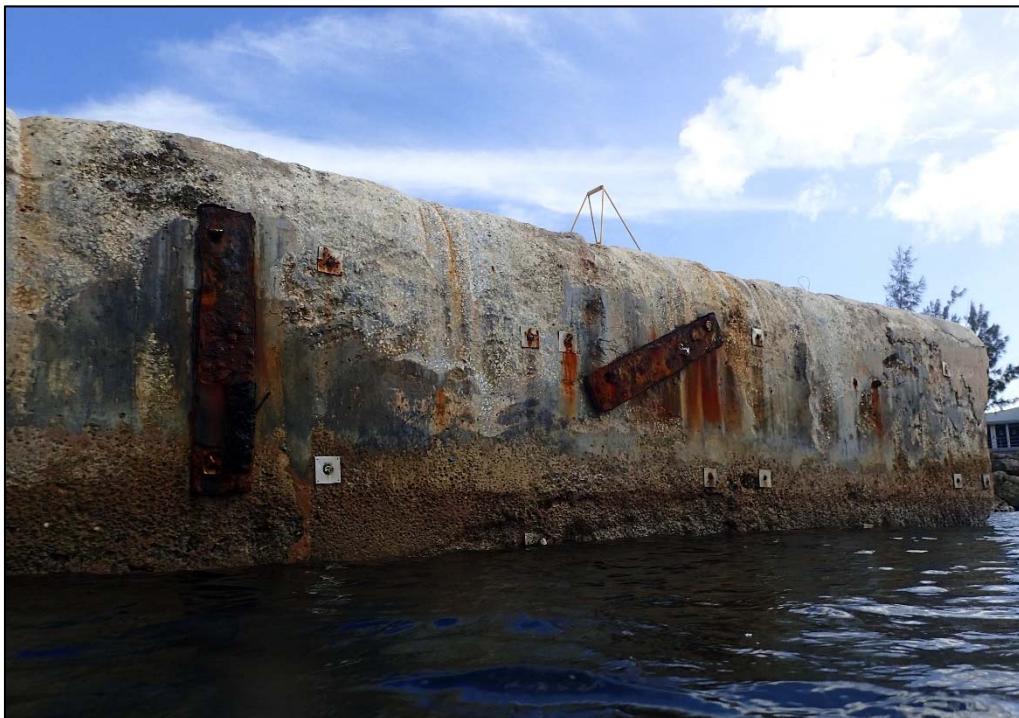
Photo 16. Berth 1 concrete cap. Widespread abrasion damage due to friction on the top of the cap and erosion damage resulting in cement particle/aggregate loss on the lower portion of the cap.

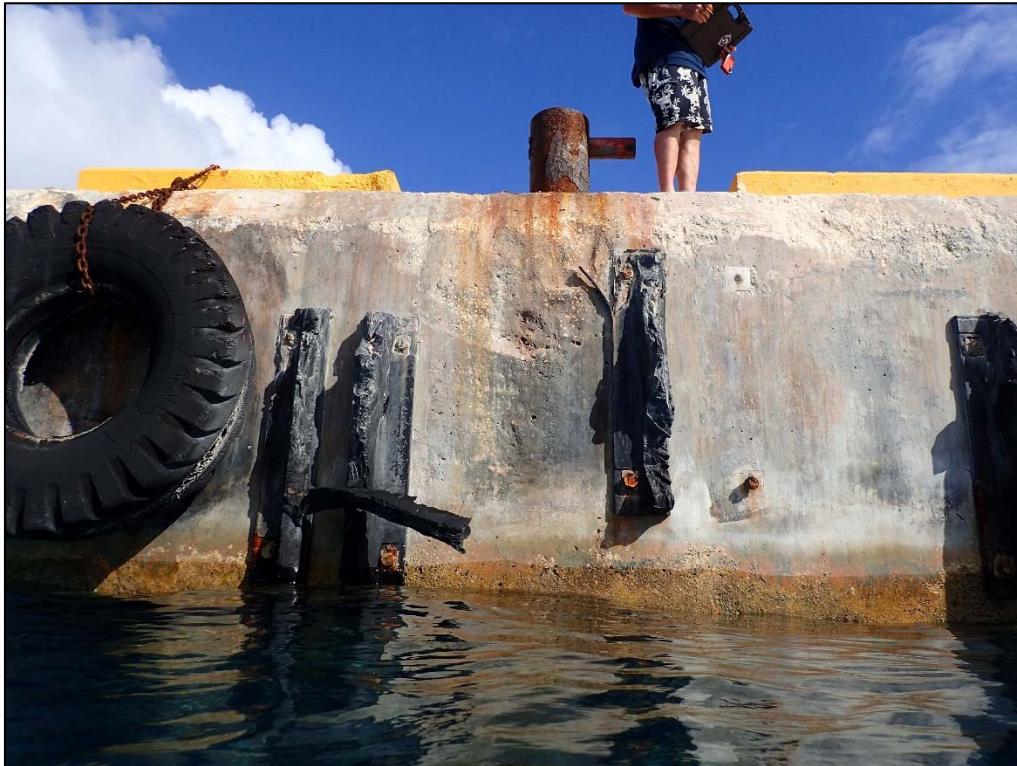
Photo 17. Berth 2 concrete cap. Typical condition of the face of the cap at Berth 1. The concrete is in satisfactory condition and less susceptible to abrasion damage than at Berth 2.

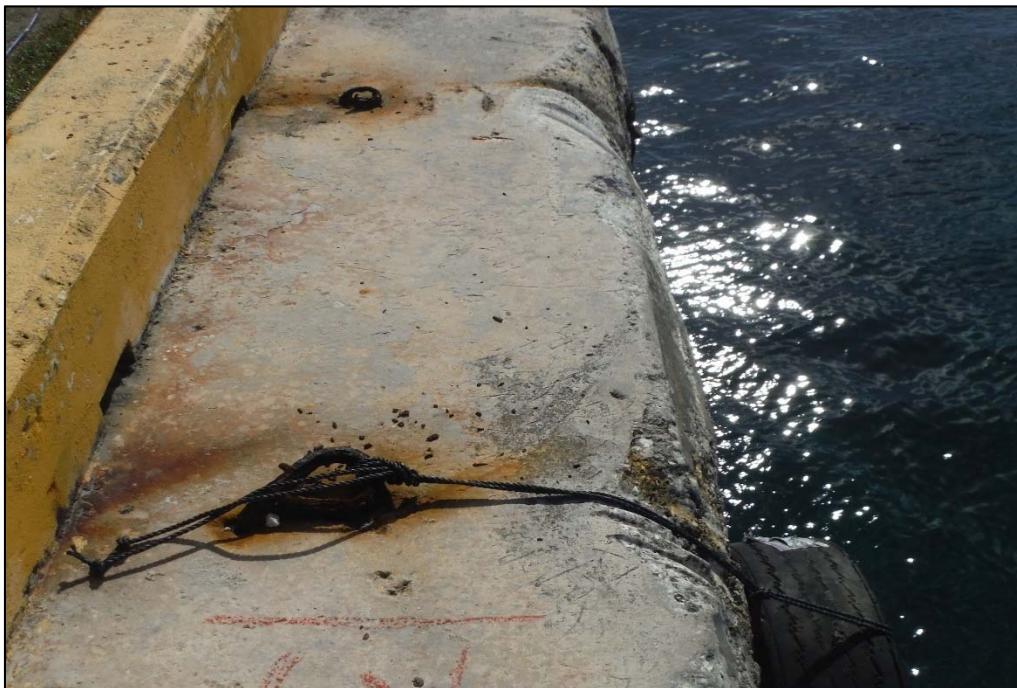
Photo 18. Berth 1 concrete cap Station 0+30 looking south. Typical abrasion damage seen from above deck from wires and chains used to hang tires for makeshift fenders. This is typical of both berths.

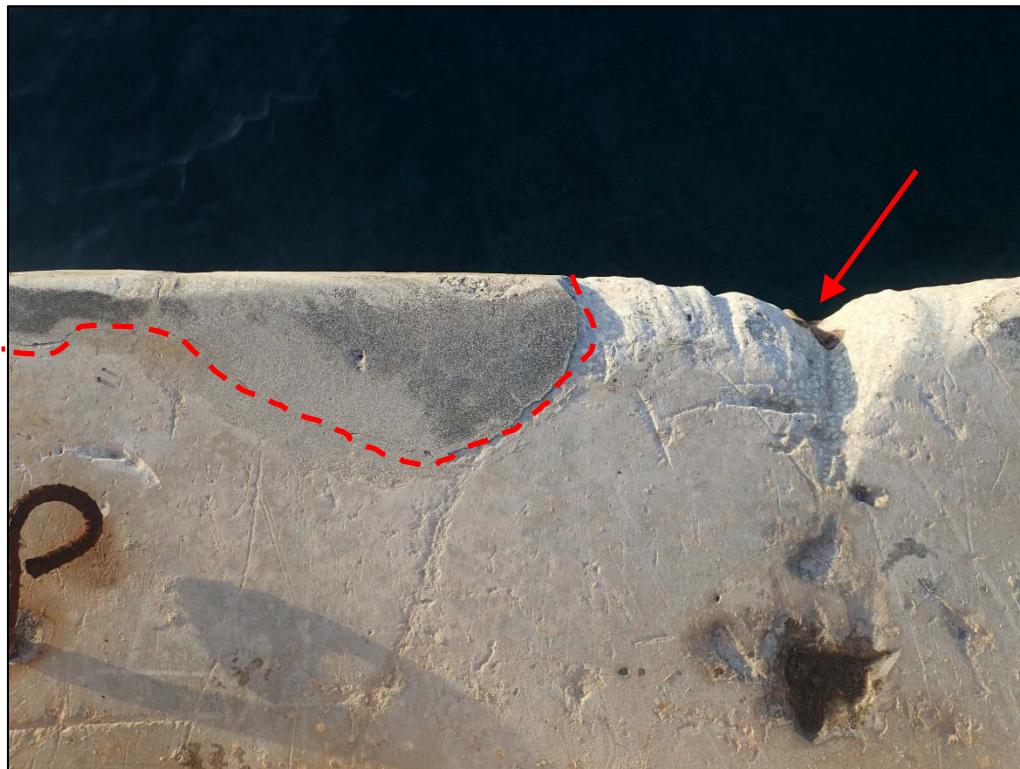
Photo 19. Berth 1 concrete cap Station 1+05. A repaired spall seen on the left (red dashed line) on top of the cap at Berth 1. There are a total of four repaired spalls at Berth 1. Typical abrasion damage with exposed rebar on the right (red arrow).

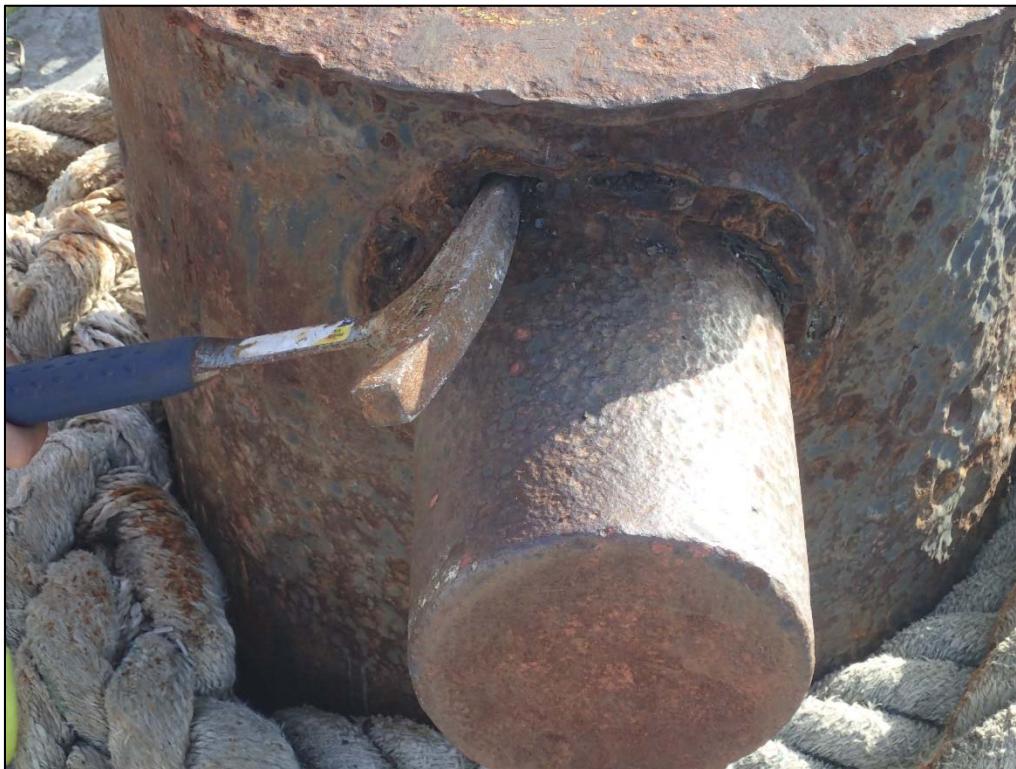
Photo 23. Berth 2, Sta. 0+50. Severe corrosion noted at the weld of the horn to the bollard cylinder. The hammer penetrates an area where there is 100% section loss of the weld material. The mooring bollard should be replaced.

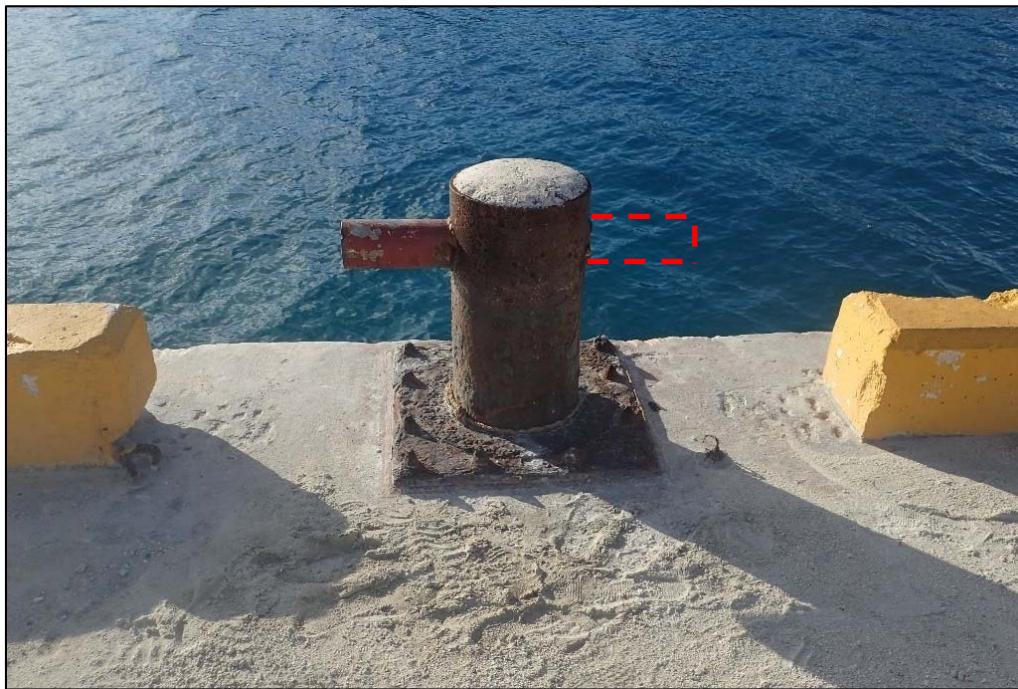
Photo 24. The bollard at Berth 2 Sta. 0+90 is missing a horn (red dashed line). The mooring bollard should be replaced.

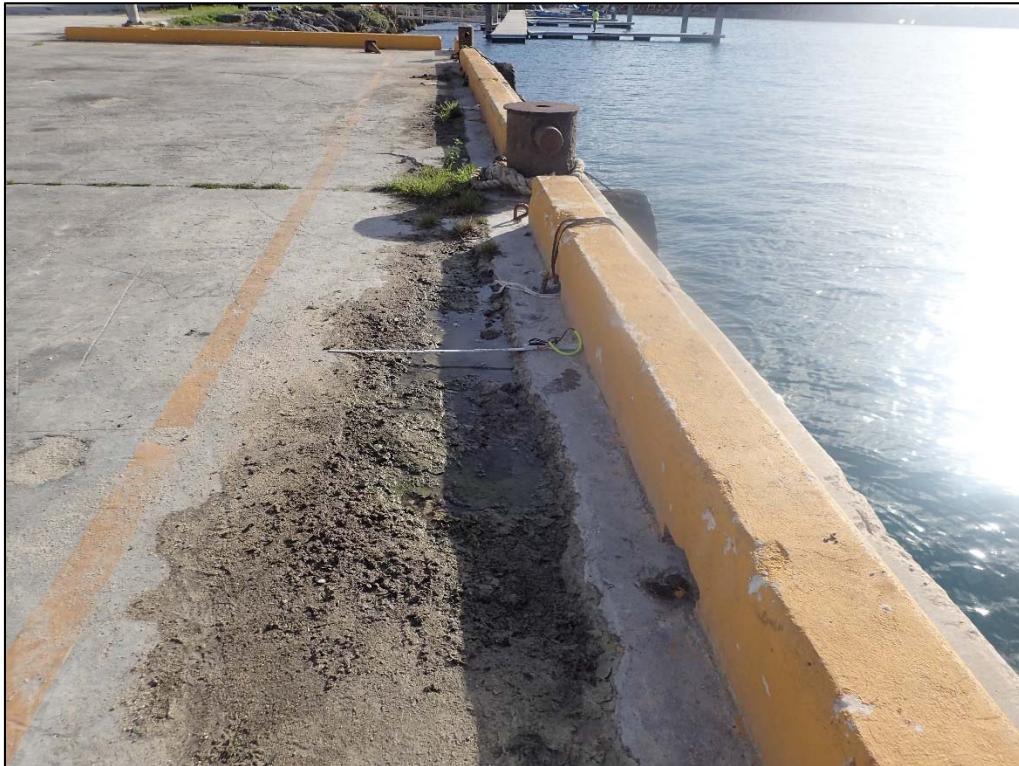
Photo 27. Subsidence behind the concrete cap at Berth 2 looking south.

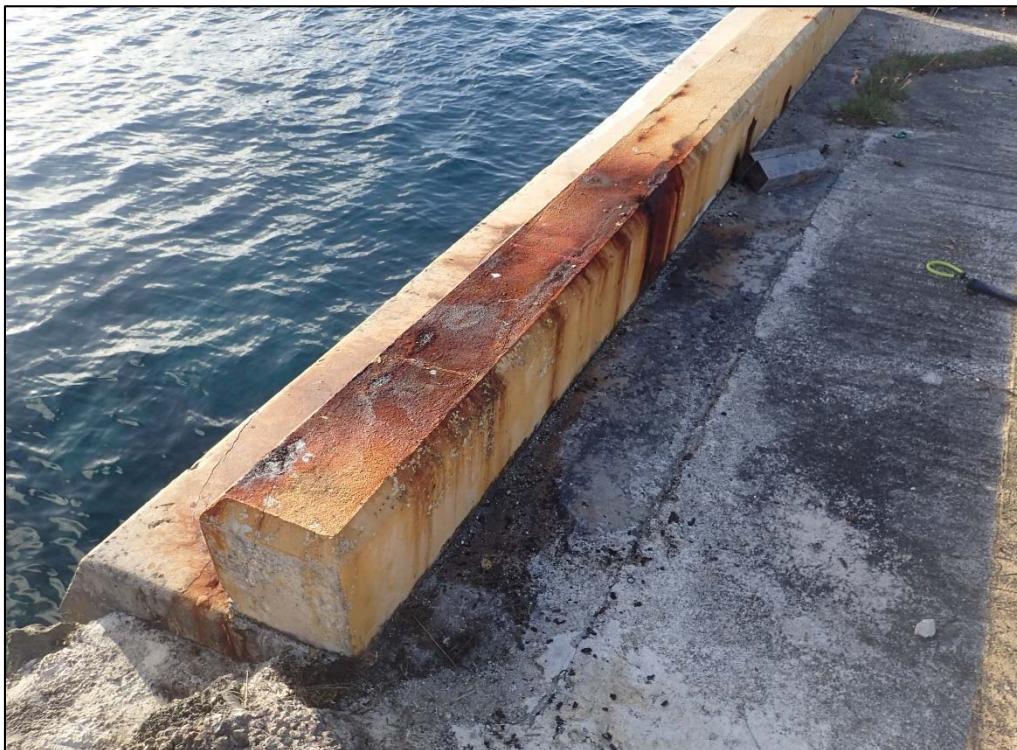
Photo 30. Berth 1. An example of closed corrosion spalling indicated by the orange staining and cracks at the edges of the curb on the south side.

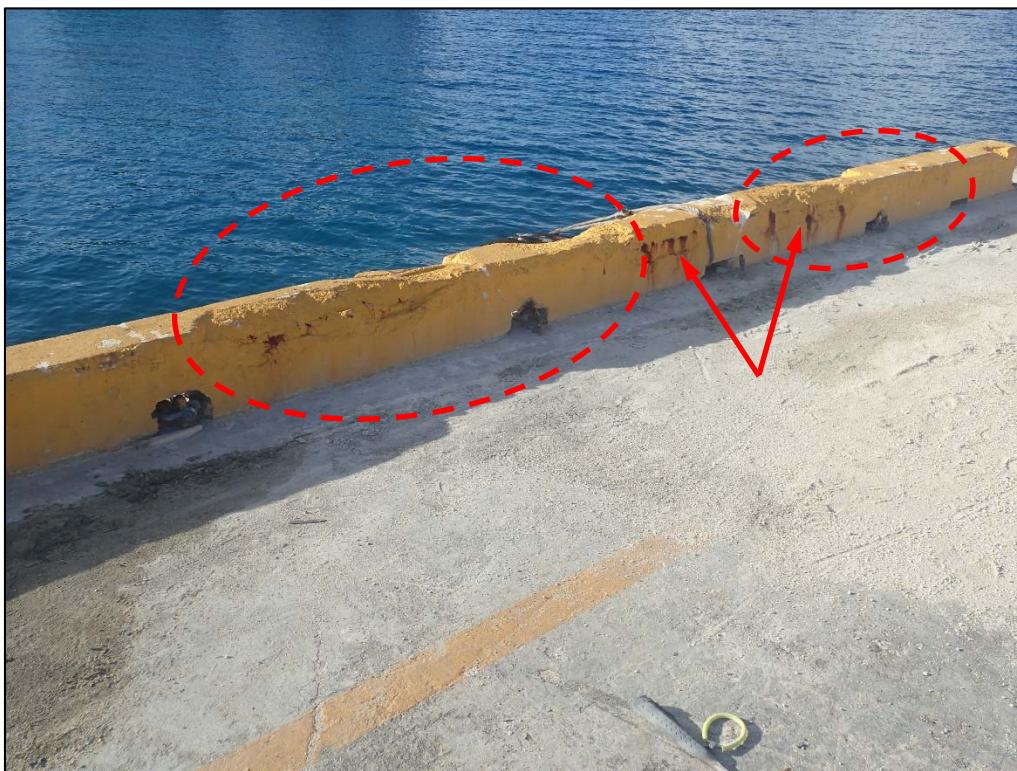
Photo 31. Berth 2. Typical corner spalls (oval) and rust bleeding (arrows) from Sta. 0+64 to 0+80.

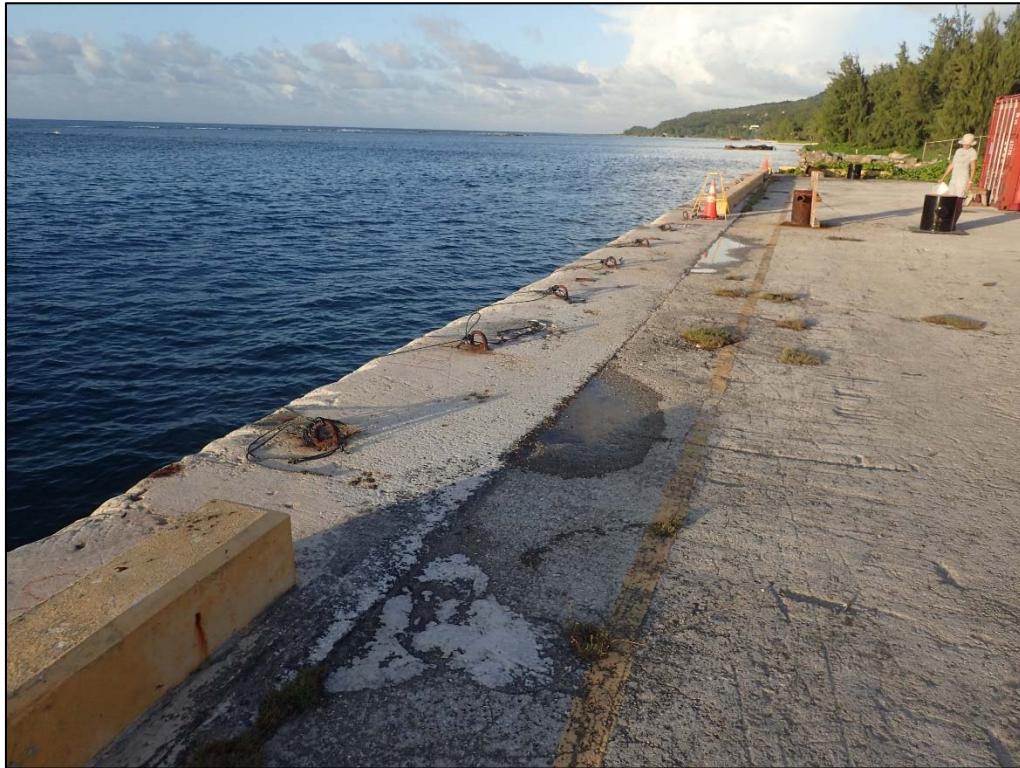
Photo 32. A section of curb was removed at Berth 1 from Station 0+33 to 0+75.

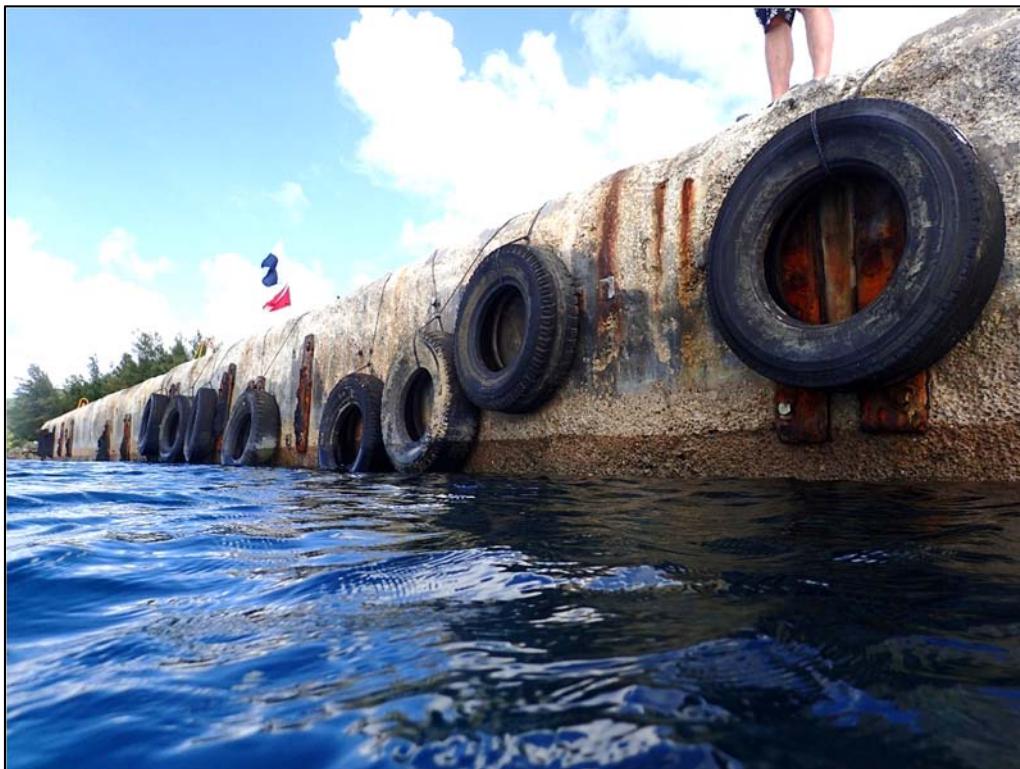
Photo 33. Berth 1. Remnants of failed V-fenders and tires found on the face of Berth 1.

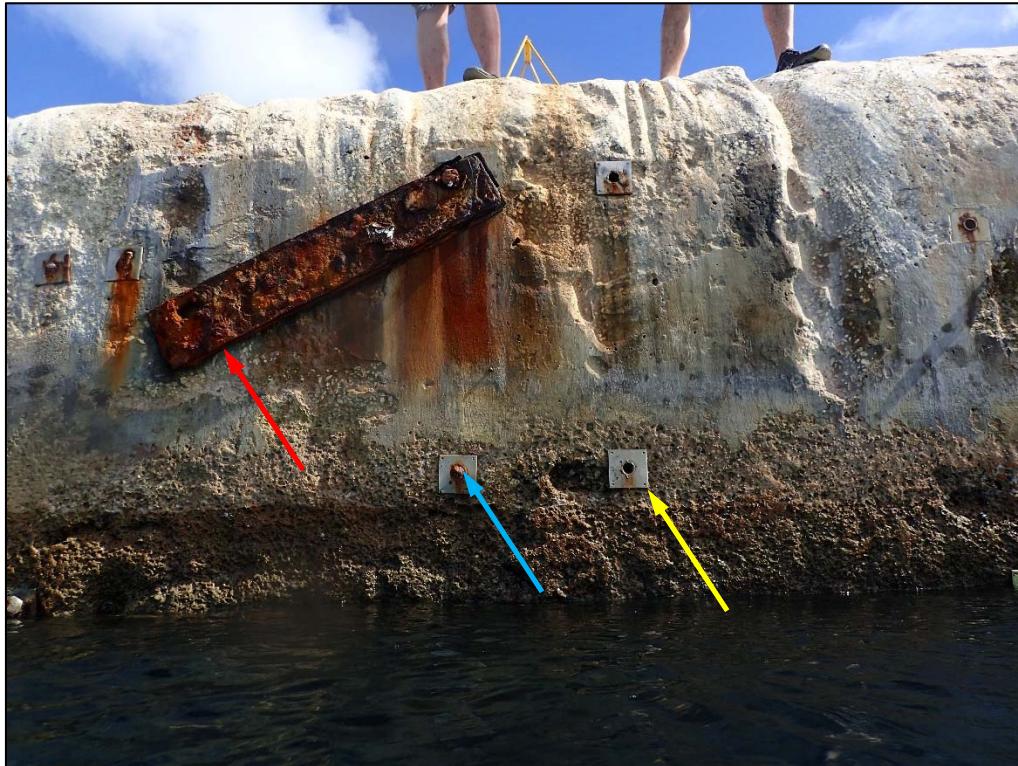
Photo 34. Berth 1. A remnant of the V-fender (red arrow), stainless steel inserts (yellow arrow) and bolts (blue arrow) remain.

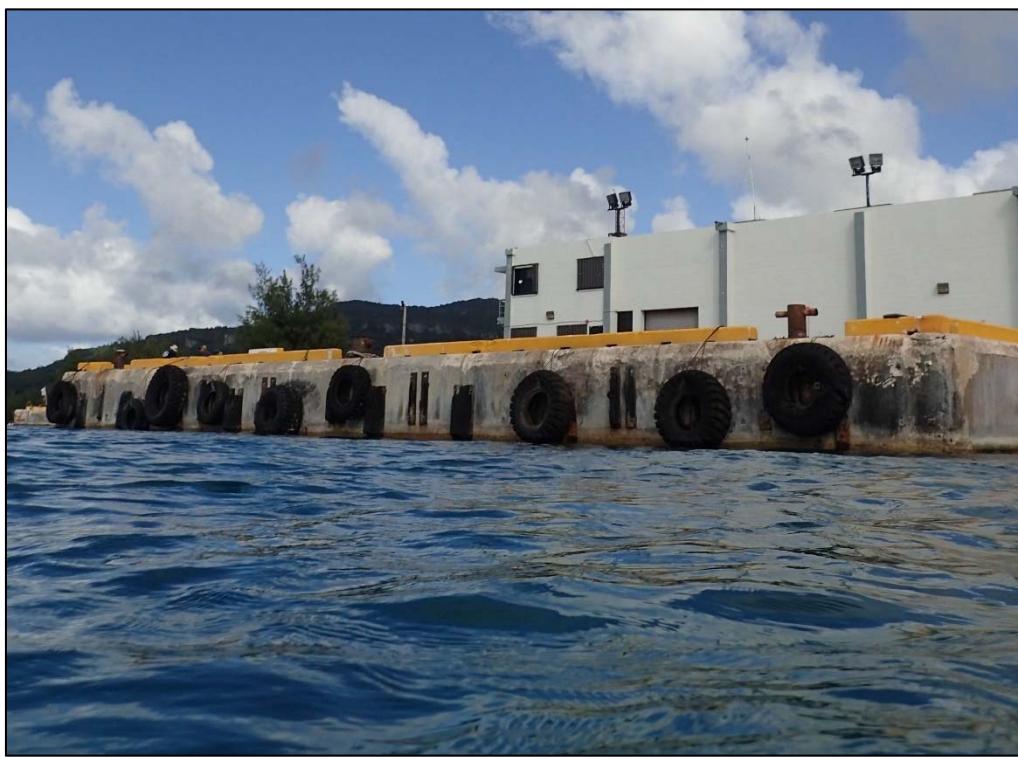
Photo 35. View of the V-fender remnants and added tires suspended from the curbs and cap at Berth 2.

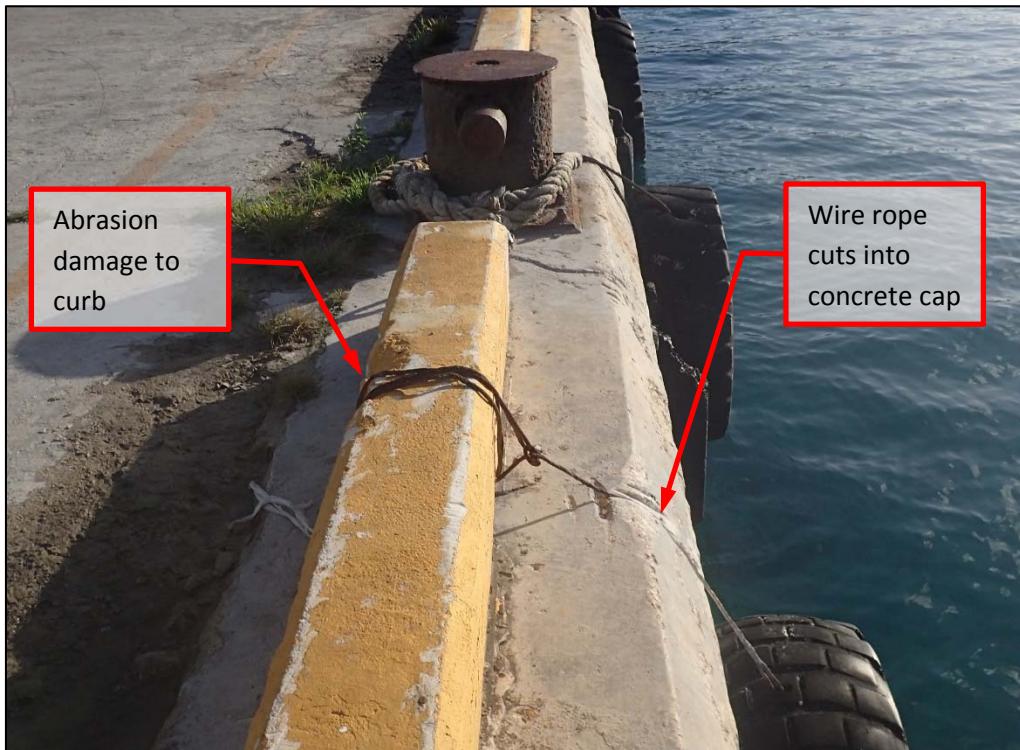
Photo 38. Berth 2 Station 0+55. Wire rope is used to fasten the tire to the curb resulting in abrasion damage to the curb and the corner of the concrete pile cap.

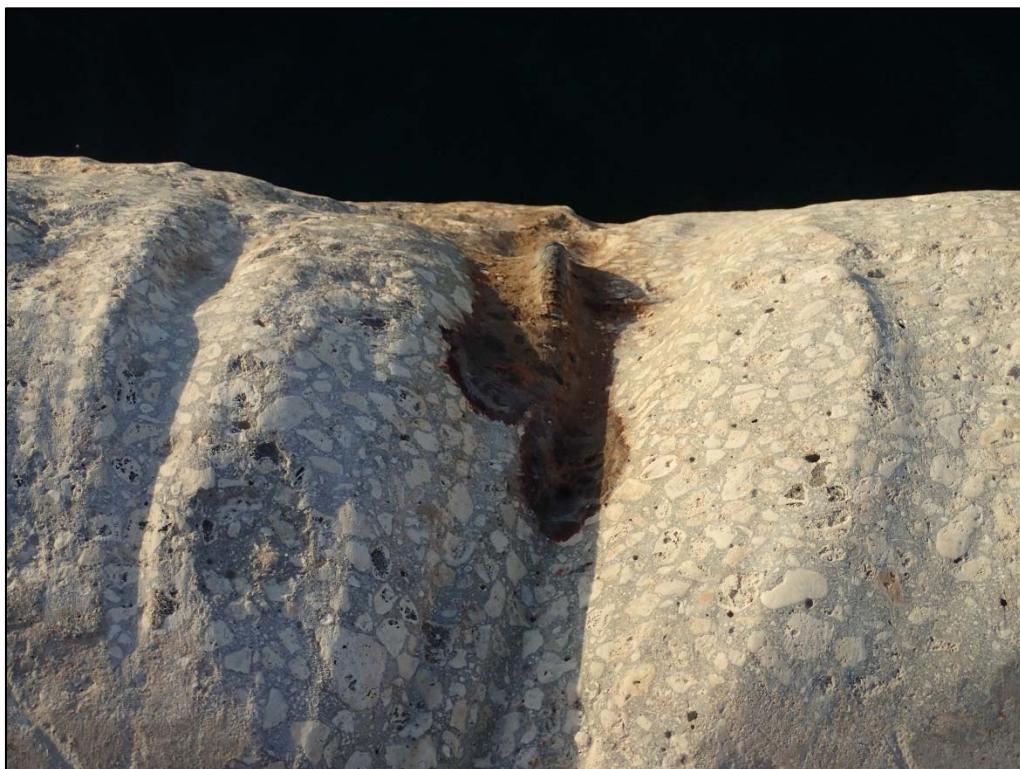
Photo 39. Berth 1 Sta. 1+05. Abrasion damage from hanging tire fenders resulting in exposed reinforcing steel in the concrete cap.

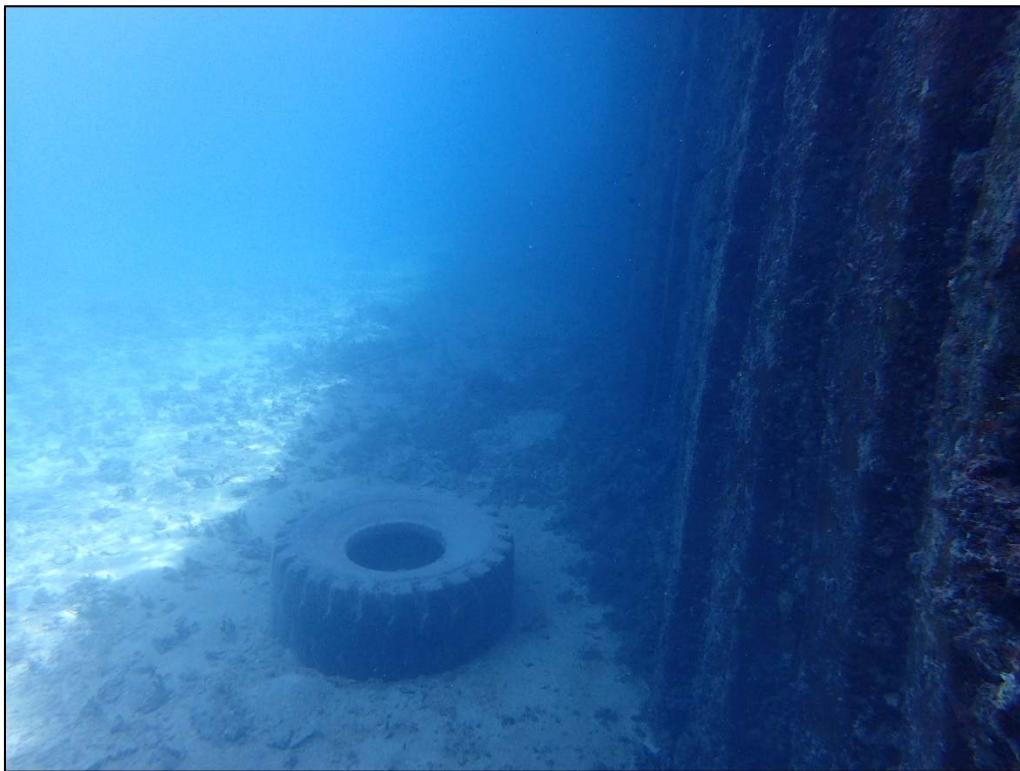
Photo 42. The bottom condition and a tire at Berth 2 Station 0+40.
