Drinking Water and Wastewater Master Plan – Rota, Commonwealth of the Northern Mariana Islands

Prepared for
Commonwealth Utilities Corporation

June 2015

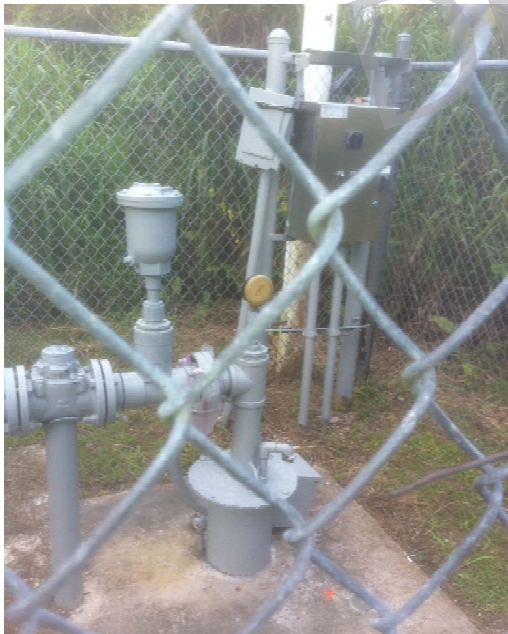
Figure 2.2.2-1. Typical Well Fencing

The wellheads inspected were in good condition. No ponding or large cracks were observed on the wellhead slabs. The wellheads commonly consisted of an 8- to 10-inch riser elevated 10 to 18 inches above the wellhead slab.

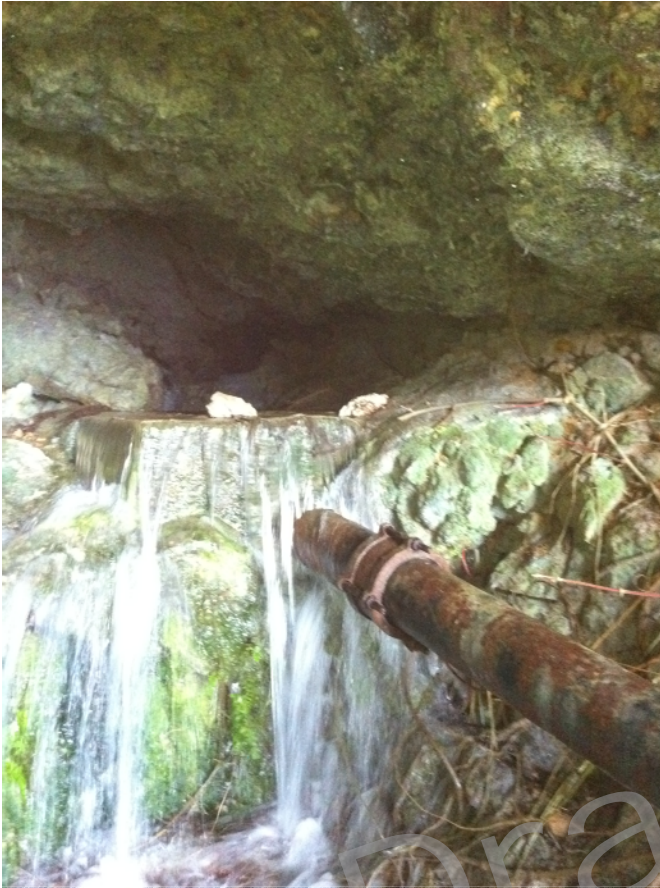
Figure 2.2.2-4. Onan Cave Overflow

Based on the field assessments and the GWUDI study (discussed later), the primary recommendation is to harden the Rota Cave against surface related contamination and to abandoned the Onan Cave because of the inability to properly seal it. The outer structure around the Rota Main Cave should be hardened with a taller fence to improve security against intruders. If in the future unauthorized intrusion becomes a problem, CUC could consider deploying a solar powered video camera with cellular communications.

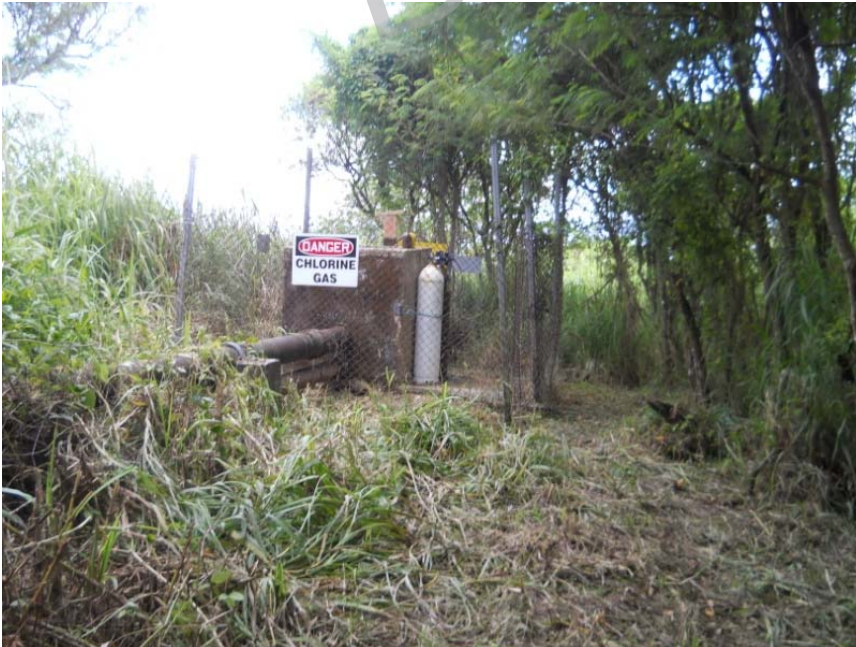
Figure 2.2.2-6. Chlorination System along the Onan Cave Transmission Line

The pressure differential over the abandoned PRV along the Onan Cave/Ginanlangan Tank transmission line is also large enough to generate a vacuum in the ejector. To generate the vacuum a large amount of flow, estimated at 700 gpm, is also needed. The combined flows from the Main Cave and Onan Cave have been enough to keep the Onan Cave transmission line chlorination system operating year round. Figure 2.2.2-6 is a photo of the chlorination system along the Onan Cave transmission line.

While this is not the typical condition for most chlorination systems, it does make efficient use of the existing hydraulics. This results in power savings because a booster pump is not needed.

It is recommended that an engineer experienced in chlorination systems evaluate the Rota treatment systems and design a proper chlorination system. Options that may be considered are as follows:

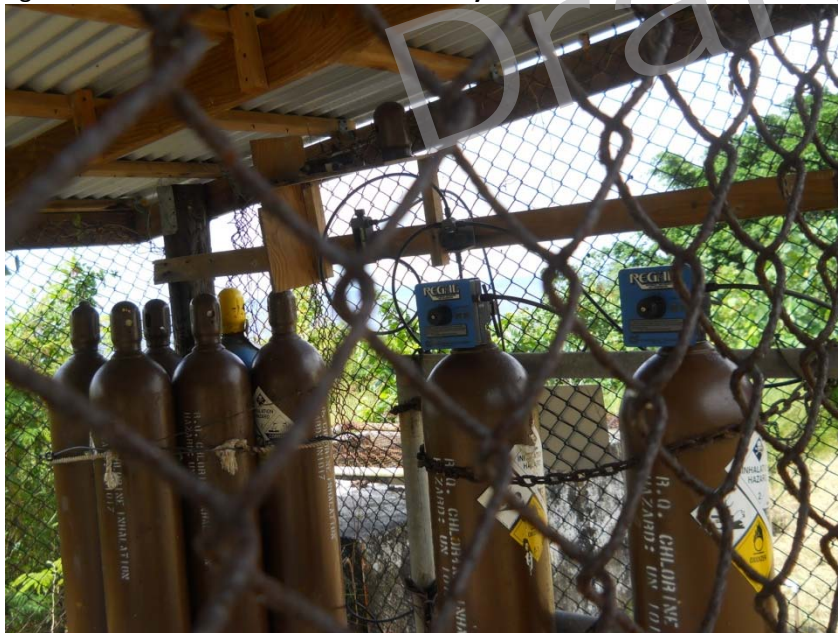
Figure 2.2.2-7. Kaan Tank Active Chlorine Cylinders

No chlorine alarm scale is installed at either site. The chlorine cylinders were properly chained to a secure wall at each site, but the sites are still accessible to vandalism.

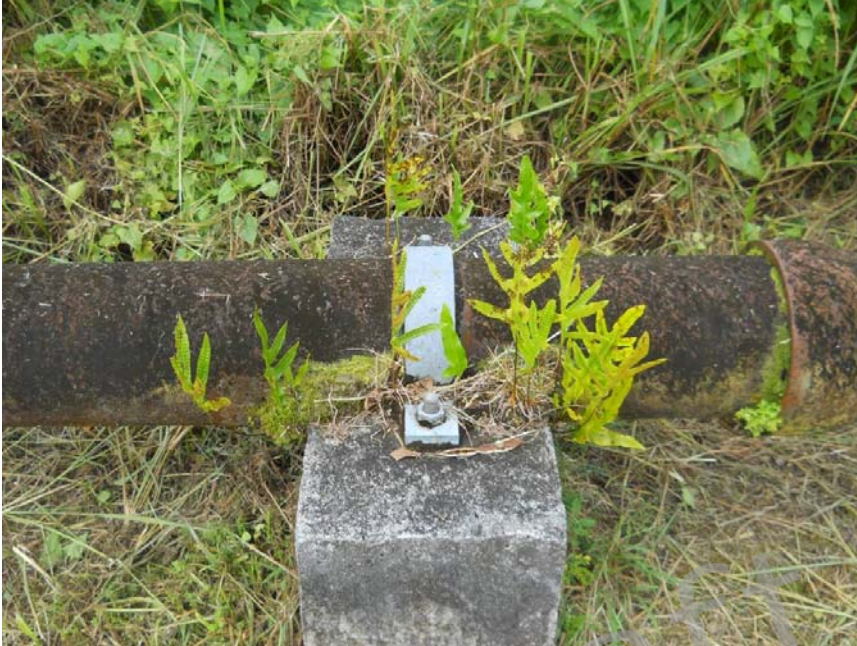
Figure 2.2.2-9. Kaan Transmission Line and Concrete Pedestal

The concrete pedestals that the transmission lines are secured to show signs of root intrusion. CUC conducts routine clearing around these pedestals to control the root intrusion.

- Continue to conduct routine clearing around the concrete pedestals that support aboveground transmission pipelines to control the root intrusion.
- Routine painting of the site piping is recommended.

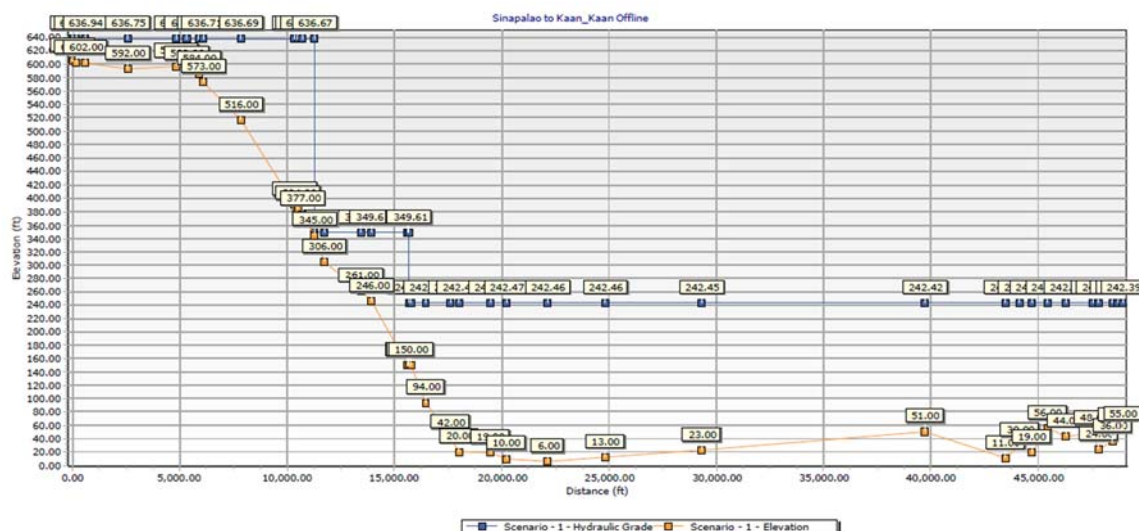
Figure 2.2.3-6. Model Output of HGL from Ginanlangan to Kaan Tank

The real-world condition between the two PRVs is a vacuum. This status was confirmed by opening a fire hydrant between the two PRVs. The condition may be the result of a HGL set by the Kaan tank. Project team personnel could not confirm that the Kaan tank was off line. Some notable measured and modeled points include the following:

- Specify aluminum or stainless steel pilot piping for reapers, upgrades, and replacements.
- Install a pressure reducing/sustaining valve (PRSV) at the existing upper PRV as a short-term correction to vacuum and pump cavitations between the Ginanlangan to Kaan Tanks.
- Conduct additional training on the maintenance and operation of PRVs.

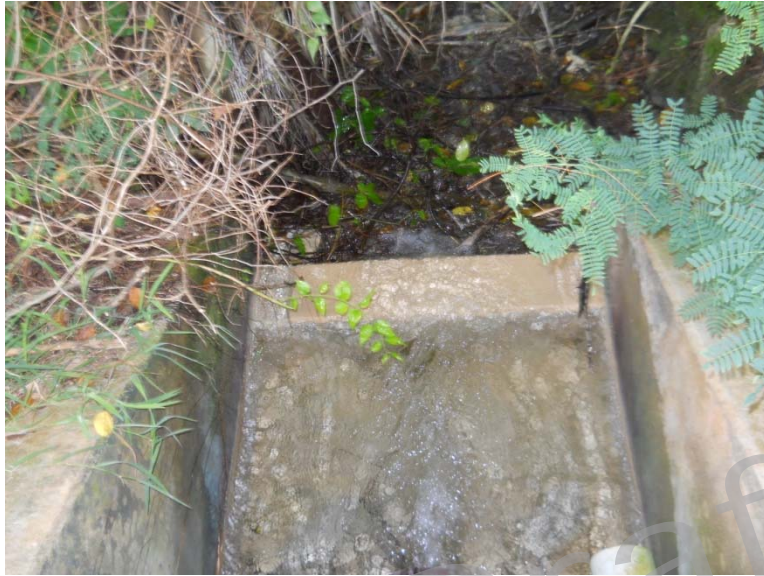
Figure 2.2.3-11. **Photo of the Kaan Tank Overflowing during the Wet Season**

- Repair the altitude valve at the Kaan Tank as an interim recommendation until Rota Water System Reconfiguration Phase II project decommissions the Kaan Tank.
