2021

# Availability of Street-Level Supports for Walking in Saipan

Commonwealth of the Northern Mariana Islands

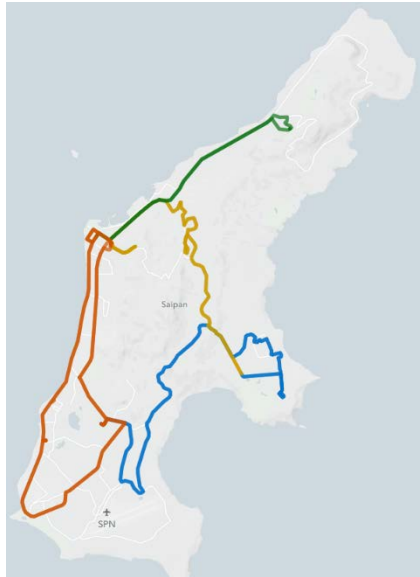
Figure 2. COTA Proposed Route System  
Commonwealth Office of Transit Authority, 2020

Saipan was selected as the focus of this assessment, as the majority of the population in the CNMI lives on this island and it is the official capital of the CNMI. A key aspect of walkability is increasing transportation options for community members. A partnership with the CNMI's public transportation office, the Commonwealth Office of Transit Authority (COTA), was formed to determine assessment sites on the island of Saipan. This partnership was key in identifying sites of interest for site selection. As of 2020, there were two COTA bus routes currently in place and another three routes are proposed to serve the island of Saipan (figure 2). The goal of this partnership was to determine the walkability in each of these routes to assess feasibility and accessibility of the bus stops.

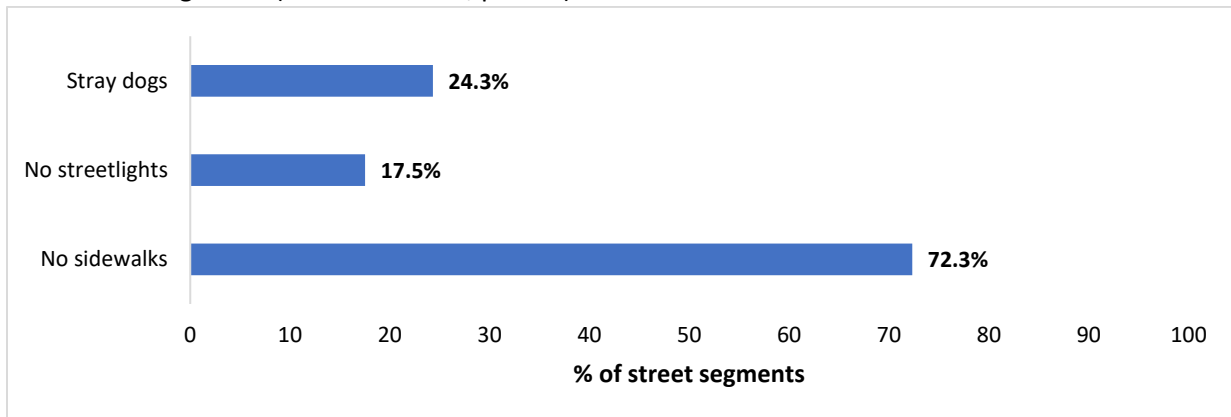
Figure 3. Street-Level Safety Hazards on Saipan, 2021

When safety factors were assessed, it was found that 17.5% of segments have no street lights, 24.3% had stray dogs present during the audit, and 72.3% had no sidewalks (figure 3). Of the segments with sidewalks, 78.3% had no buffer between the sidewalk and the road. Of the segments without a sidewalk, 30.7% had no other roadside space to walk. Of the segments with roadside space to walk, 35.4% had overgrown vegetation that restricted walking or biking. Interestingly, commercial segments had a higher prevalence of no streetlights compared to residential segments (19.2% vs 12.0%,  $p < 0.05$ ). In addition, residential segments had a significantly higher prevalence of stray dogs present compared to commercial segments (42.0% vs 18.6%,  $p < 0.05$ ).

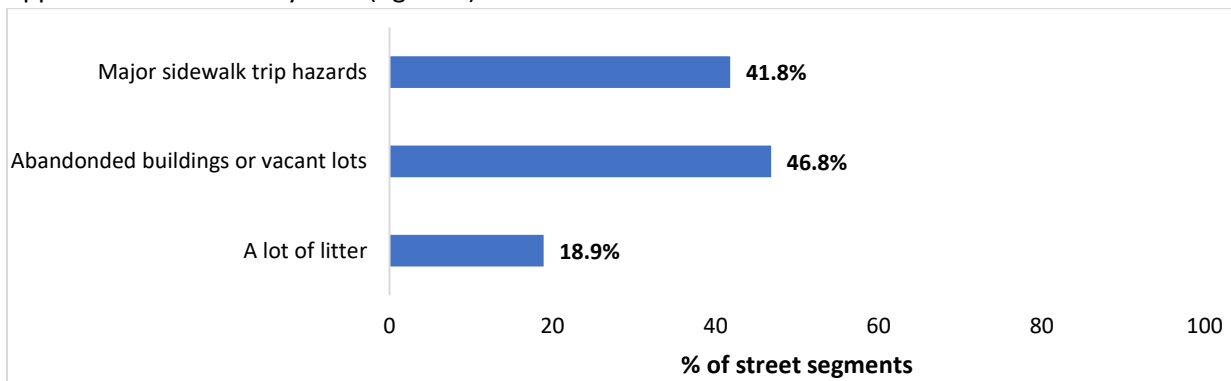
Figure 4. Street-Level Physical Disorder on Saipan, 2021

When physical disorder was assessed, it was found that 41.8% of sidewalks had major trip hazards, such as misalignment, overgrowth, cracks, or an incomplete sidewalk. 46.8% of segments had abandoned buildings or overgrown vacant lots and 18.9% were considered to have some or a lot of litter, as opposed to none or very little (figure 4).

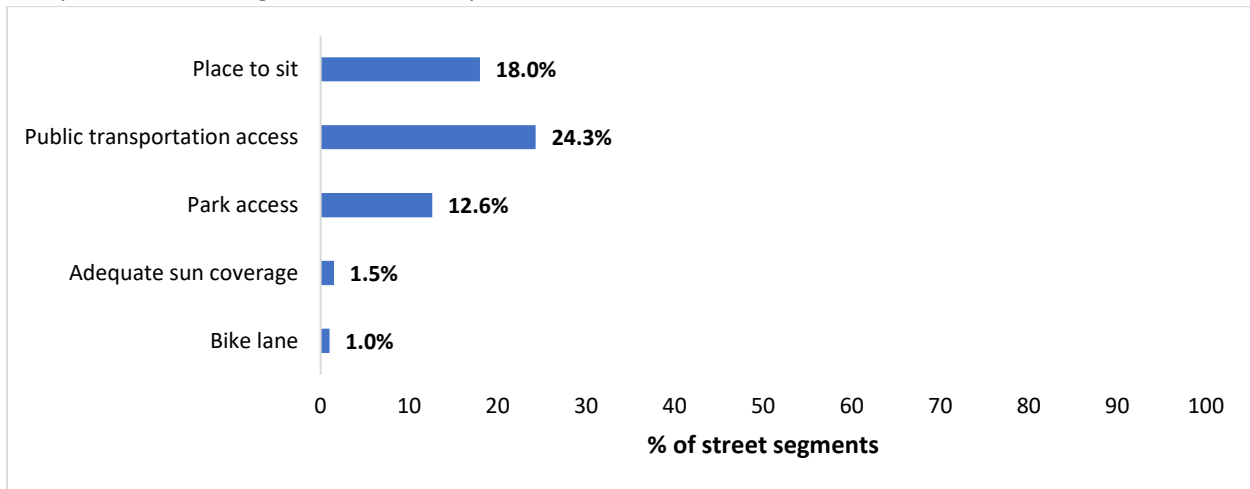
Figure 5. Street-Level Functional Design on Saipan, 2021

When functional design was assessed, it was found that 12.6% of segments had access to a park, 24.3% had public transportation access, 18.0% had places to sit, 1.5% had adequate sun coverage, and 1.0% had a designated bike lane (figure 5). There was significantly more public transportation access in commercial areas (30.1%), compared to residential (6.0%) ( $p < 0.05$ ). There were significant sun coverage differences between commercial and residential, with residential areas having a higher percentage of adequate sun coverage (2.0% vs 1.3%,  $p < 0.05$ ).

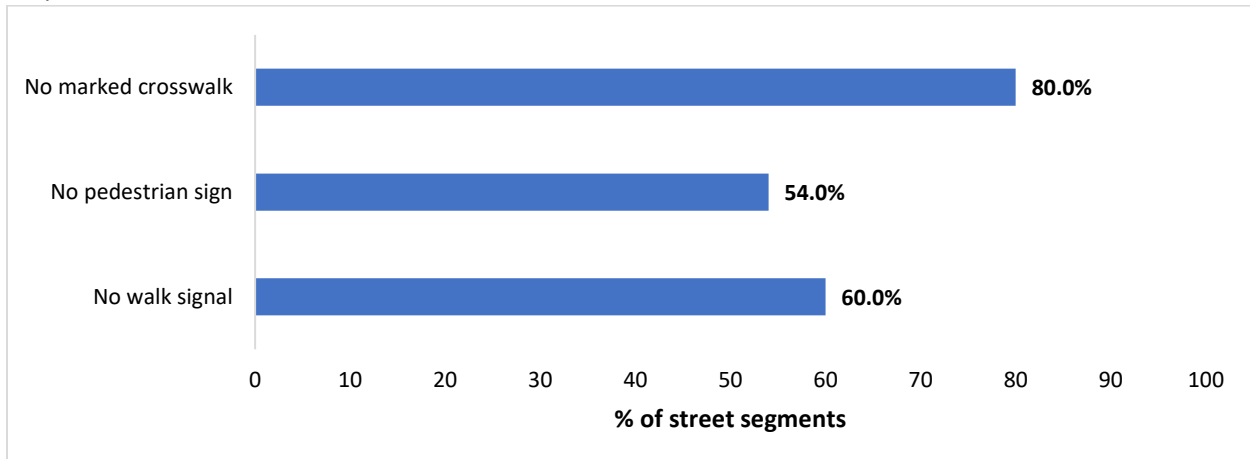
Figure 6. Crossings on Saipan, 2021

When crossings were assessed, it was found that 60.0% had no walk signal present, 54.0% had no pedestrian signs present, and 80.0% had no marked crosswalk on the road (figure 6, table 4). Of the crosswalks that were marked, 67.4% were worn or faded to the point they are difficult to see. When ramps at curbs were assessed, 64.7% had no ramps, 11.8% had only one ramp, and 23.5% had ramps at both curbs. In addition, 84.3% of crossings had overgrown vegetation that restricts roadside access for walking or restricts crossing visibility. Qualitative data collected from the audit tool noted auditor comments in the field, including lack of crosswalk access, high traffic areas, and nonfunctional walk signals. One auditor noted the danger of some crosswalks in high traffic areas, where most cars do not stop.

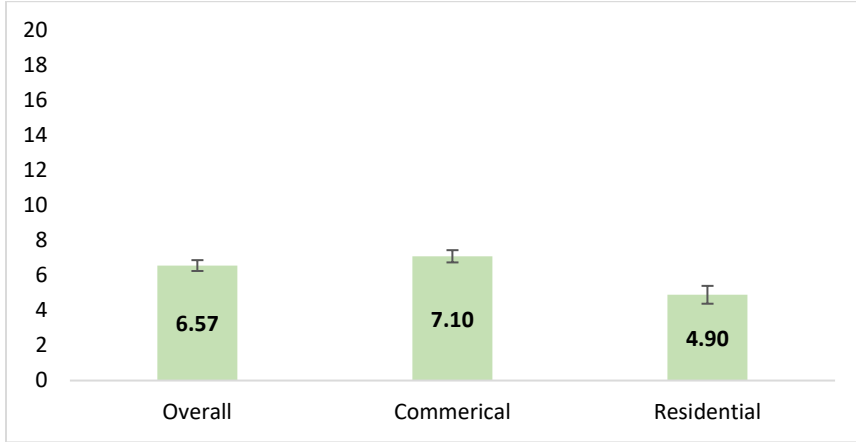
Figure 7. Walkability Scores by Area Types on Saipan, 2021

The overall walkability score of all street segments evaluated on Saipan was 6.57 (95% CI: 6.25, 6.88) out of 20 possible points (table 3). Commercial areas had a higher walkability score (7.10; 95% CI: 6.76, 7.45) than residential areas (4.90; 95% CI: 4.39, 5.41) ( $p < 0.05$ ) (figure 7). However, there was variation among the segments audited, regardless of segment type (figure 8).

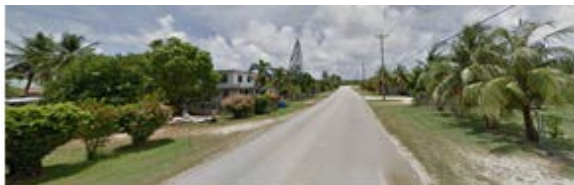
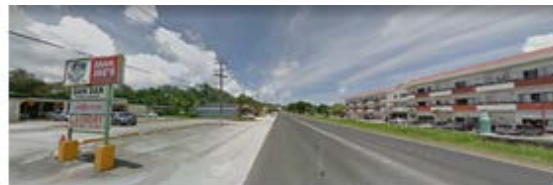
S2.	Type of segment	<input type="checkbox"/> Residential(0) <input type="checkbox"/> Commercial (1)
-----	-----------------	--

Decide whether the segment predominantly consists of residential housing or commercial buildings. If the segment is evenly split, choose “commercial”.

Residential

Commercial

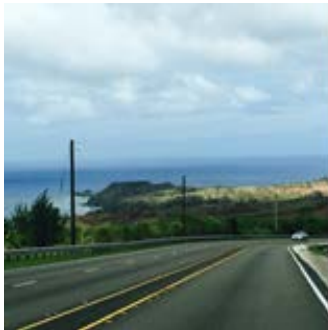
S6.	Are street lights installed?	<input type="checkbox"/> None (0) <input type="checkbox"/> Some (wide spacing) (1) <input type="checkbox"/> Ample (regularly spaced) (2)
-----	------------------------------	--

None

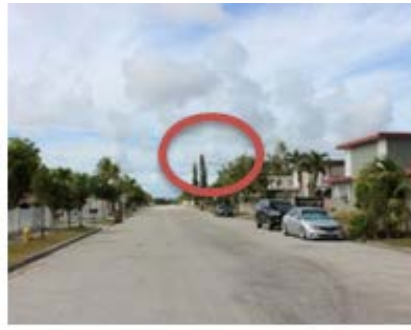
Some (wide spacing)

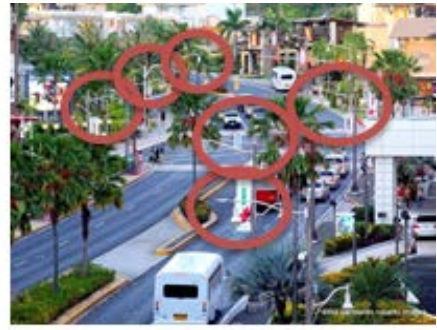
Ample (regularly spaced)

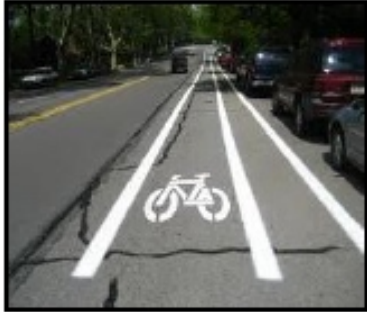
S8.	Is there a designated bike lane? (do not include sharrows or shared lane markings)	<input type="checkbox"/> No (0) <input type="checkbox"/> Painted line (1) <input type="checkbox"/> Physical barrier (2)
-----	--	---

**Painted bike lane**

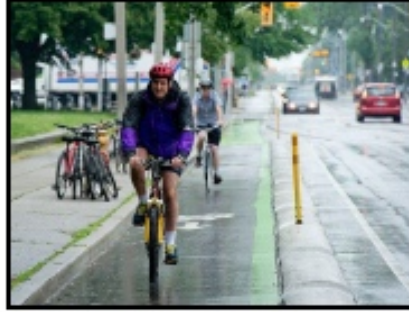
**Bike lane separated from traffic**

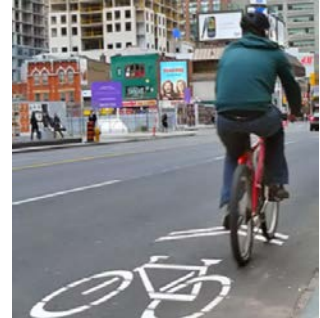
**Sharrow**

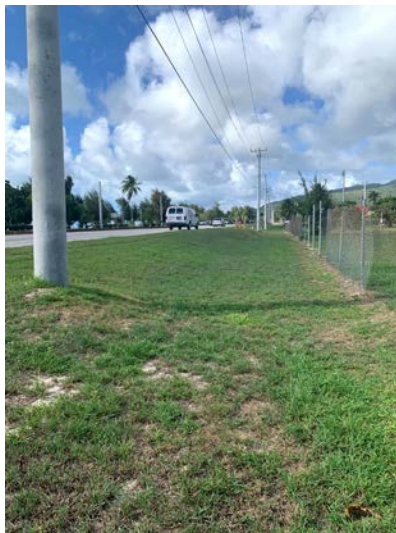
S9.	Is a sidewalk present? <i>If no, skip to S12</i>	<input type="checkbox"/> No (0) <input type="checkbox"/> Yes (1)
-----	--	---

No sidewalk

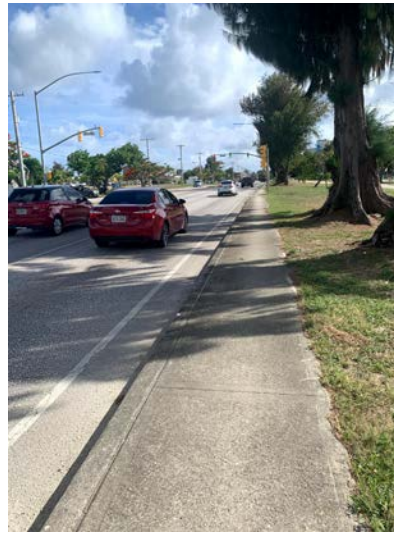
Count any sidewalk along a segment, whether short or long.

Sidewalk

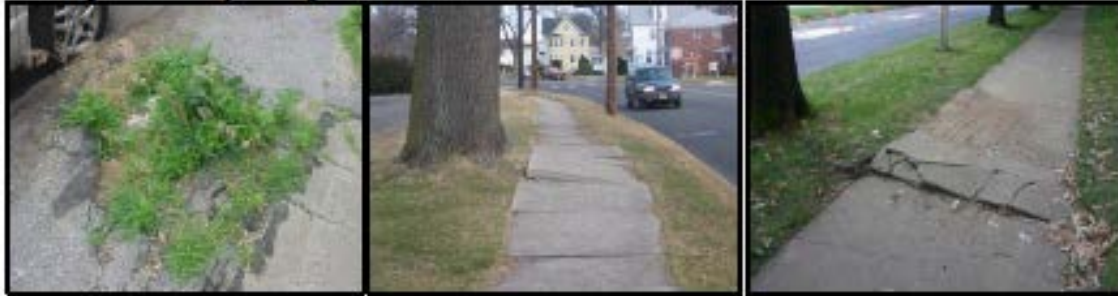
**Examples of major trip hazards**

A major trip hazard increases the likelihood of tripping due to a raising or lowering in the walkway. A hazard could be due to plants, roots, slippery moss, or general erosion. A major trip hazard would require pedestrians to look down to avoid tripping.

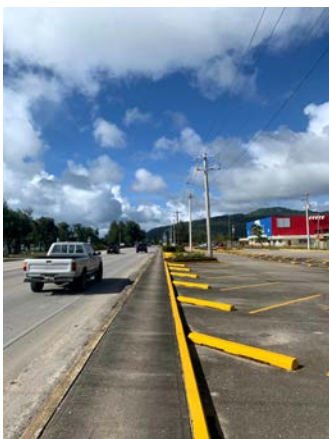
No Buffer

A buffer separates vehicular and pedestrian zones parallel to the edge of paved roads. They often occupy space between traffic lanes and walking paths that is not intended for either vehicular traffic or walkers. Any buffer on a segment, no matter how long, will be counted.

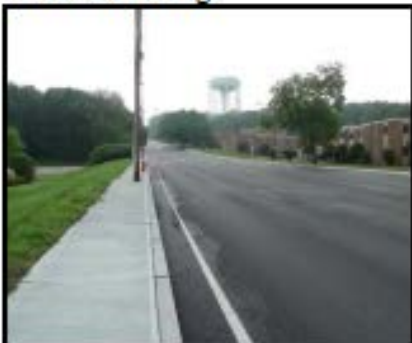
S14.	What percentage of the length of the sidewalk/walkway is covered by trees, awnings, or other overhead coverage?	<input type="checkbox"/> 0-25% (0) <input type="checkbox"/> 26-75% (1) <input type="checkbox"/> 76-100% (2)
------	---	---

**0-25% coverage**

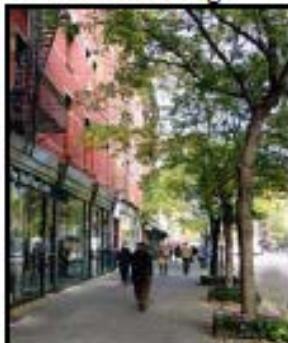
**26-75% coverage**

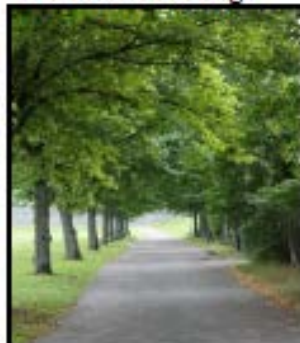
**76-100% coverage**

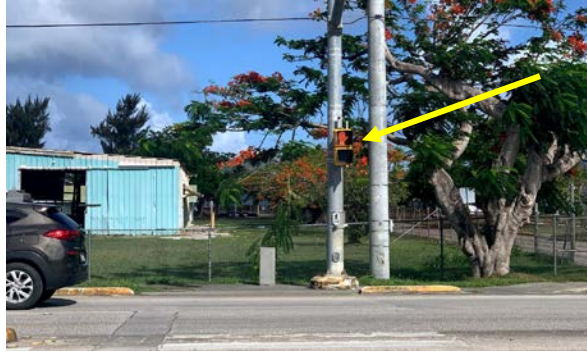
Pedestrian walk signals provide some indication for the pedestrian to know when to walk or don't walk.

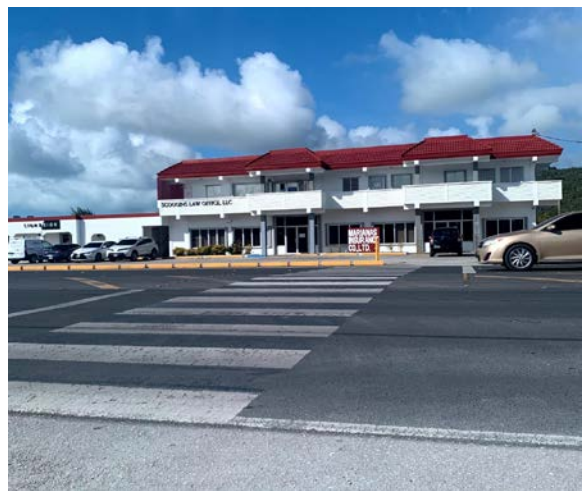
A marked crosswalk is a designated point on a road at which some means are employed to assist pedestrians wishing to cross. They are designed to keep pedestrians together where they can be seen by motorists, and where they can cross most safely with the flow of vehicular traffic. Pedestrian crossings are often at the intersections, but may also be at other points at busy roads that would otherwise be dangerous to cross.

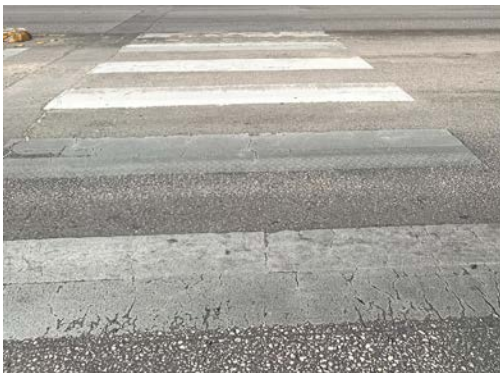
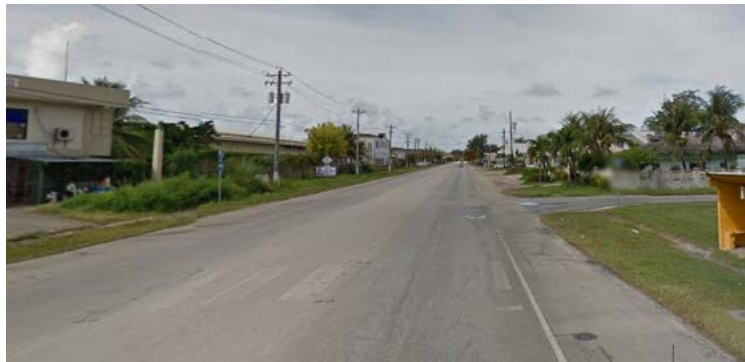
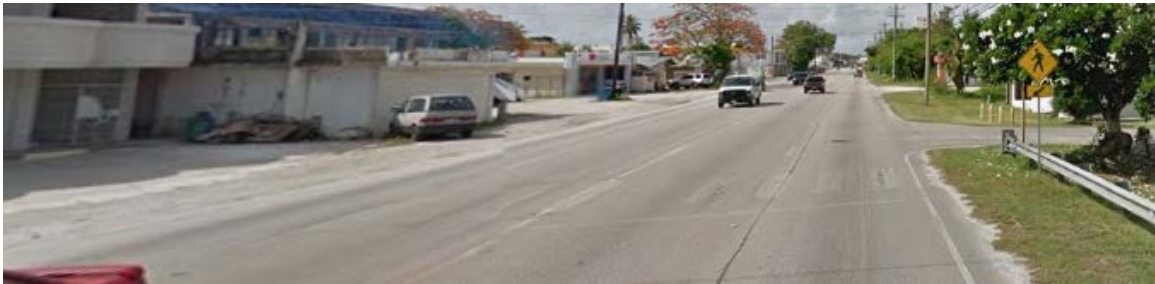
C6.	Are any of these crosswalks worn or faded to the point that they are difficult to see?	<input type="checkbox"/> No (0) <input type="checkbox"/> Yes (1)
-----	--	---

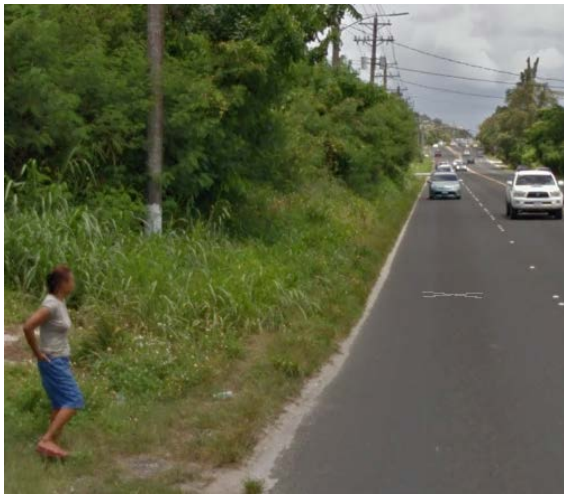
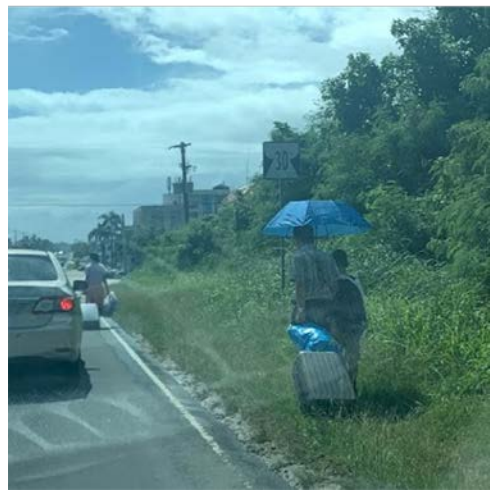
C7.	Does overgrown vegetation restrict roadside access for walking/biking or restrict corner/crossing visibility?	<input type="checkbox"/> No (0) <input type="checkbox"/> Yes (1)
-----	---	---
