2018  
Commonwealth of the Northern Mariana Islands  
305(b) and 303(d),  
Water Quality Assessment Integrated Report

Bureau of Environmental and Coastal Quality  
September 2018

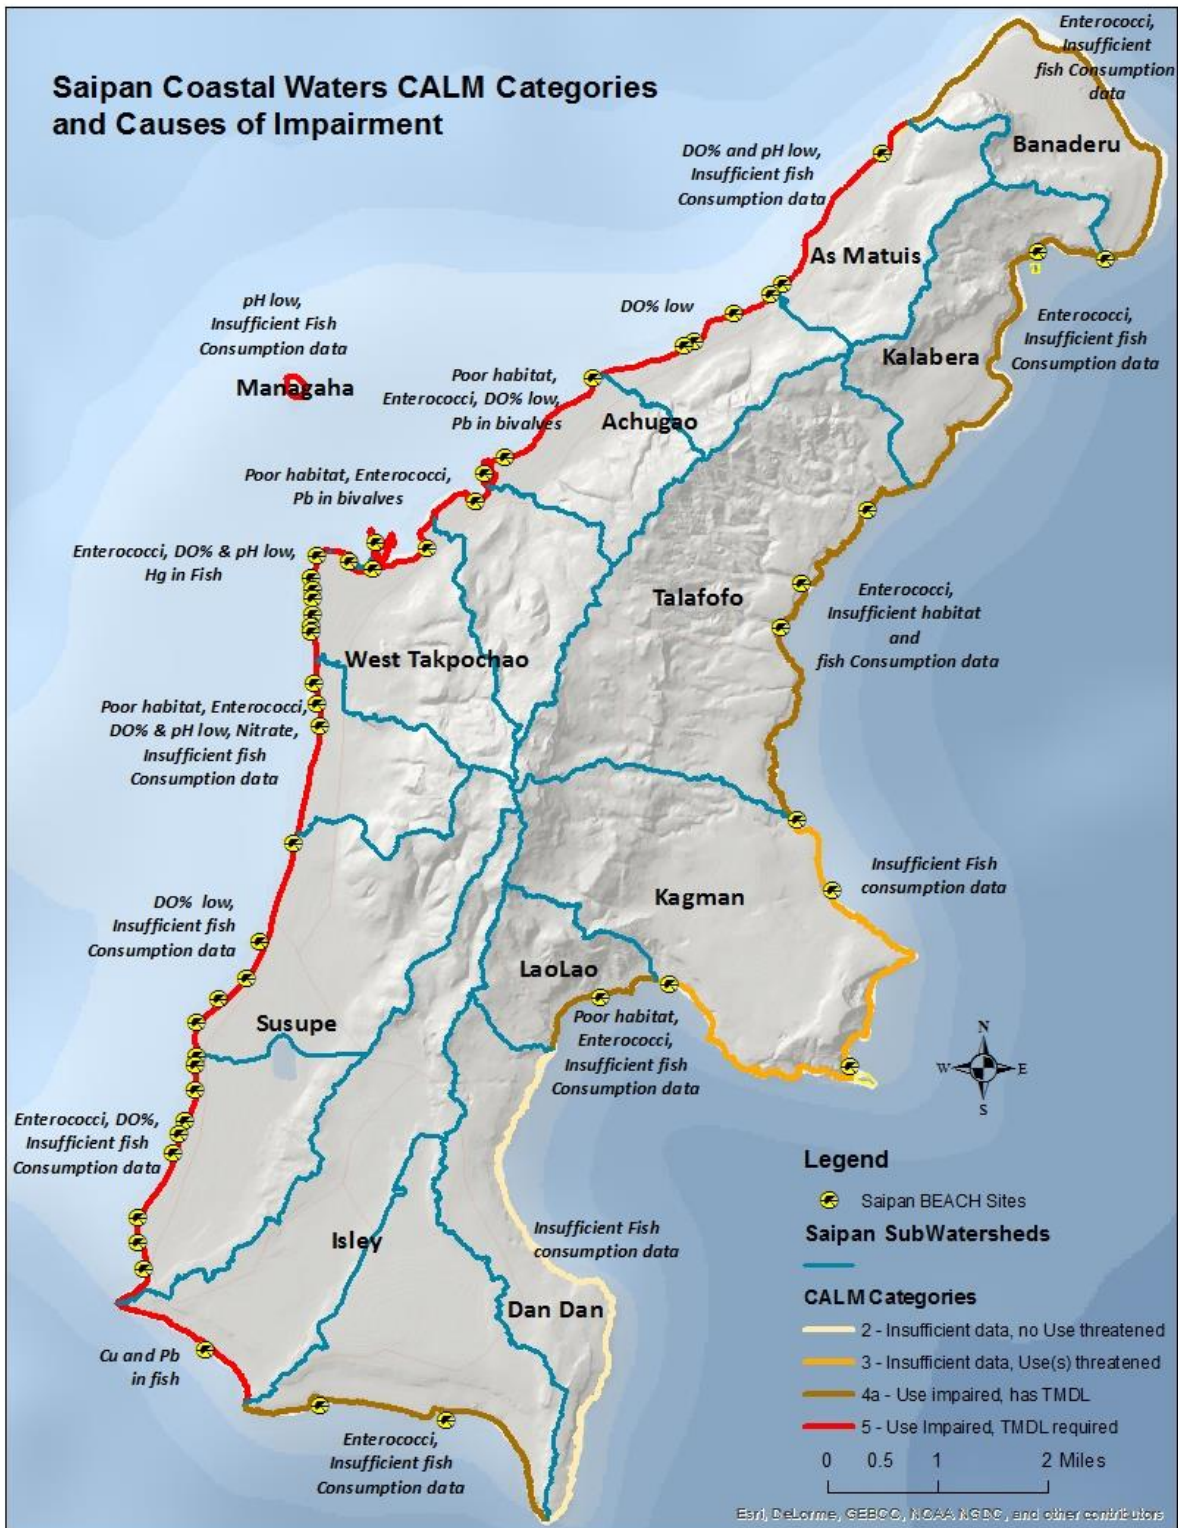
FIGURE I. Saipan Coastal CALM Categories and Causes of Impairment

Figures I – III., on the following pages depict the various causes of coastal water impairment, as well as the watershed’s Consolidated Assessment and Listing Methodology (CALM) category.

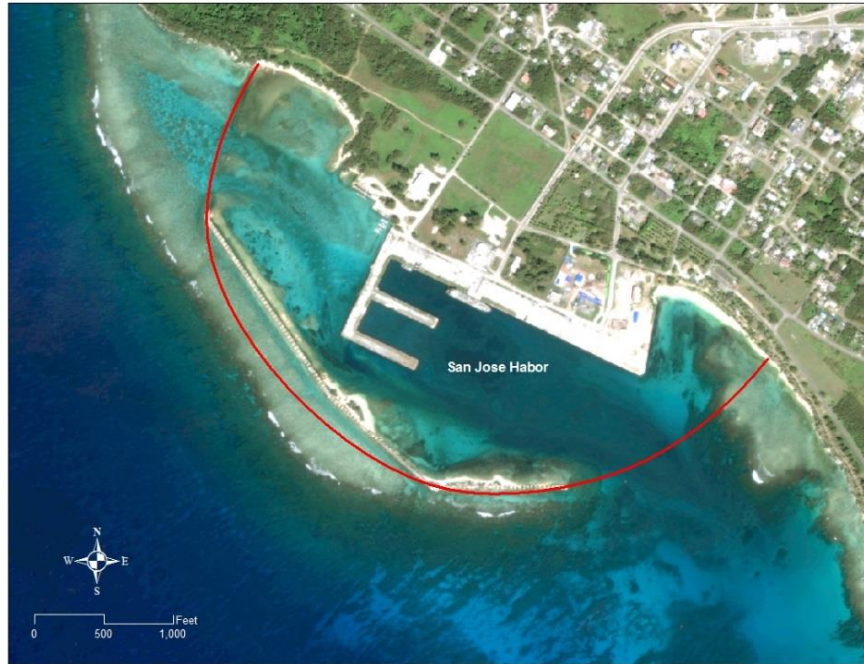
**FIGURE B-4. Class A Waters of San Jose Harbor, Tinian**

The other Class A waters are limited to the existing harbors on Tinian and Rota.

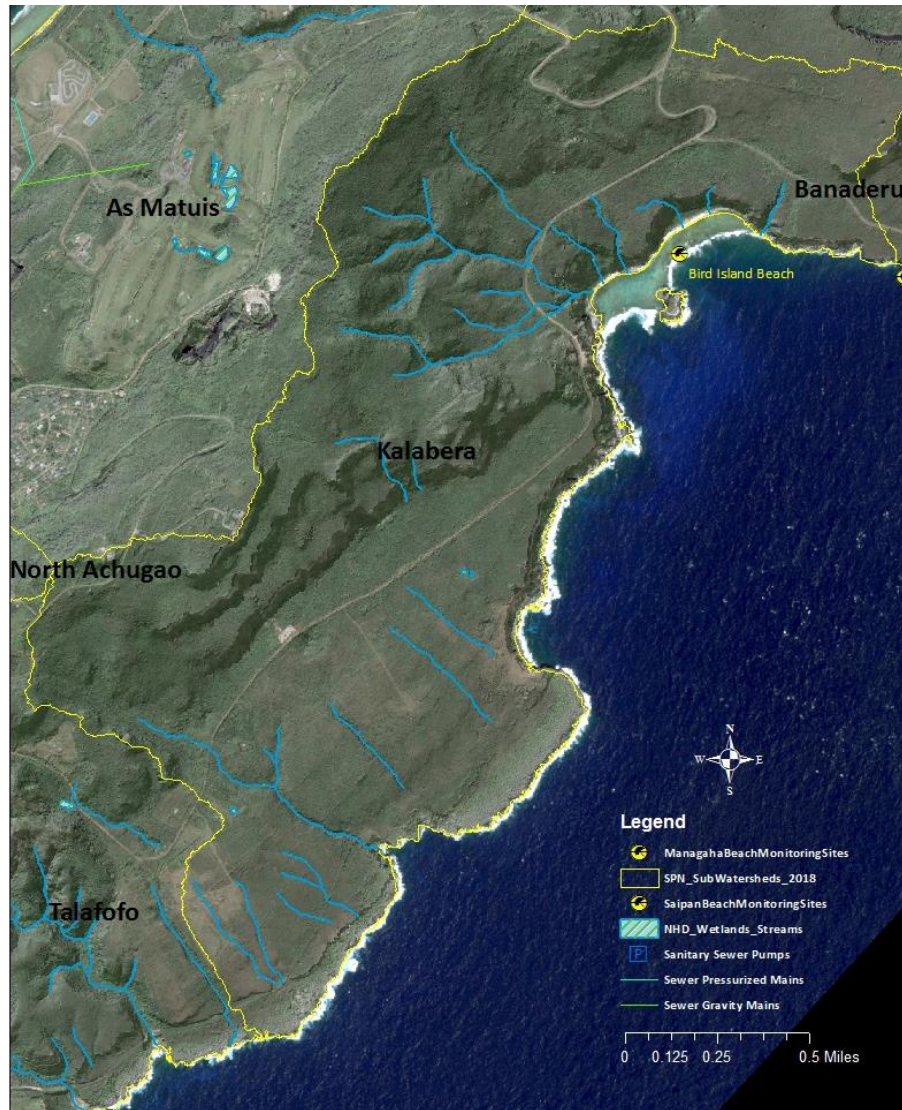
FIGURE C-7. Kalabera Watershed (Segment 12)

Kalabera has only one long-term BEACH monitoring site, which is located on Bird Island Beach.

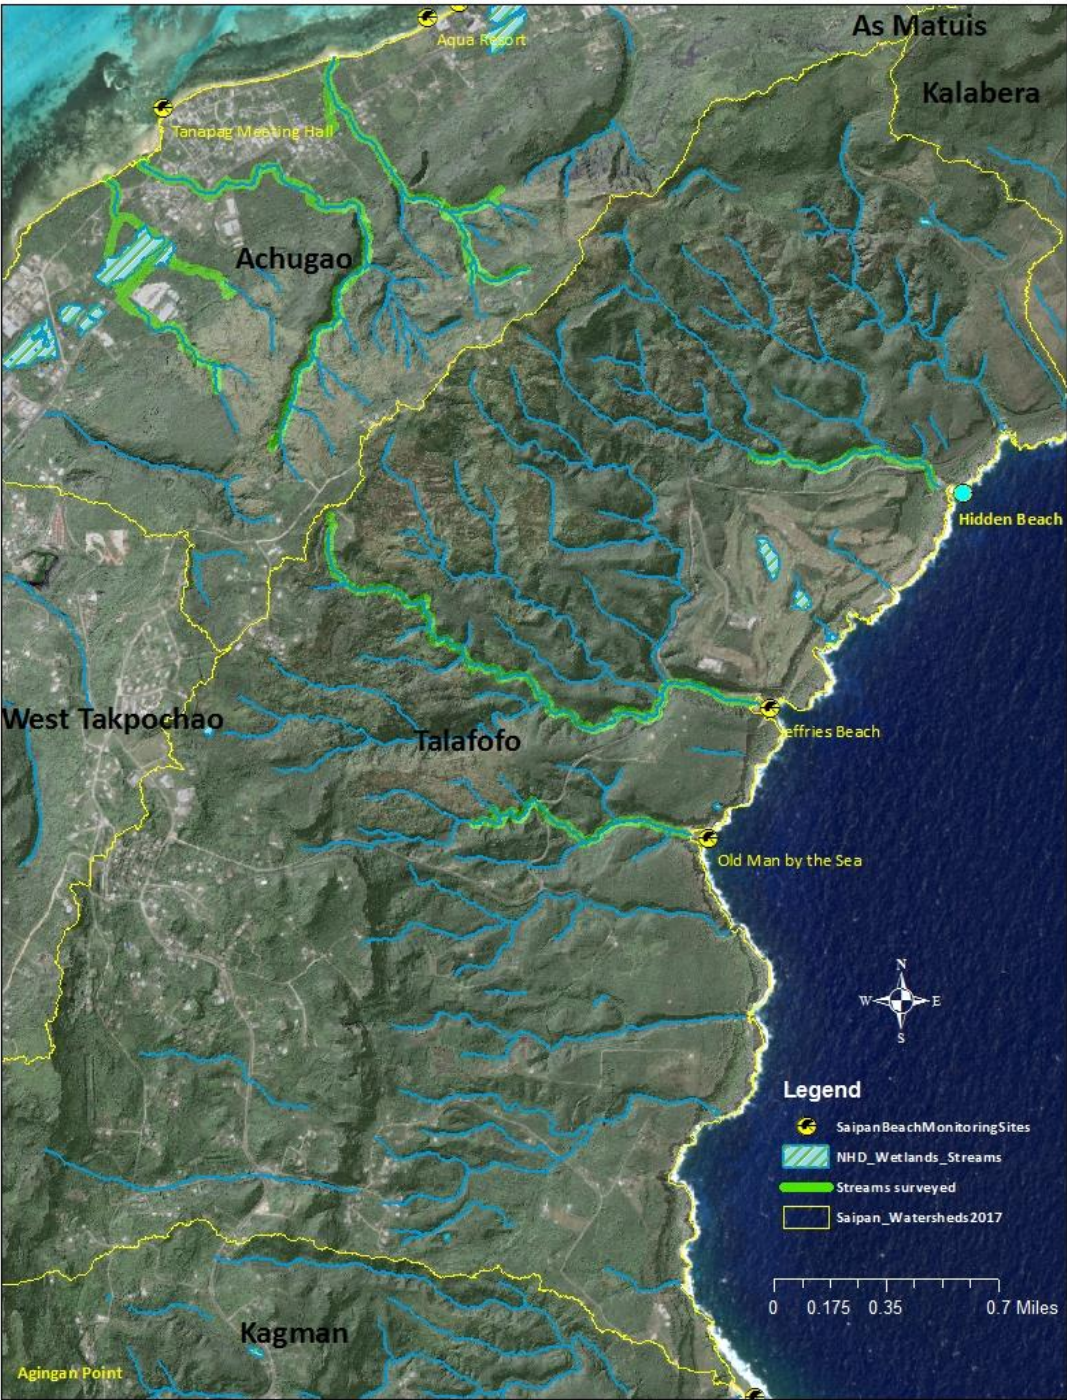
FIGURE C-8. Talofofo Watershed (Segment 13)

Visitors enjoy the ruggedness of this unspoiled terrain, and the isolation of its far-off beaches. The rutted coral roads leading down to Hidden and Jeffrey’s beaches in the lower watershed are, “... directly in-line with the slope...and are deeply eroded.” (2017 TMDL). The erosion is almost entirely due to heavy traffic by tour companies and independent rented SUVs driving in “the gully networks” which contribute to sediment-laden storm water flowing directly to coastal waters.

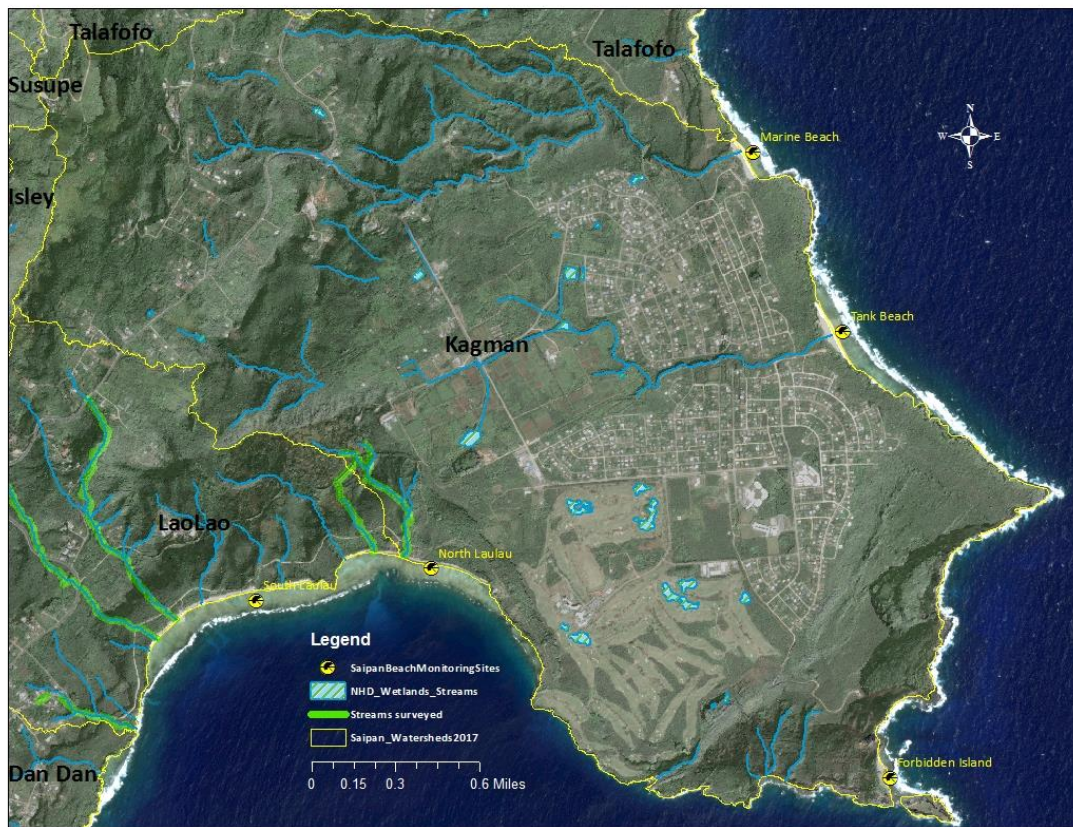
**FIGURE C-9. Kagman Watershed (Segment 14)**

The Kagman Watershed borders Lao Lao Bay and contains the Lao Lao Bay Golf Resort. It has three long-term BEACH monitoring sites located at Forbidden Island, Marine, and Tank beaches, as shown in Figure C-9., on the following page. The remote Forbidden Island site is rarely monitored. However, its location far removed from any development, provides' its coastal waters with protection from most anthropogenic stressors.

This reporting cycle, the North Lao Lao (SEB 02) long-term BEACH monitoring site is now used to assess the Kagman watershed. This site was relocated from the Lao Lao watershed as the result of the newly delineated watershed boundaries using Saipan’s watershed catchment basins, (Figure C-1 on page 34) shows that this site’s water quality is actually influenced by rainfall in the Kagman watershed.

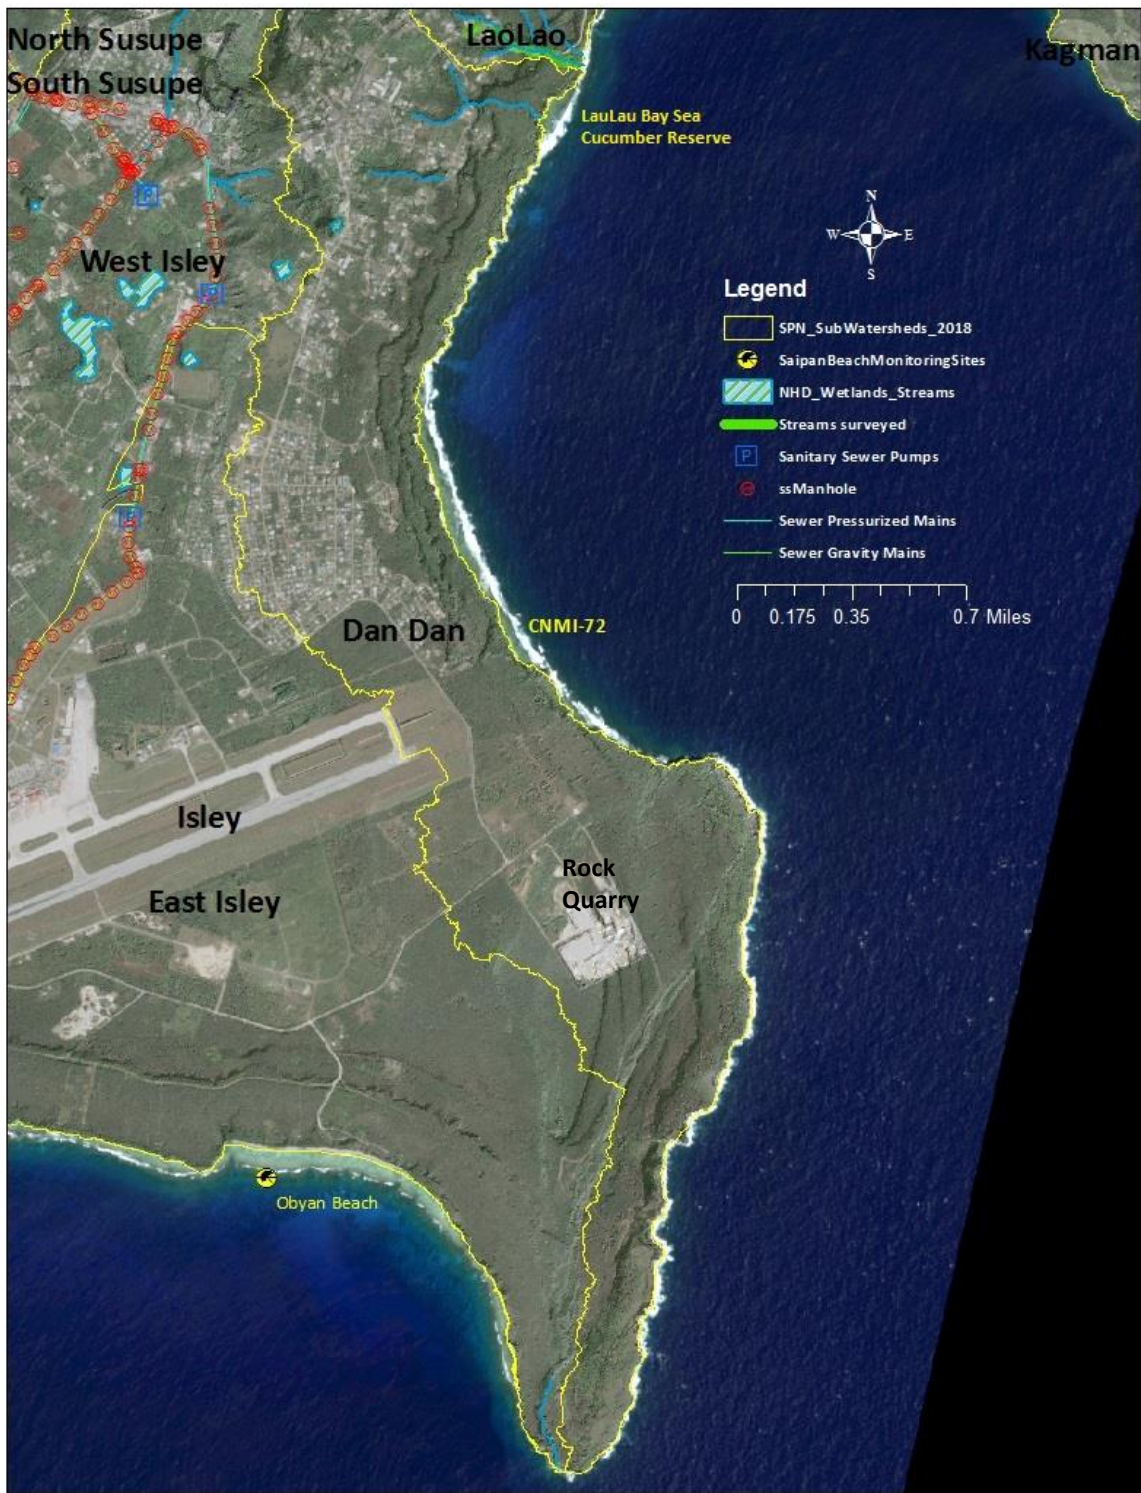
FIGURE C-11. DanDan Watershed (Segment 16)

There is only one long-term reef flat monitoring site (CNMI 72) used for assessment purposes. It was established in 2010, as part of the National Coastal Condition Assessment study and is shown in Figure C-11., on the following page. It is located adjacent to a pristine beach next to a cliff line, which may only be accessed via a private road, with permission from the adjacent land owner. Visitors must use a rope to descend to the shoreline.

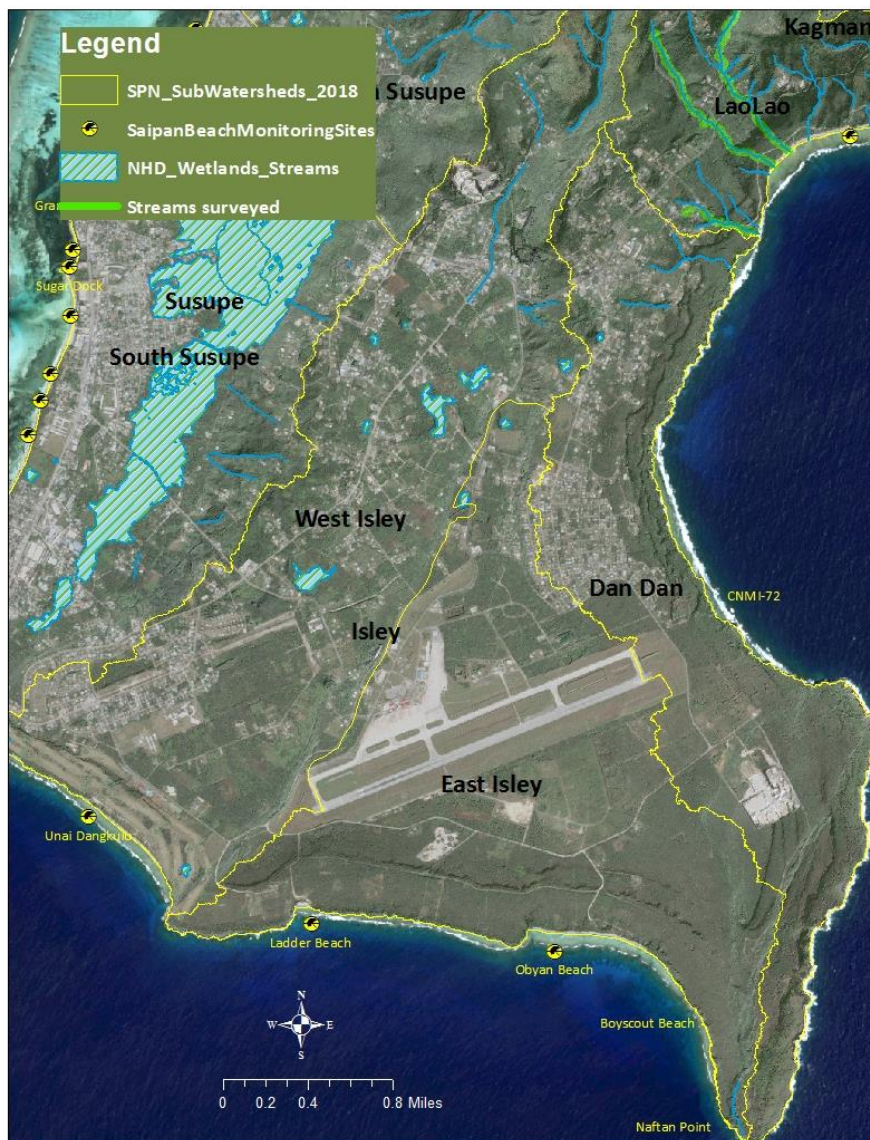
**FIGURE C-12. Isley Watershed (Segment 17A and 17B)**

The Isley Watershed is divided into two sub-watersheds, East (17B) and West (17A), Figure C-12.

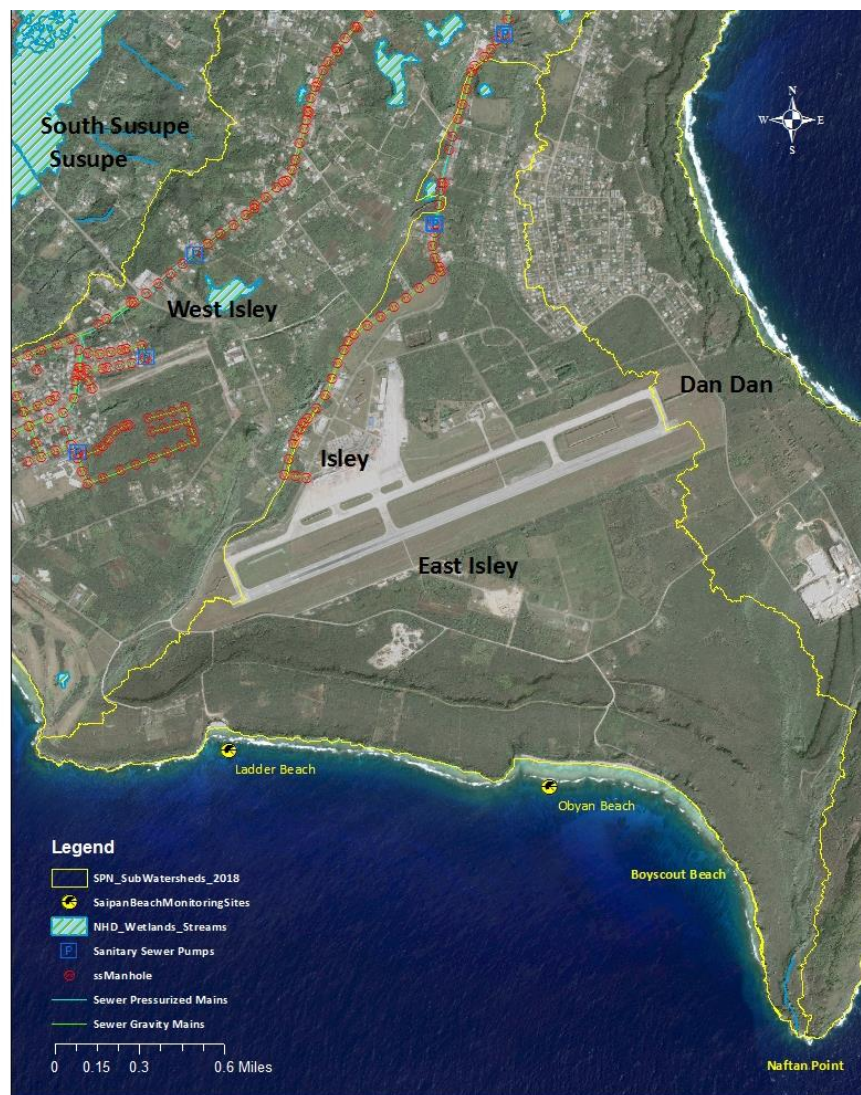
**FIGURE C-13. East Isley Watershed (Segment 17B)**

The watershed is sparsely populated with a few homes. There are three long-term BEACH monitoring sites located at Obyan, Ladder, and Boy Scout Beaches.

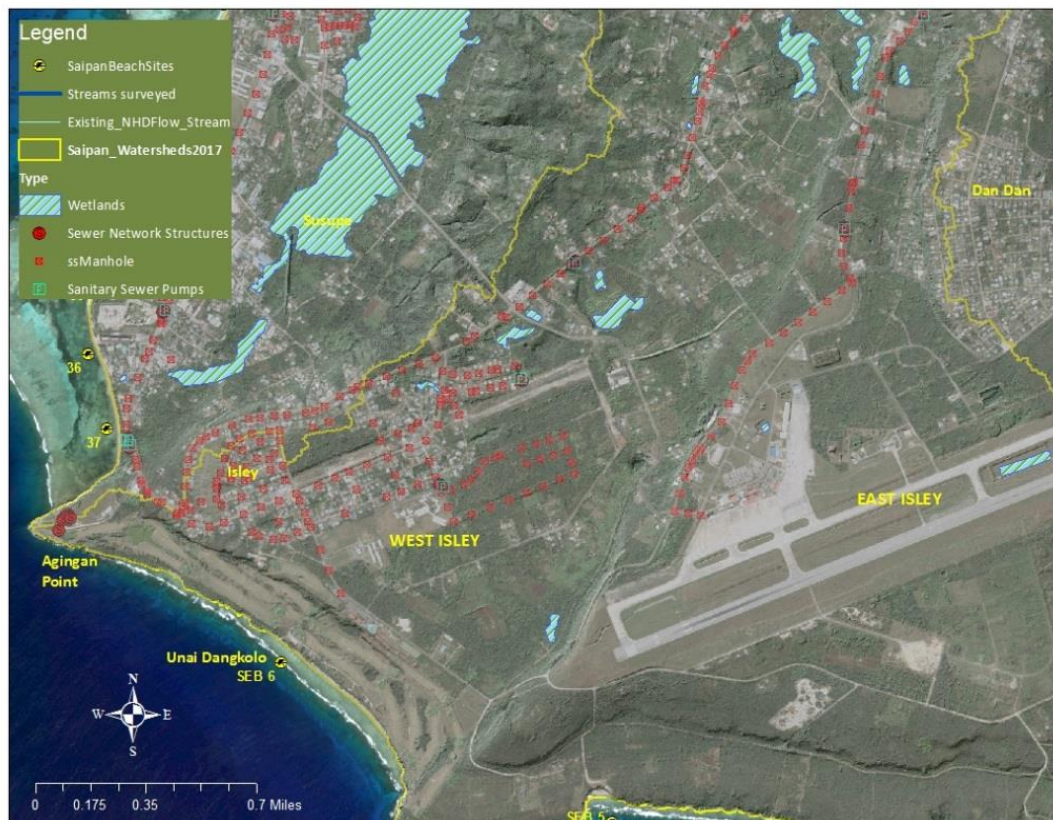
**FIGURE C-14. West Isley Watershed (Segment 17A)**

West Isley is more densely populated than East Isley with the majority of residents and businesses connected to the CUC municipal sewer system. CUC’s Agingan WWTP outfall is located off “Agingan Point” on the western tip of the watershed, adjacent to the South Susupe watershed. The WWTP, which is NPDES permitted is now only working at approximately 50% capacity (2017 Watershed Working Group presentation, William Gilmore, CUC Deputy Director). West Isley has one long-term BEACH monitoring site located on Unai Dangkolo Beach located west of Coral Ocean Point Golf Course and Resort, as shown in Figure C-14.

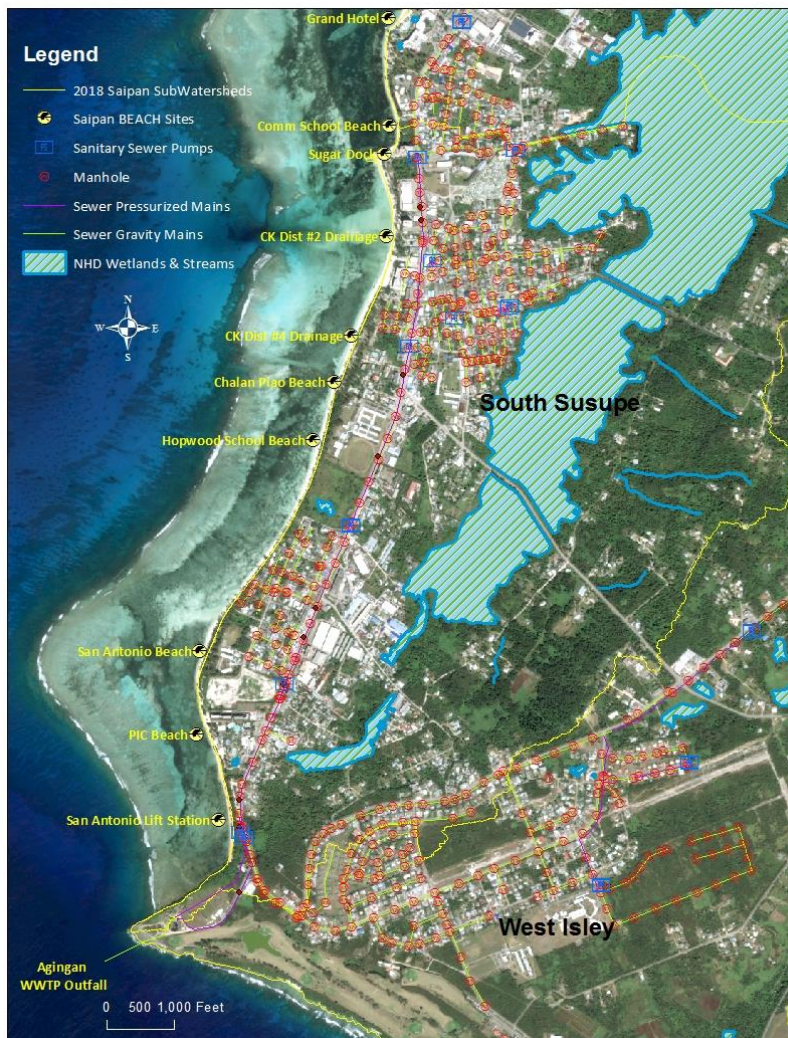
**FIGURE C-16. South Susupe Watershed (Segment 18B)**

There are eight (8) long-term BEACH monitoring sites. The CUC San Antonio Sewer Lift Station A-16 is the southernmost Site. Sugar Dock is the northernmost site and is a popular boat launch, swimming, boogie boarding and platform diving site.

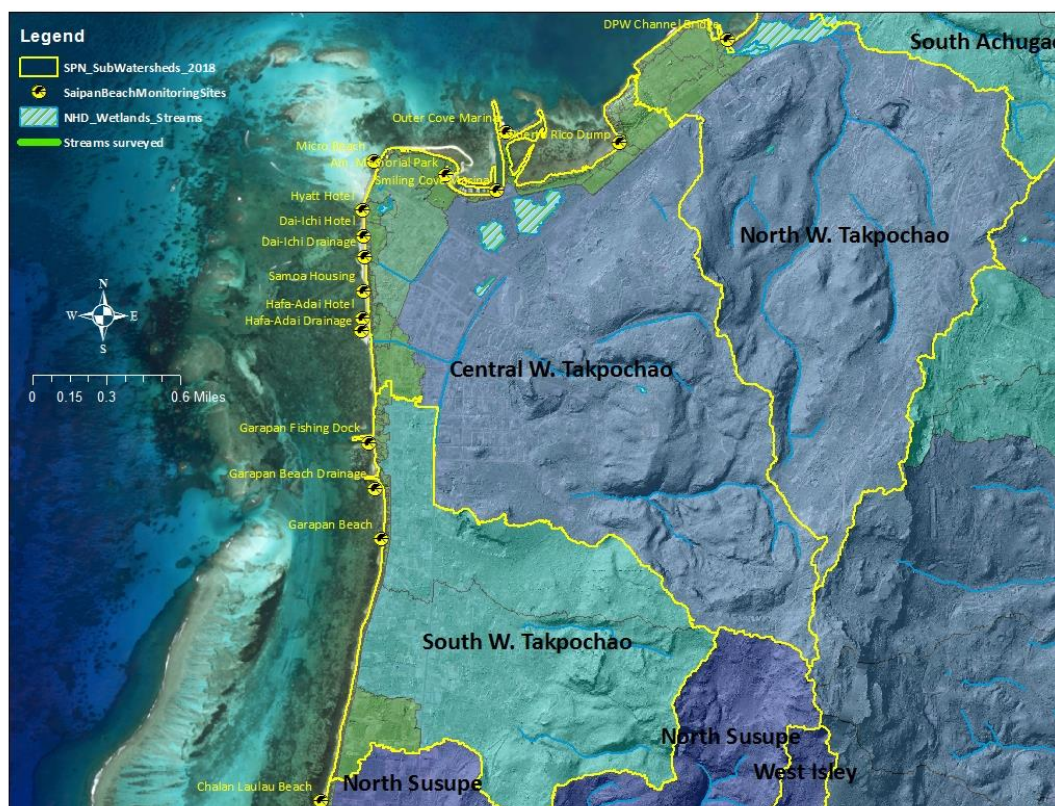
**FIGURE C-20. New Sub-watershed Boundaries using 2017 Watershed Catchment Basins**

The new sub-watershed boundaries are display in Figure C-20., below and are depicted in various shades of green to purple based on size of land area.

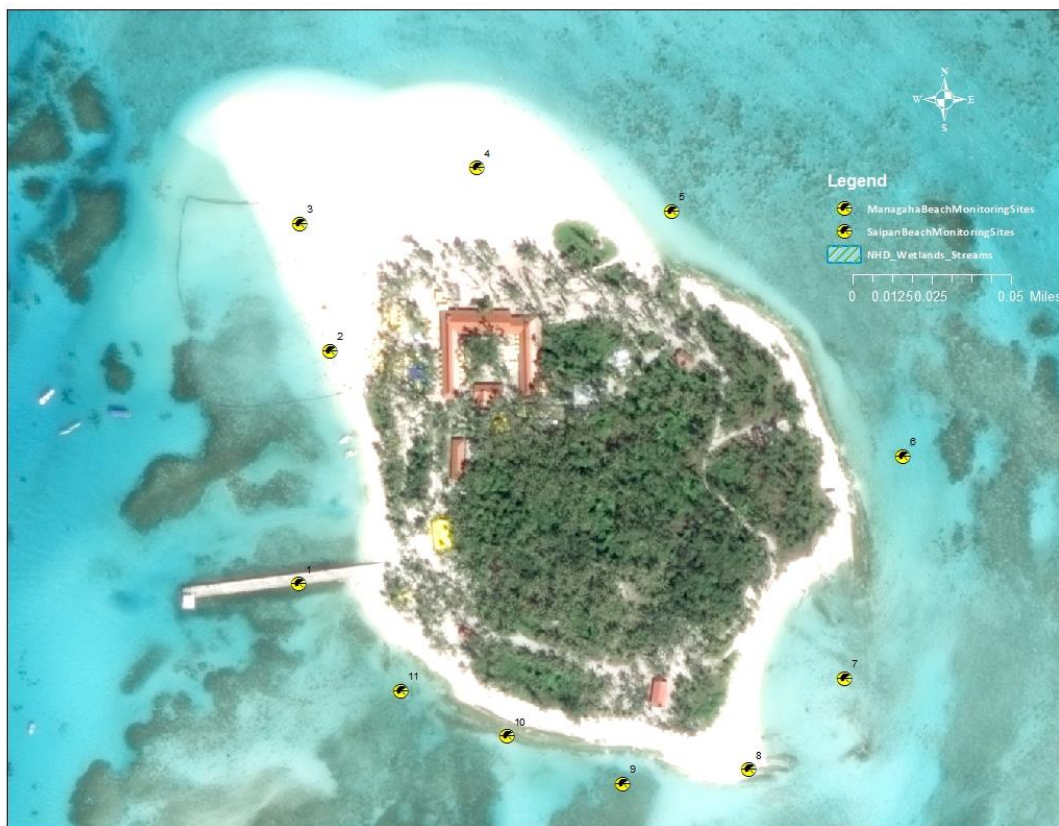
**FIGURE C-29. Mañagaha (Segment 23)**

Mañagaha Island is a small sand cay in the Saipan Lagoon covering only 0.03 square miles, with 0.6 miles of coastline (Figure C-29.). It is the number one destination for tourists visiting the CNMI with close to 300,000 visitors a year (MVA tourist exit surveys, 2016).

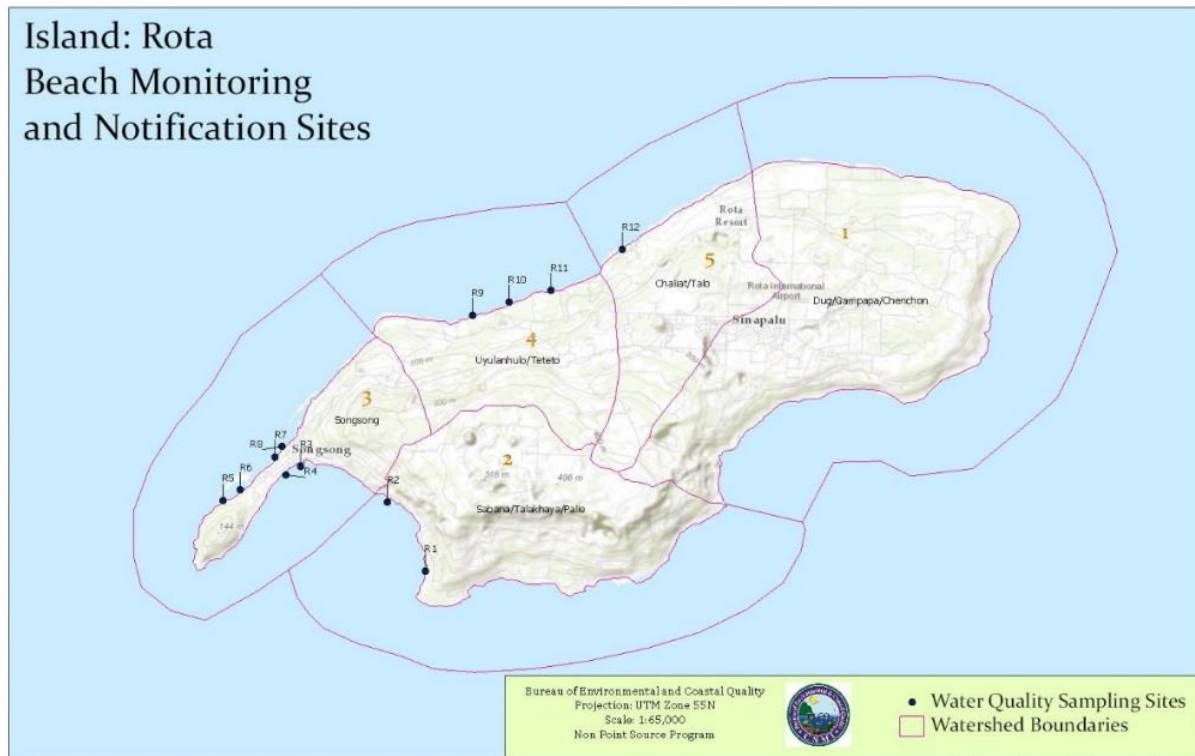
**FIGURE C-30. Rota's BEACH Water Quality Monitoring Sites**

Rota is split into five (5) watersheds, with 12 regularly monitored BEACH sites, Figure C-30.

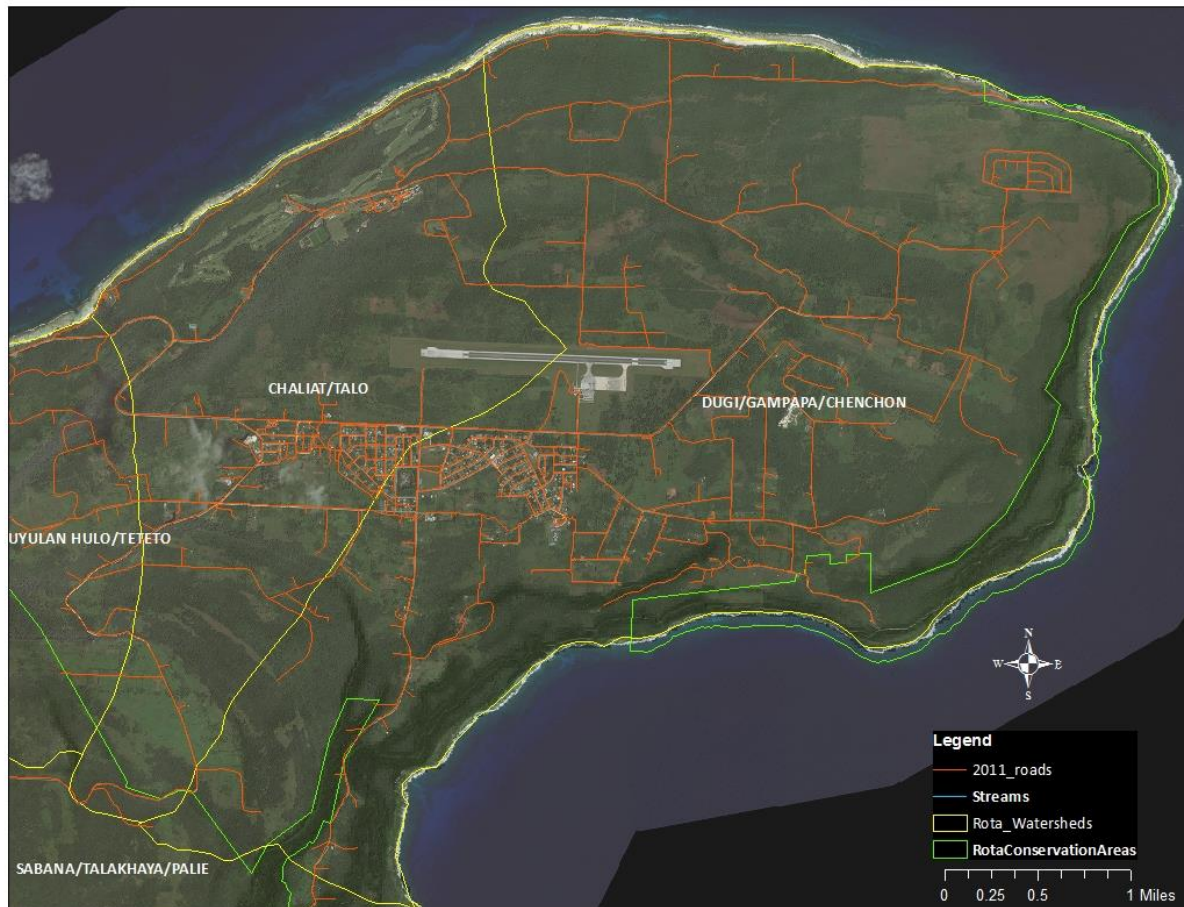
**FIGURE C-32. Dugi/Gampapa/Chenchon (Segment 1)**

The Dugi/Gampapa/Chenchon is the largest watershed on Rota based on land coverage and contains Rota’s Benjamin Taisacan Manglona International Airport. It is also the most remote and undeveloped area on Rota, as shown in Figure C-32., on the following page.

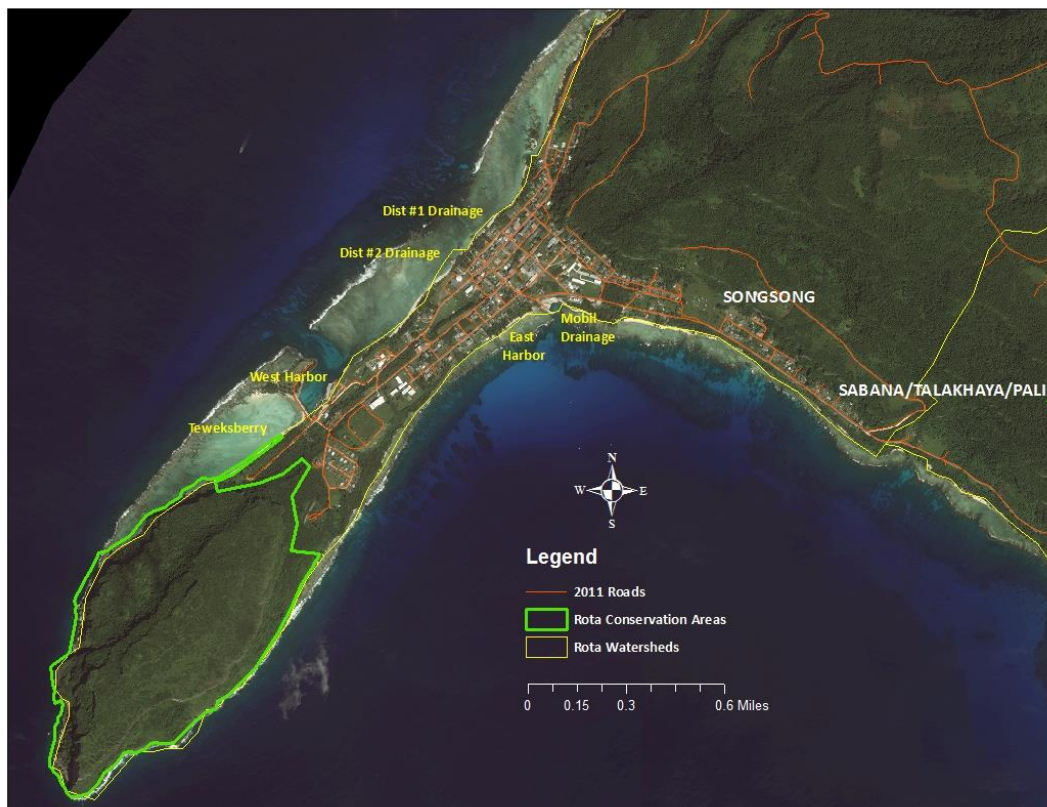
**FIGURE C-35. Songsong (Segment 3)**

There are six (6) long-term BEACH monitoring sites surrounding the Songsong watershed, on Rota's western peninsula (Figure C-35., below). The peninsula contains the most developed and densely populated area on Rota, Songsong Village. It also contains the East and West Harbor and the fuel depot, which are Rota's only designated Class A waters.

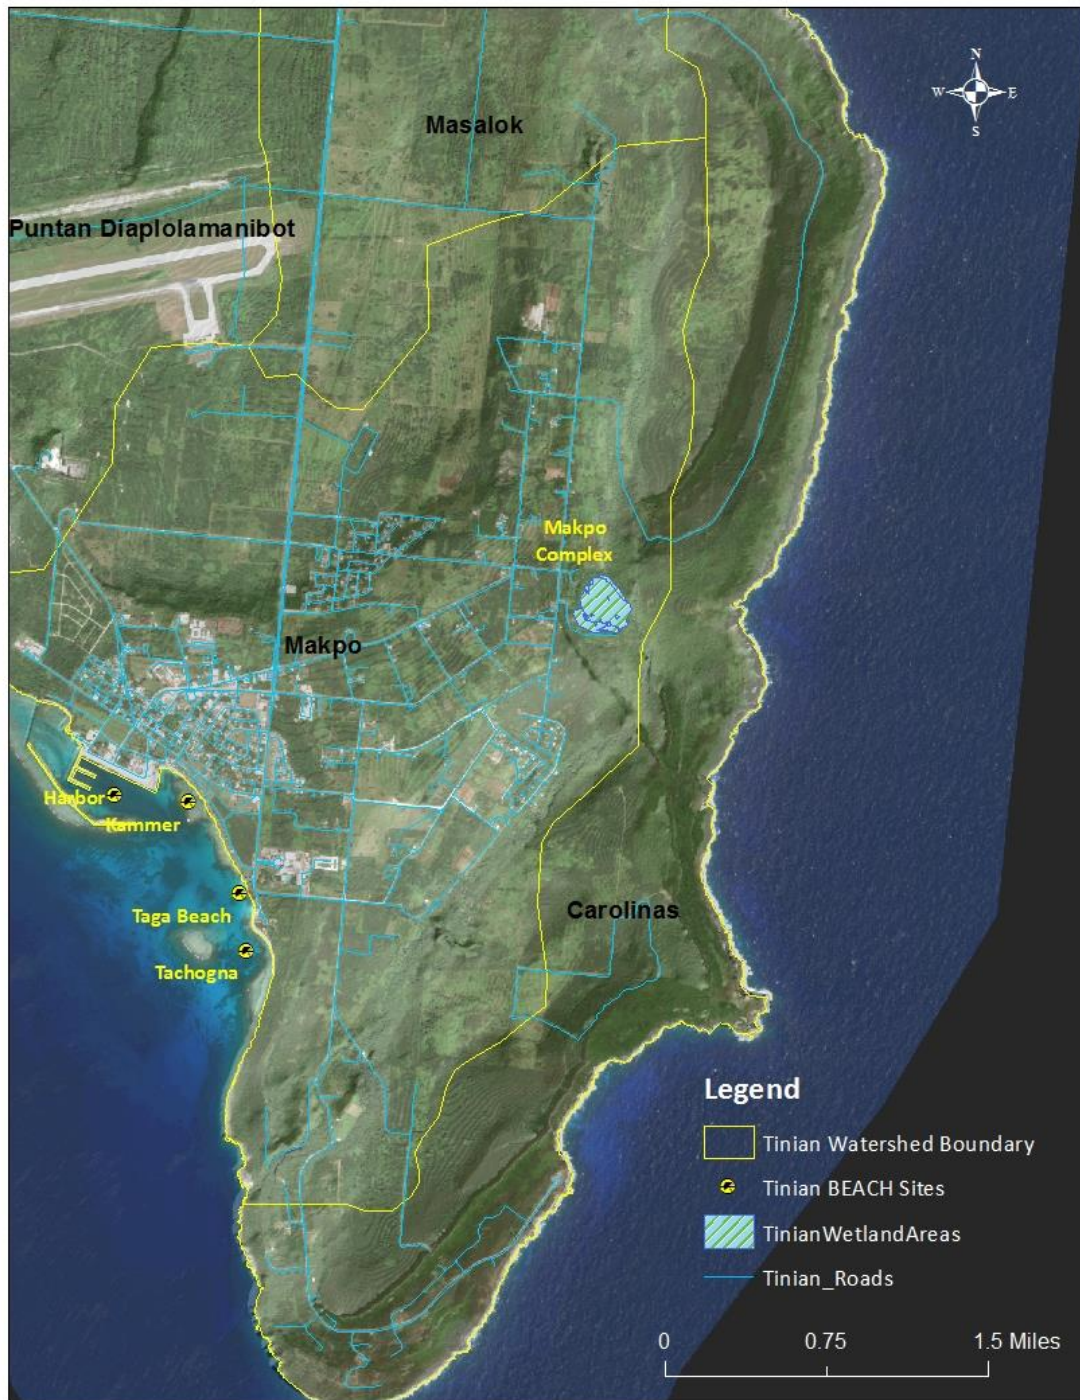
FIGURE C-42. Carolinas (Segment 8)

The Carolinas watershed lies along the southern east coast of Tinian (Figure C-42.).

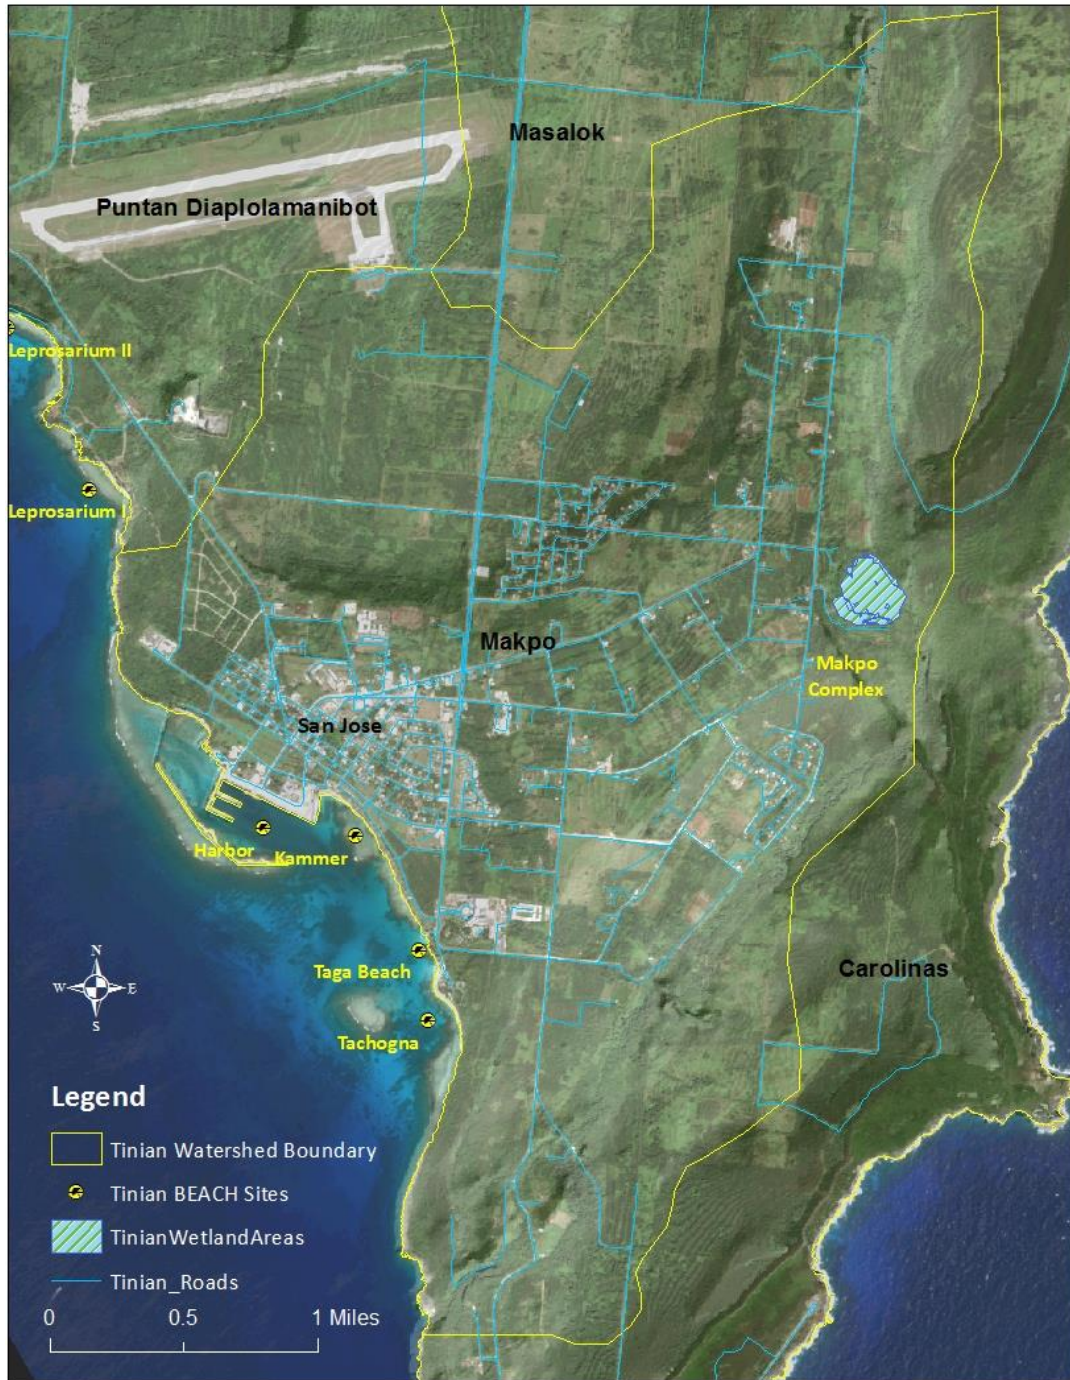
**FIGURE C-43. Makpo and Makpo’s “San Jose” Harbor (Segment 9 and 9H)**

Figure C-43., on the following page shows the three (3) long-term BEACH monitoring sites in Makpo's coastal waters, and the one BEACH site in Makpo Harbor's coastal waters.

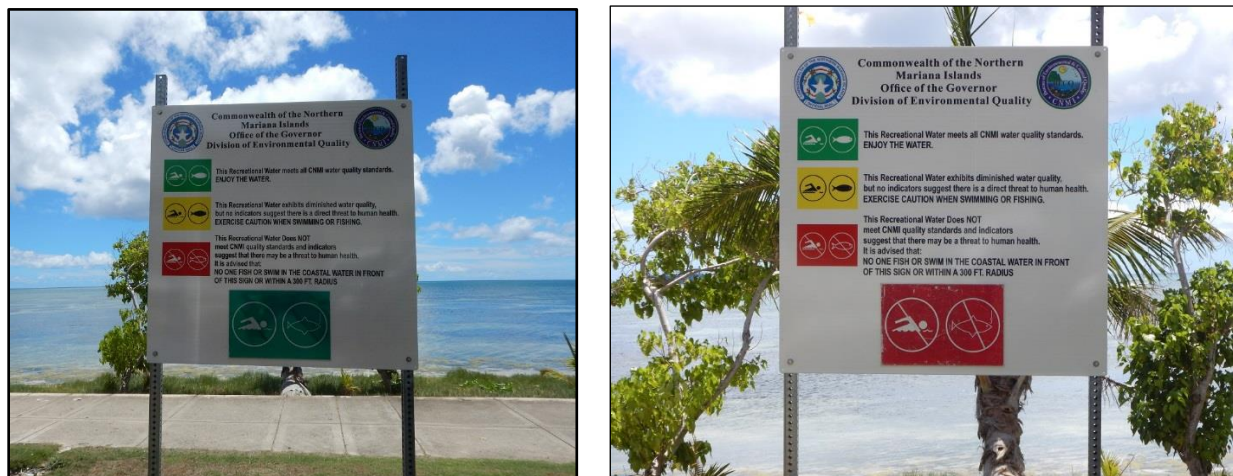
FIGURE C-47. BEACH Advisory Sign Boards

Beach Advisory signboards are posted at 10 sites on Saipan’s shoreline with internationally recognizable symbols for “no swimming” and “no fishing”, as shown in Figure C-47., below. Red Placards are posted whenever results call for a Public Advisory.
