# ***DRAFT FINAL*** **DETAILED PROJECT REPORT**

***SAIPAN LAGOON***  
***AQUATIC ECOSYSTEM RESTORATION STUDY***  
*Contract No. DACA83-01-D-0014-0002*

# Draft Final Detailed Project Report

## Aquatic Ecosystem Restoration Study at Saipan Lagoon Saipan, Commonwealth of Northern Mariana Islands

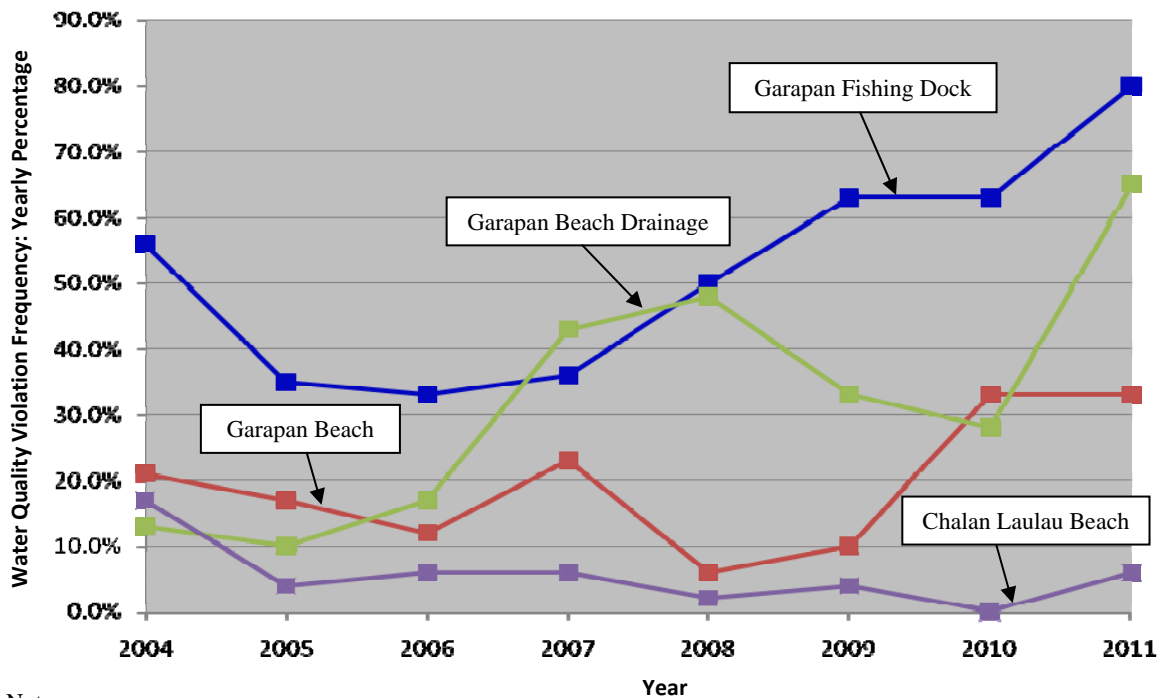
17 **Figure 5: Water Quality Violation Frequency at Monitoring Stations Within Study Area, 2004-2011**

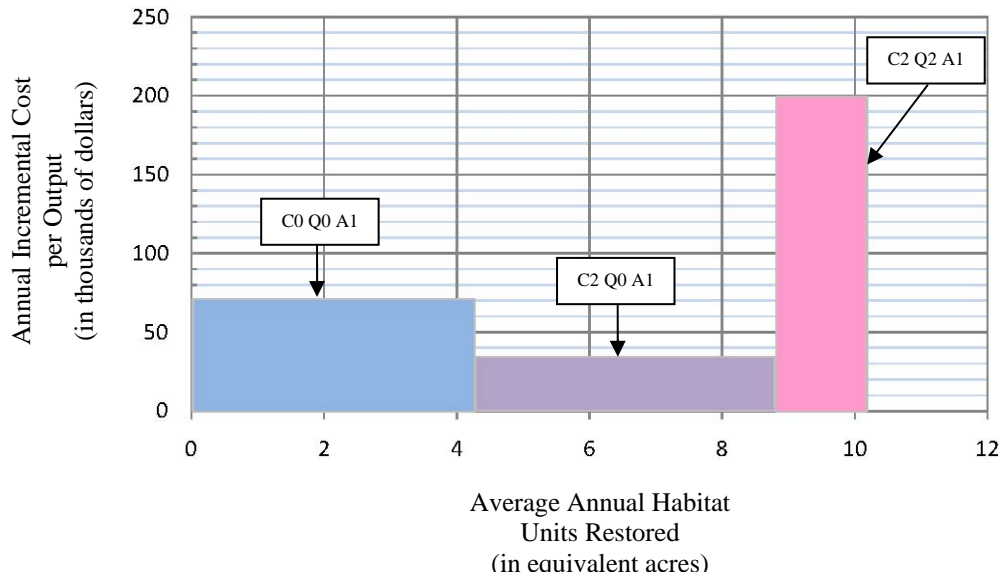
**Figure 11: Final Incremental Cost Analysis, Incremental Cost versus Output**

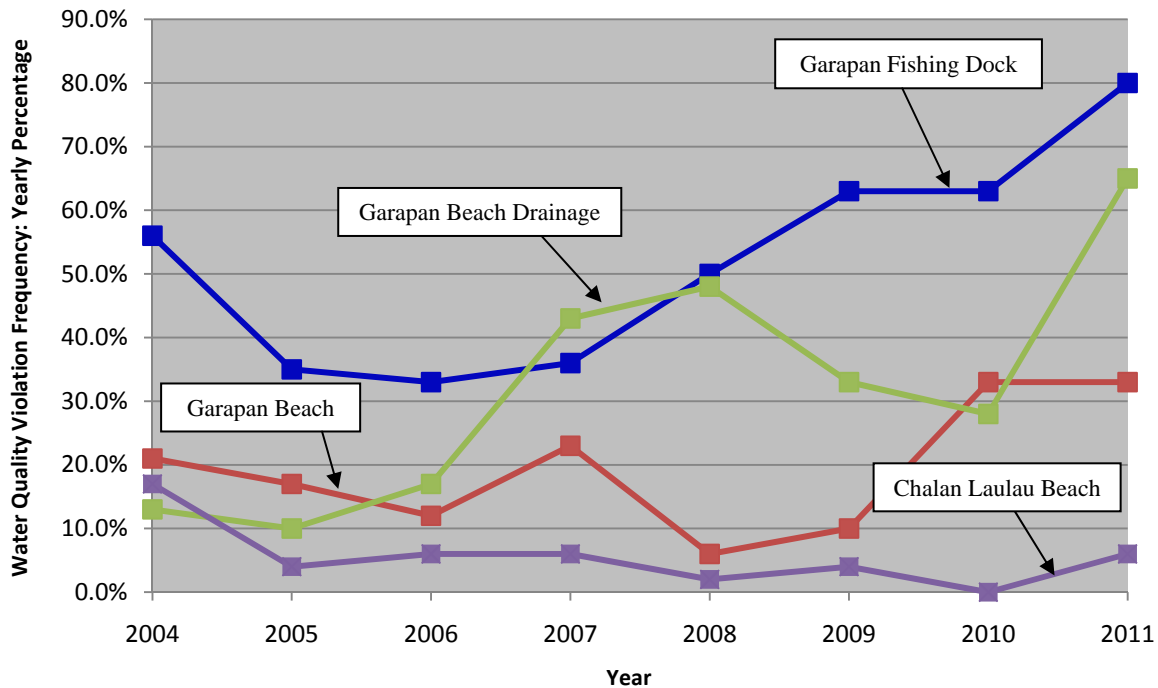
1 **Figure 6: Water Quality Violation Frequency at Monitoring Stations within Study Area, 2004-2011**

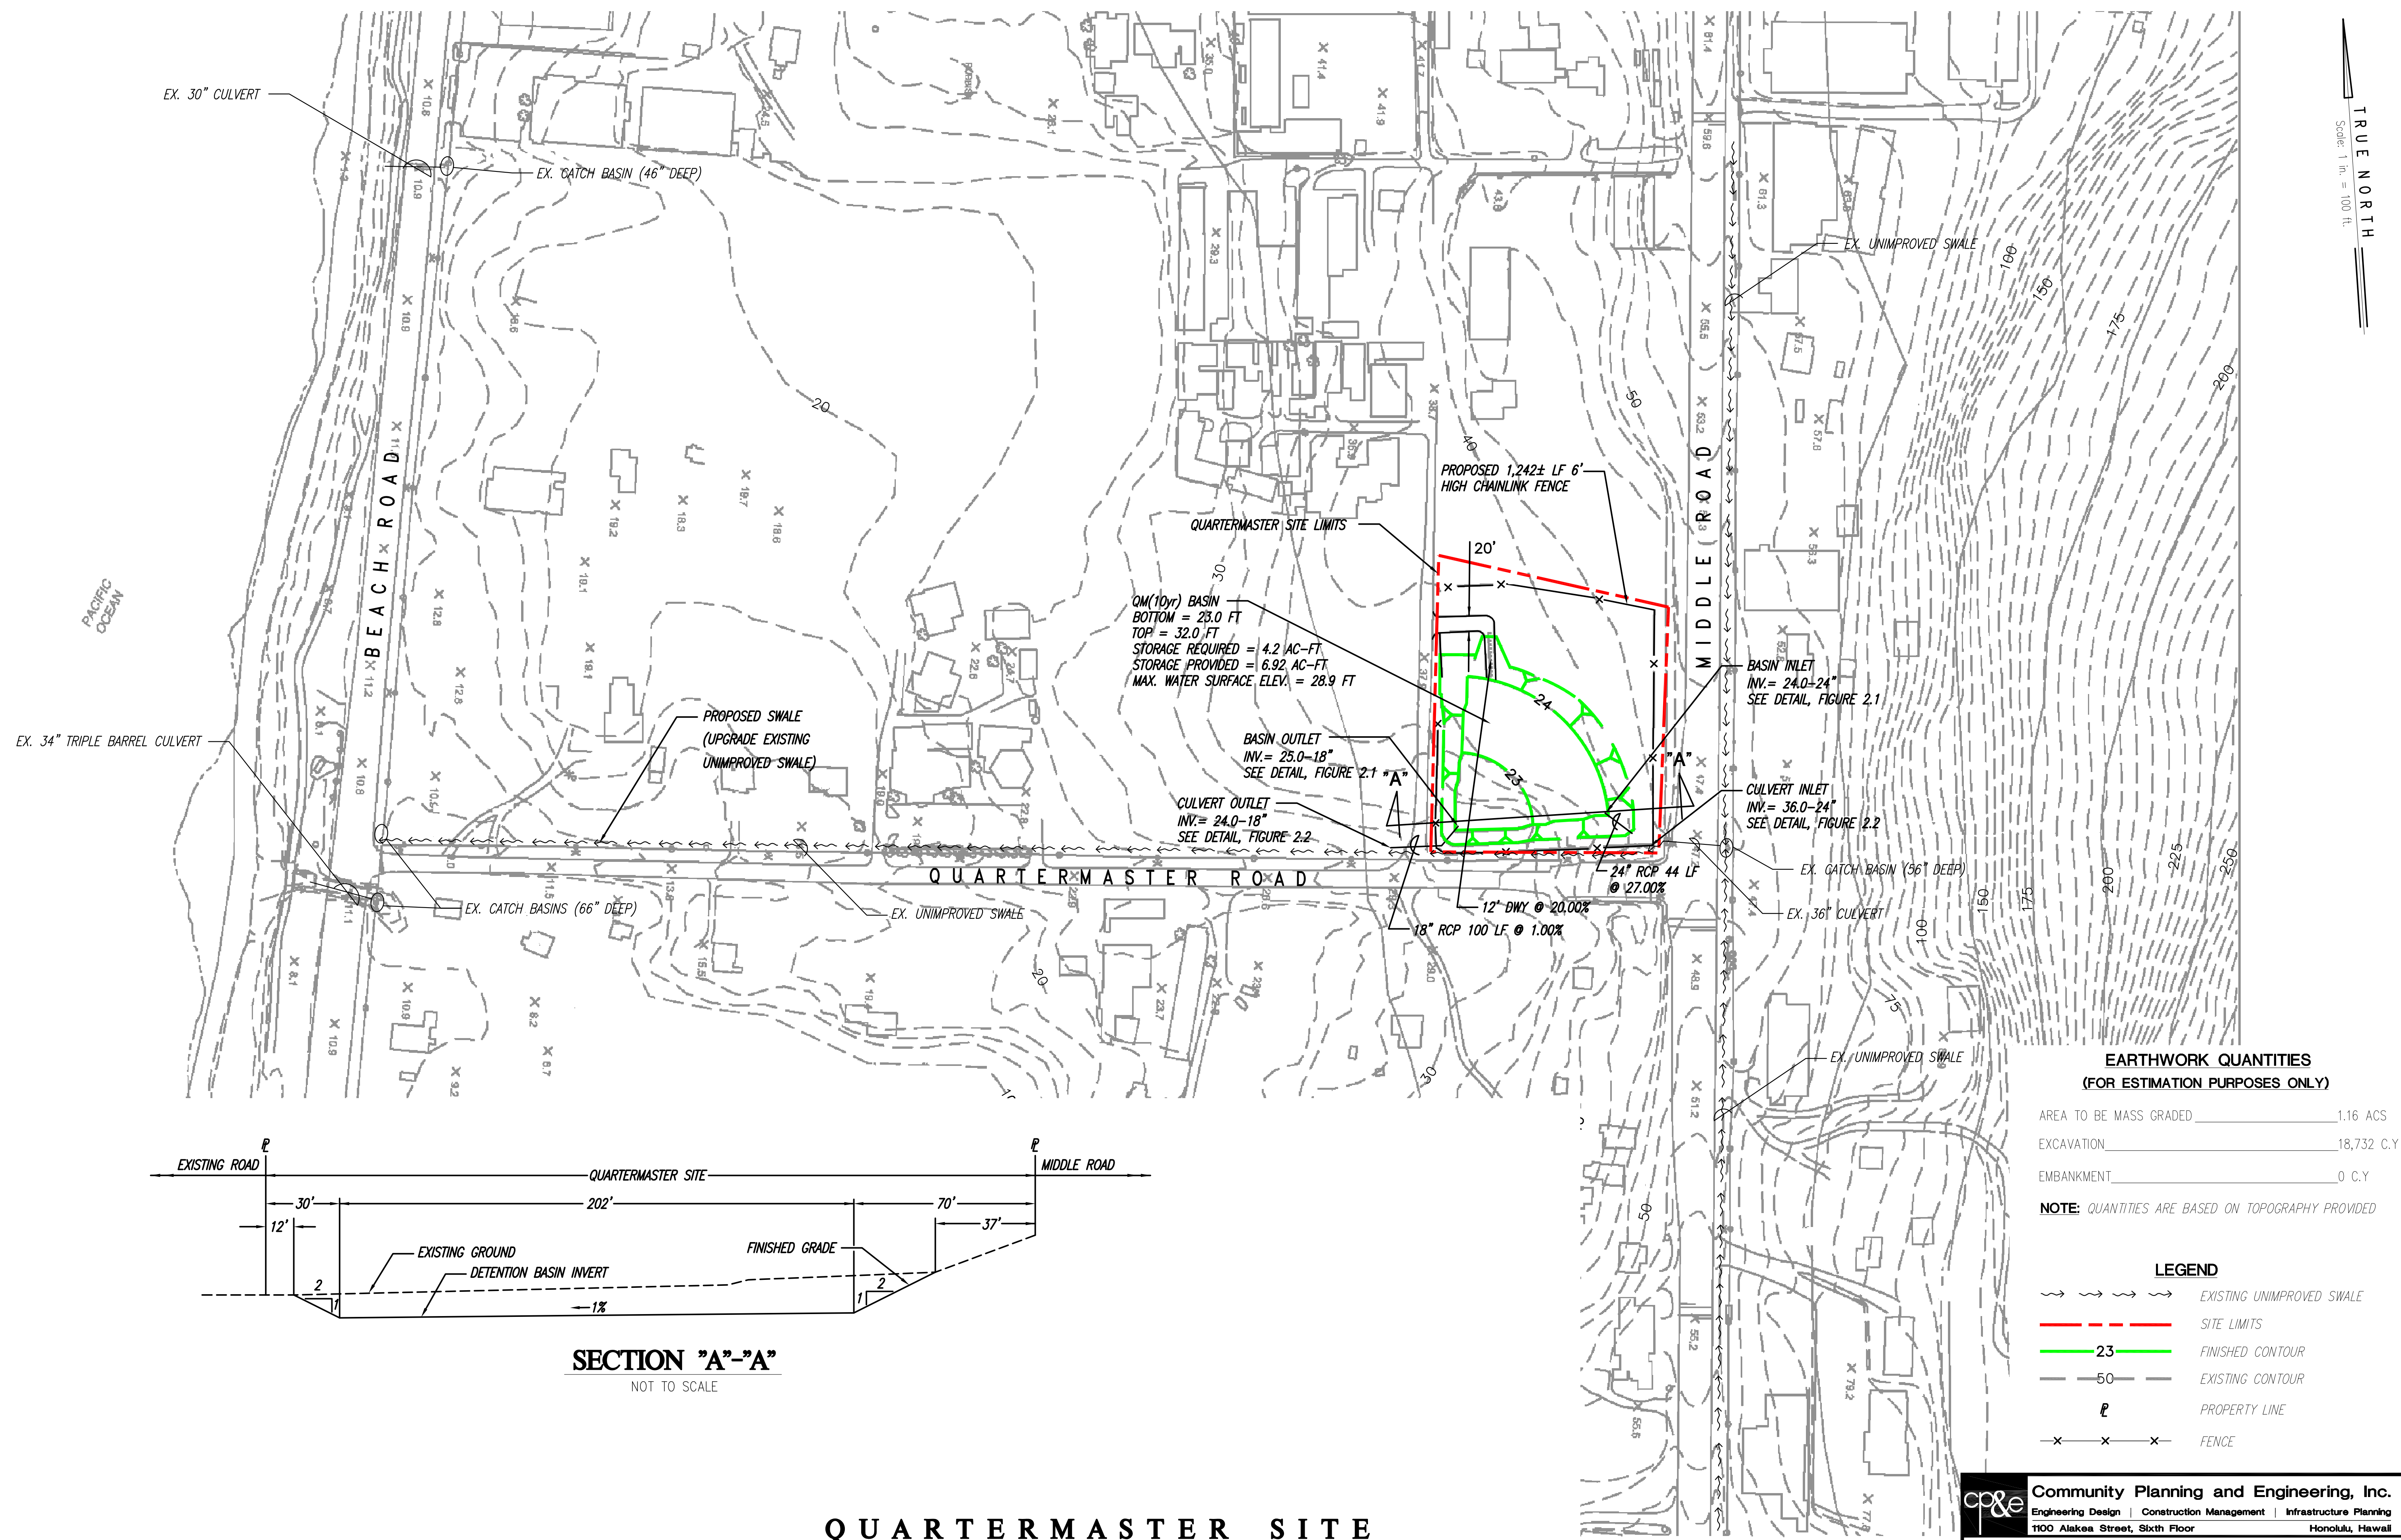
**FIGURE 2.3 - QUARTERMASTER SITE**  
**10 YEAR STORM EVENT PRELIMINARY DESIGN**
