# Performance of Public Buildings and Critical Facilities

Mitigation Assessment Team Summary Report and Recommendations

Commonwealth of the Northern Mariana Islands  
Super Typhoon Yutu

P-2179

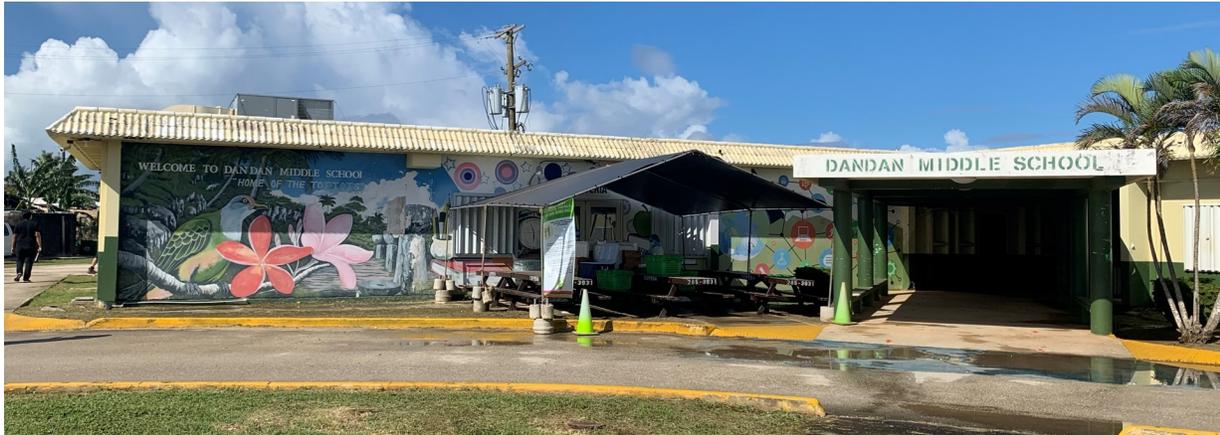
**Figure 21: Cafeteria at DanDan Middle School used as an emergency shelter.**

The buildings currently used in the CNMI as emergency shelters have not been evaluated by design professionals using a consistent methodology to determine their level of hazard vulnerability. HS&EM and PSS have selected specific buildings on school campuses to be used for these emergency shelters or refuge areas. The primary criteria in selecting the buildings for use include: (1) they are located outside of the Special Flood Hazard Area (flood zone), and (2) they are constructed of reinforced concrete frames or walls and have a concrete roof deck. In most cases, the emergency shelter buildings have windows protected with storm shutters and reinforced doors.
