ROTA WEST HARBOR MASTER PLAN

Commonwealth Ports Authority

April 2018

Prepared By | Moffatt & Nichol, Honolulu, Hawaii
In Association With | PEGS and Micronesian Environmental Services, Inc.

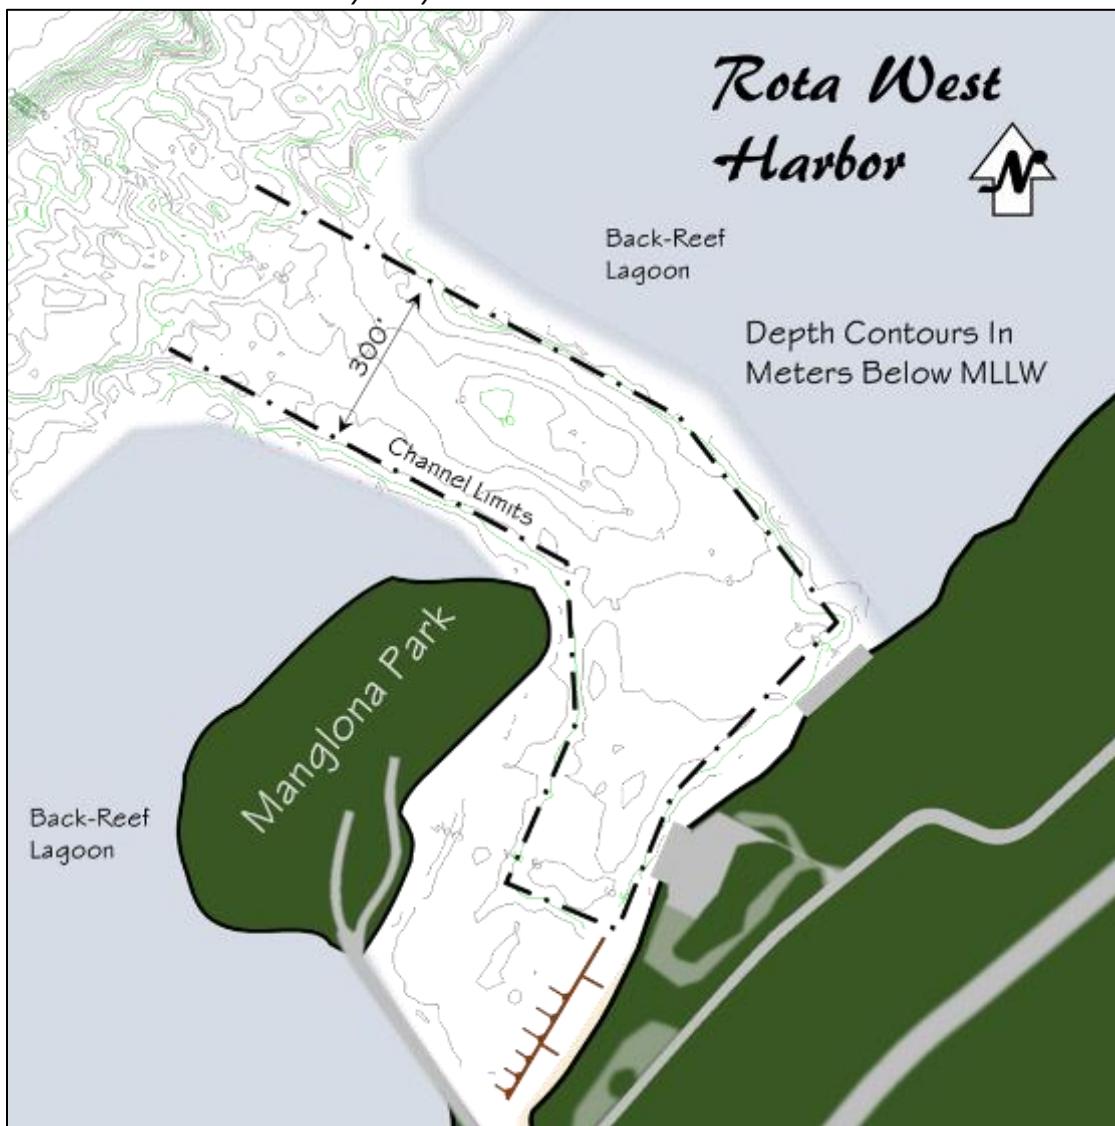
Figure 3-6: Rota West Harbor Bathymetry

Figure 3-6 illustrates the measured depth contours in meters relative to the designated channel and shoreline features. The inner harbor is found to have a depth of five meters (16.4 feet) to the permitted dredging limits. Within the margin of error, this is the design depth when the inner harbor was originally dredged.

Much of the inner harbor, and all of the entrance channel, is six meters (19.7 feet) or more in depth. The center line of the entrance channel was found to reach 10 meters (32.8 feet) in depth at one point. These soundings indicate that there has been little shoaling within the dredging limits and that current scour may have deepened the entrance channel from its design depth of 20.0 feet since it was last dredged in the 1980s.

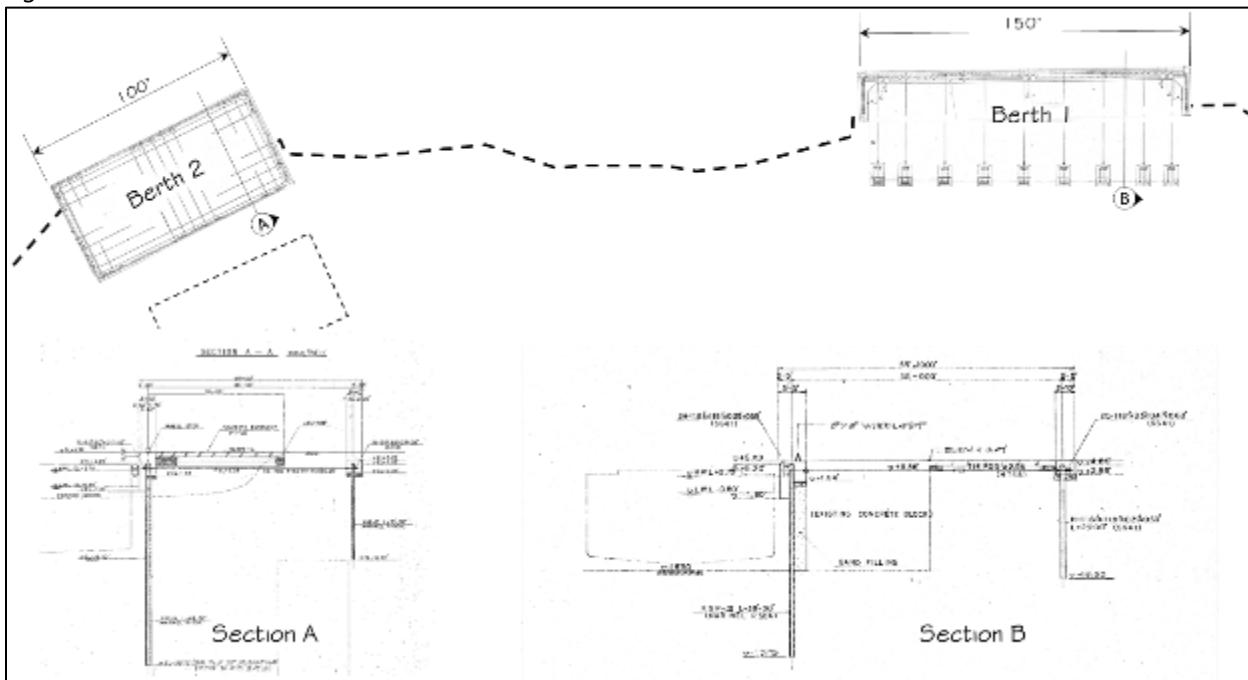
Figure 4-1: Berth 1 & 2 Structures

Berth 1 is a tied-back sheet-pile structure with deadman anchors placed approximately 60 feet behind the berth face. It was constructed over top of an older concrete and coral stone structure that may have been part of the 1930s-era sugar export dock. Berth 1 has cold-formed steel sheet on the front face with a continuous row of interlocking steel H-Piles on the north and south faces. The steel sheet piles are continuously submerged and are visible below the concrete cap at 1.8 below MLLW. The sheet piles are in satisfactory condition.

Typical corrosion losses were estimated to range between 4% and 20%. Heavy pitting and higher levels of corrosion were typically noted just below the cap. A 10-inch 18-inch void was noted in the web of the corner H-Pile at the northwest corner of Berth 1 near the mudline.

The concrete cap at Berth 1 is in poor condition. Poorly consolidated concrete at the bottom of the cap was noted throughout which has exposed the reinforcing bar. Erosion damage has also raveled aggregate away over time leaving rock pockets, typical at the north and south corners of the Berth 1 concrete cap. Corrosion spalling and rebar rust “bleeding” can be seen throughout the south face of the concrete cap. Berth 1 also shows widespread abrasion damage along the top edge of the cap due to friction of hanging wires suspending the tire fenders and erosion damage has resulted in cement particle/aggregate loss on the lower portion of the cap.

The fender system – V-type extruded arch fenders on the berth face – is in critical condition. These fenders have all failed and remaining portions of the fender system are left hanging from stainless steel anchor bolts and inserts. Makeshift fenders using tires are currently in use, suspended by wire fastened to pad eyes embedded in the top of the concrete cap and to the concrete curb. Significant abrasion damage was observed on the corner of the concrete cap from the wire rope and chains. In some instances, the cap was abraded down to exposed reinforcing steel. The tires provide little standoff distance and energy absorption, resulting in direct contact of the ship with the concrete cap.

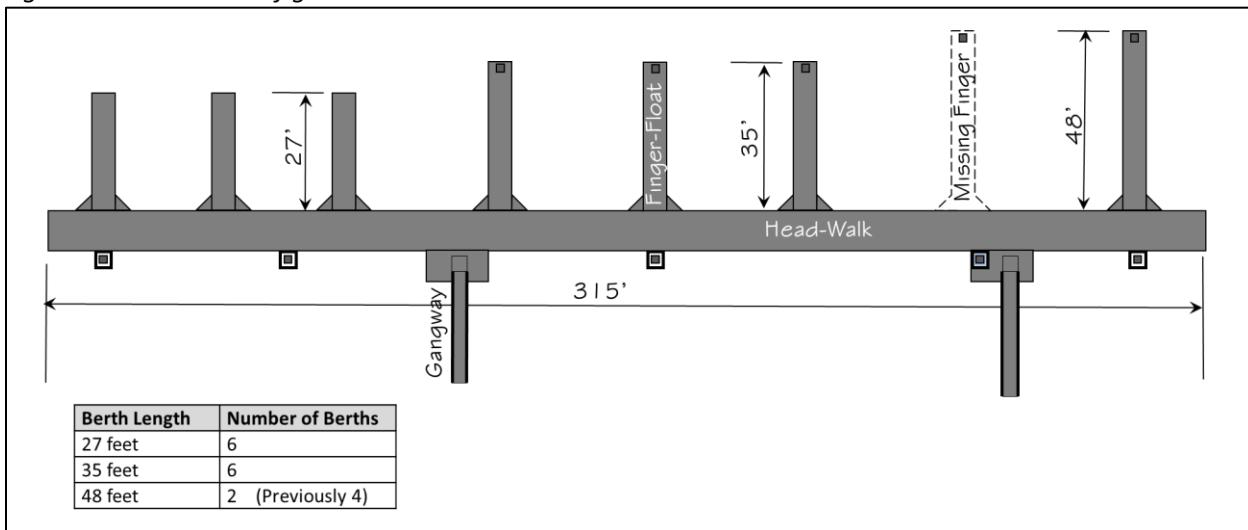
Figure 4-2: Marina Configuration

West Harbor Marina is constructed of aluminum-framed walkways (headwalk and finger-floats), plastic flotation units, concrete guide piles, and aluminum gangways.

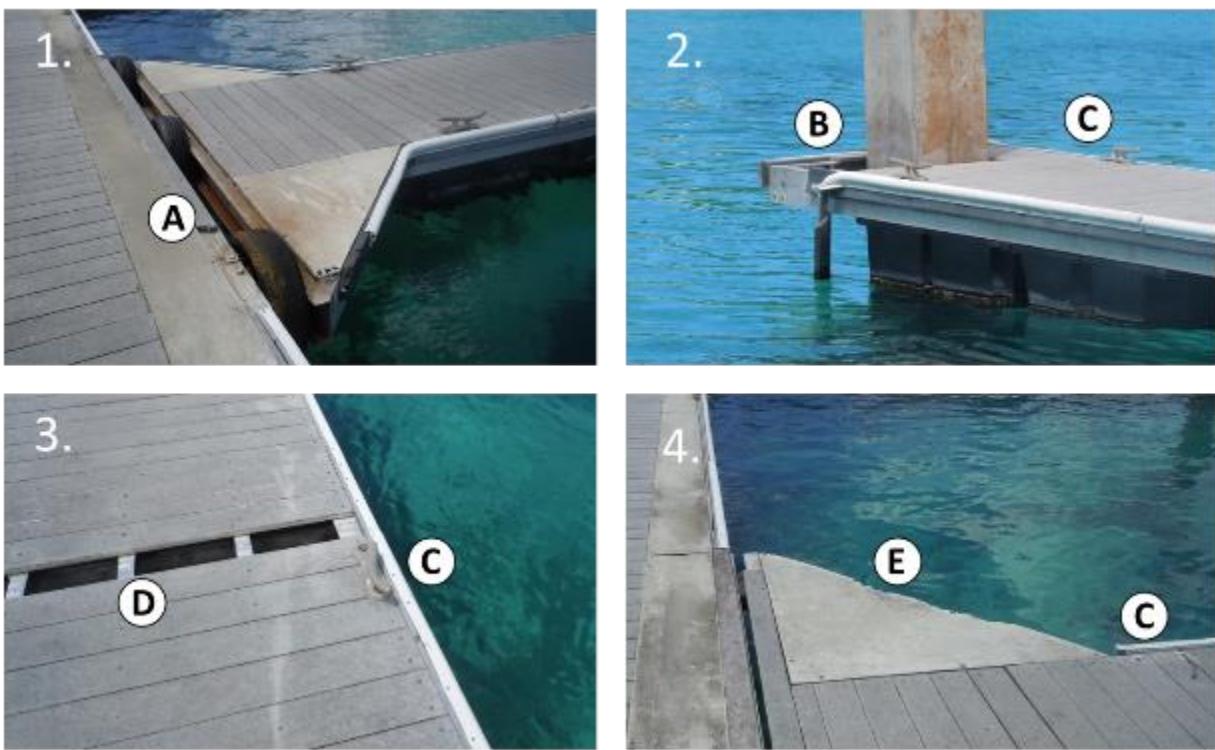
Figure 4-3: Marina Condition

In addition to the missing finger float, visible damage to the marina includes broken pile-guides, broken deck boards, broken cleats and fendering, damage to the wing gussets, and finger separation from the headwalk. Considering the marina was constructed in the 2003 – 2004 timeframe and Typhoons Tingting, Chaba, and Dolphin passed over or near Rota since then, the damage observed was relatively minor. However, not all the damage can be attributed to storms or wave action.

Figure 4-3 illustrates some of the damage found. Image 1, Item A shows the separated finger connection and repair method used. Image 2 shows a broken pile-guide on the 48-foot finger with damaged fendering. Item C on Images 2, 3, and 4 show broken or missing cleats. Item D is one of several broken deck boards observed and Item E shows damage to the wing-gusset.

Broken deck boards, mostly in the vicinity of the larger berths, indicate that heavy loads, likely on dollies or hand-trucks, were transported on the floats.

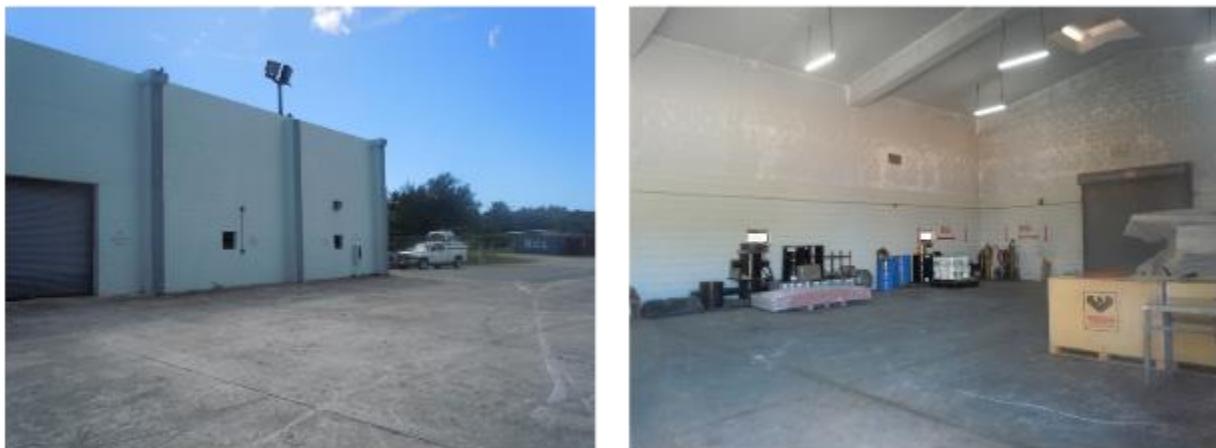
Figure 4-5: Transit Shed

The transit shed and paved operations area as shown in Figure 4-4 are in good condition and show little distress or deterioration. Repair is needed of the rolling door track on the west side of the shed.

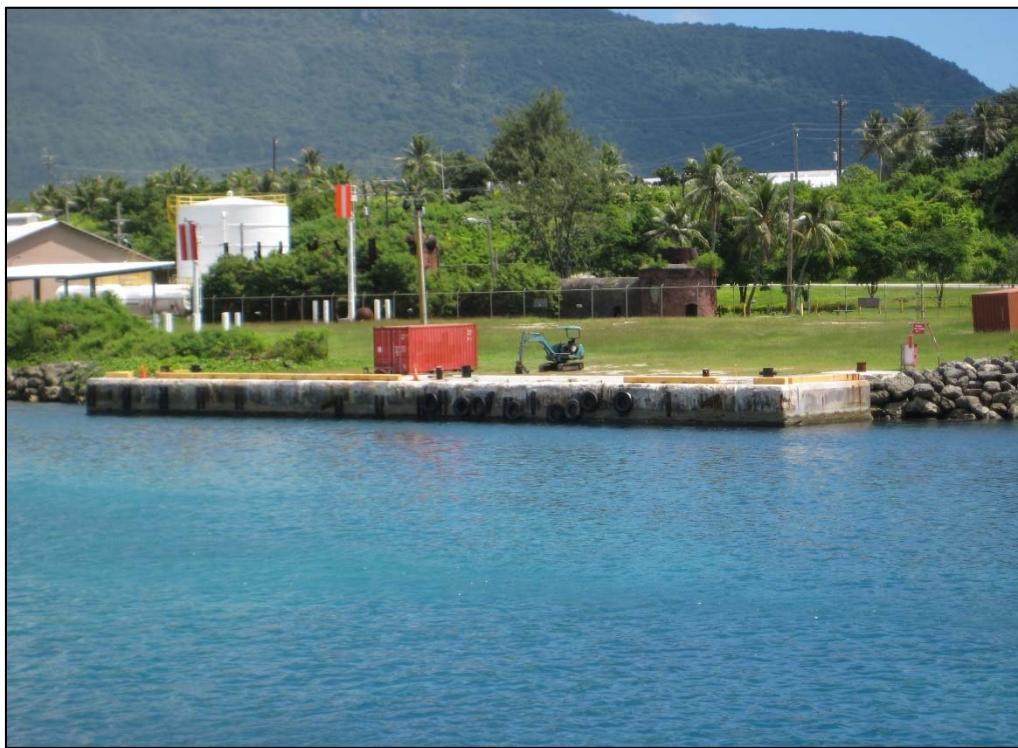
A General Site Plan is shown on Figure 2. Berth 1 is a 150-ft-long auxiliary structure (see Photo 1) and is used when weather conditions allow. Vessel docking and cargo handling primarily takes place at Berth 2 (Photo 2). Berth 2 is a 100-ft long marginal wharf constructed from steel sheet pile and concrete cap bulkhead located to the south of the turning basin and in front of the Port Operations Building. Stationing was used to record the location of defects. Station begins on the southern corner on the face of each berth and extends north. Stationing for the sides of the pier start on each northwest and southwest corner and extend eastward.

Photo 1. Berth 1 or "Old Dock" seen from the offshore island looking east.

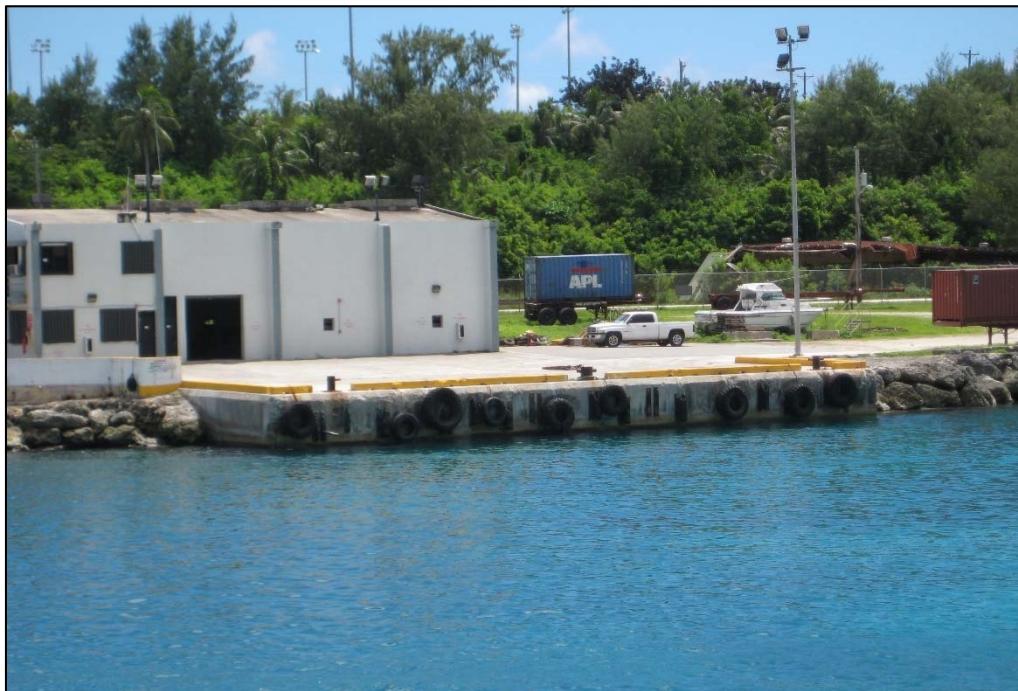
Photo 2. Berth 2 or the “New Dock” with the Port Operations Building is seen from the offshore island looking southeast.

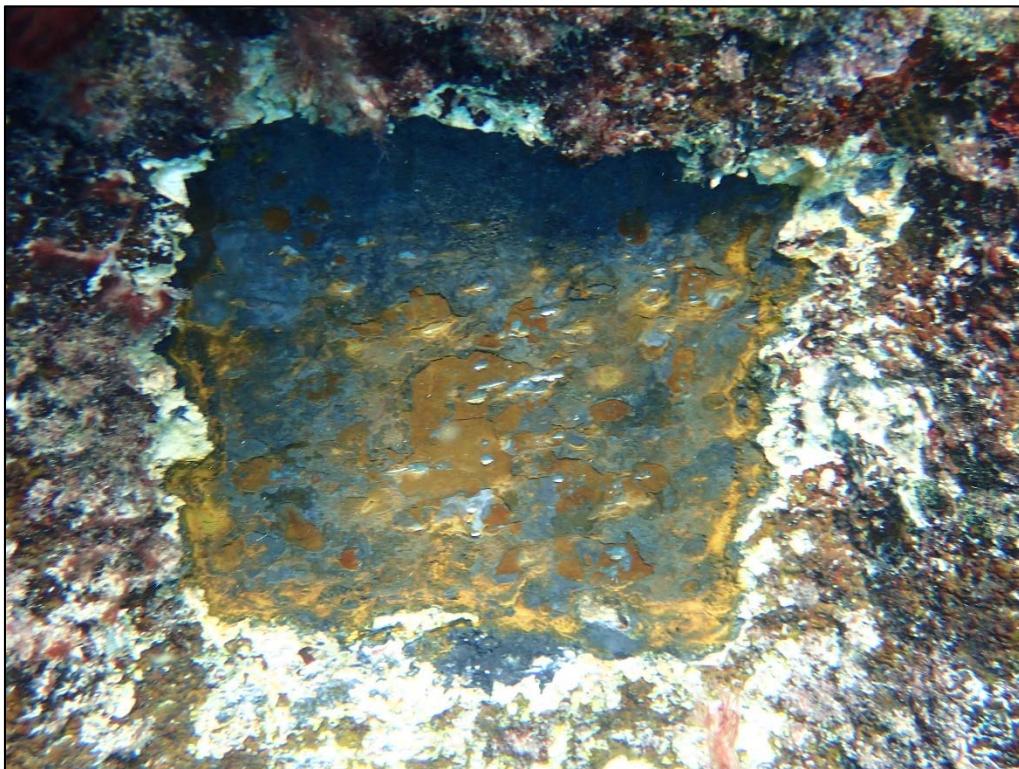
The steel sheet piles are continuously submerged and are visible below the concrete cap at El.-1.8-ft Mean Lower Low Water (MLLW), see Photo 3. A typical cleaned section of the web is seen in Photo 4 at Berth 2 and in Photo 5 of the flange at Berth 1.

Photo 4. A 12-in. by 12-in. cleaned section of sheet pile web at Station 0+14, south face of Berth 1. The face of the web is approximately 12-in. wide.

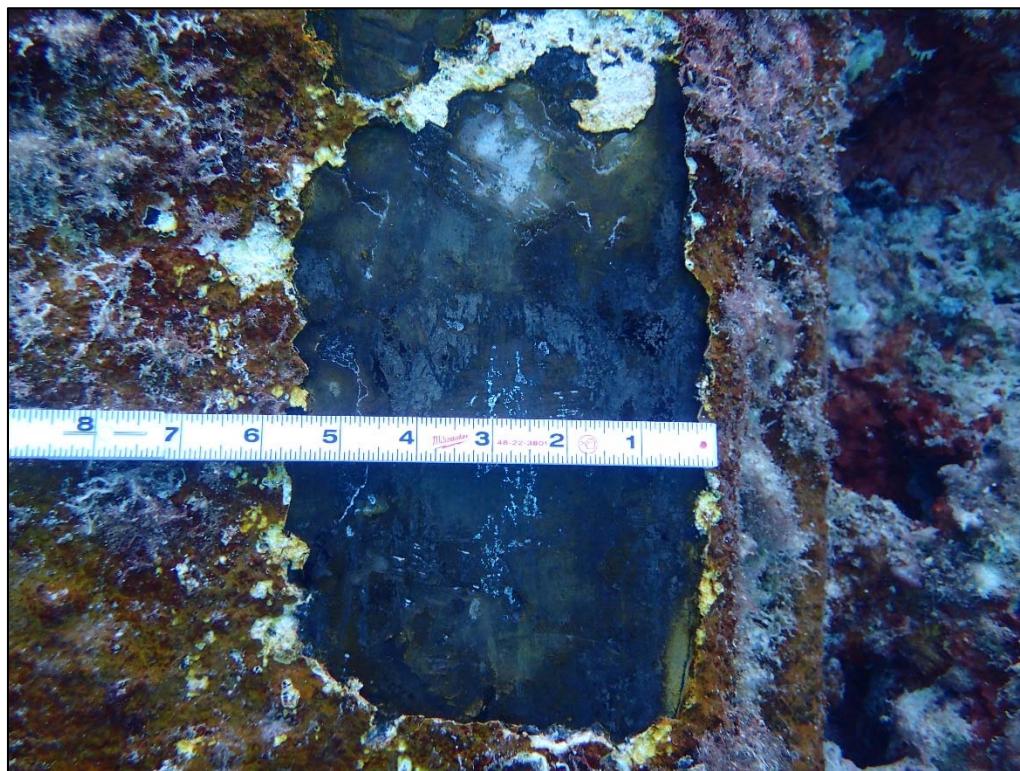
Photo 5. Cleaned section of sheet pile flange at Station 0+20, front face of Berth 2.

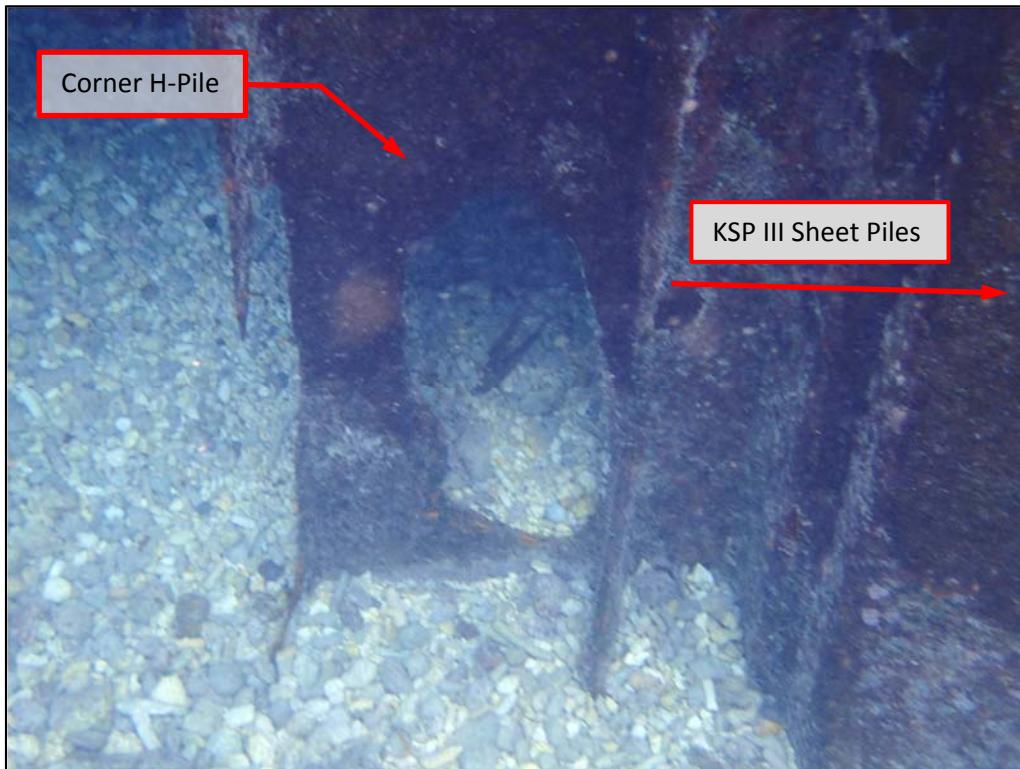
A 10-in. wide by 18-in. high void was noted in the web of the corner H-Pile at Station 1+50 (northwest corner of Berth 1) near the mudline. The H-piles on the north face are driven in a row and are linked together at the flanges. The hole was found in the H-Pile at the outboard end of the row (northwest corner) so the depth of the void is 12-in. to the web of the adjacent H-pile. The northwest flange has also experienced 100% section loss from the mudline up 18-in. See Photo 6, Photo 7, and Figure 4 for further explanation.

Photo 7. Berth 1. The corner H-pile and KSP III sheet piles connection. See Figure 4 for detail.

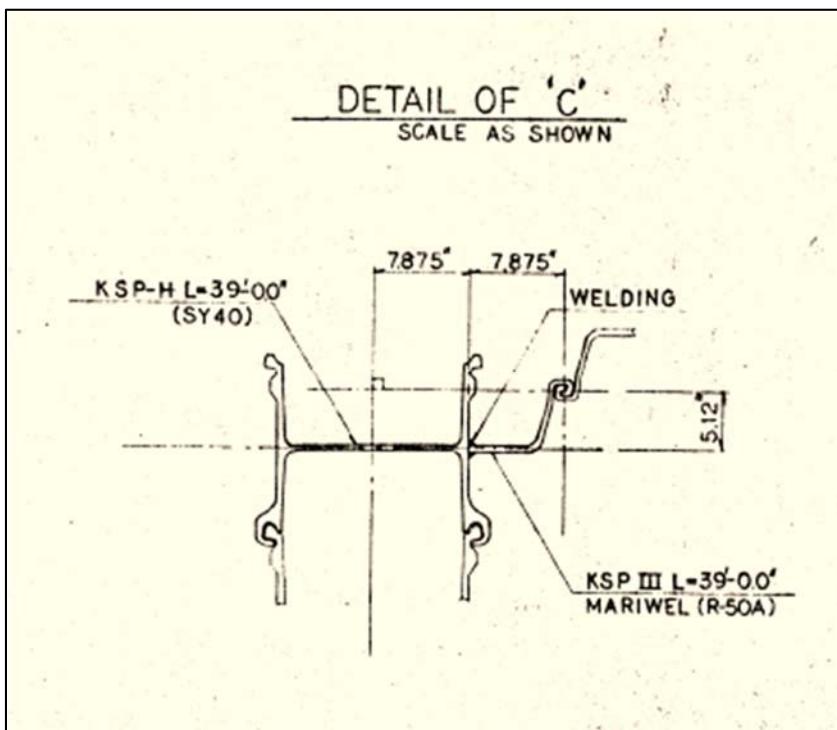
Figure 4. Detail C from Pertinent Document 2 details the corner connection of the front face KSP III sheet pile line to the south face KSP-H pile, at the southwest corner of Berth 1. The mirror image of this arrangement is seen in Photo 6 and Photo 7.

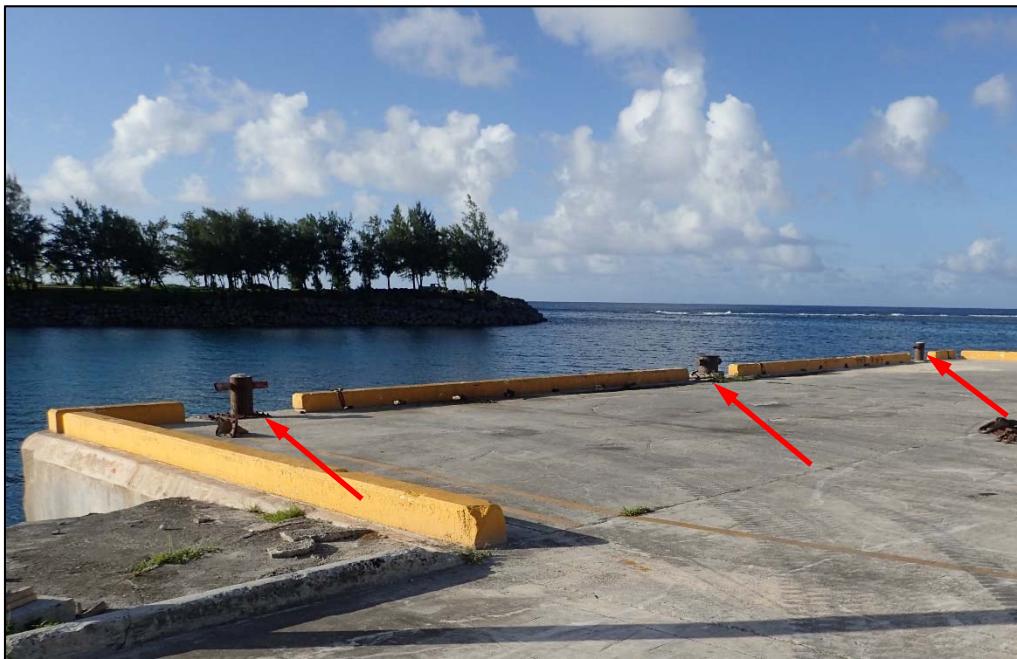
Photo 20. Layout of mooring bollards at Berth 2. Red arrows point to the single bollards at the face of the berth.

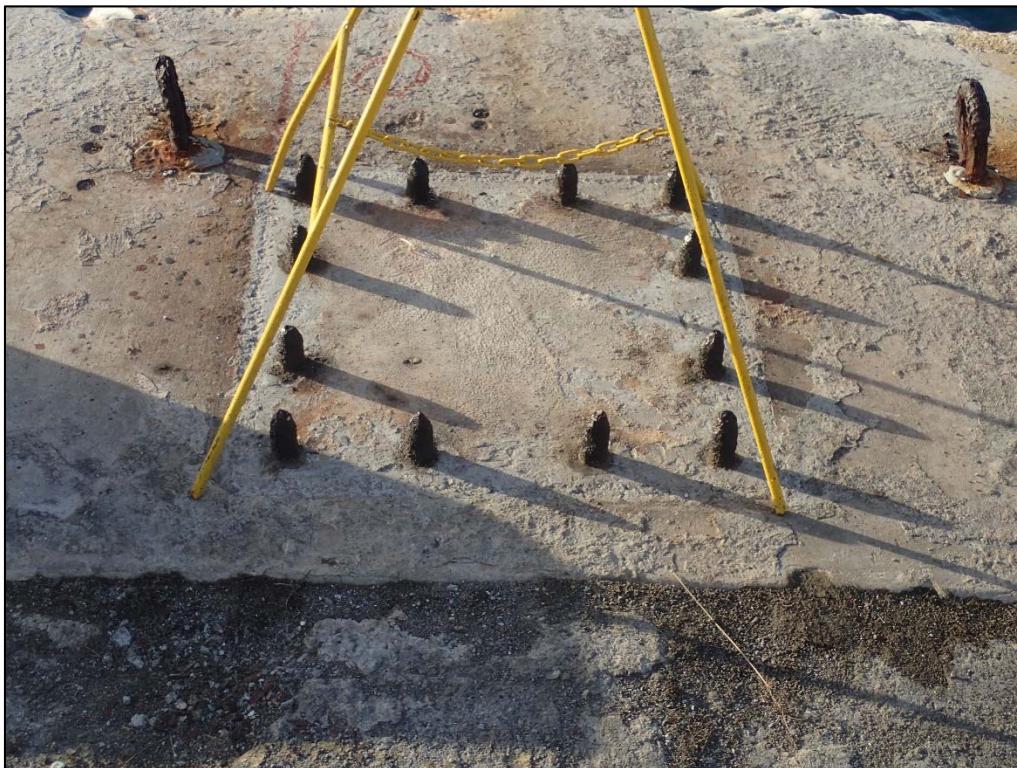
Berth 1 is designed with four single bollards, and Berth 2 has three single bollards. At the time of inspection the three bollards on the face of Berth 1 had been removed and were not inspected, see Photo 21. The bollard foundation bolts at Berth 1 were cleaned with 75% of the threads intact and sticking out of the cap approximately 2.5-in. The surrounding concrete and bolts are in satisfactory condition. New bollards with solid base plates were staged on the pier (presumably for installation).

Photo 21. Berth 1 Station 0+10 where a bollard has been removed and the anchor bolts remain.

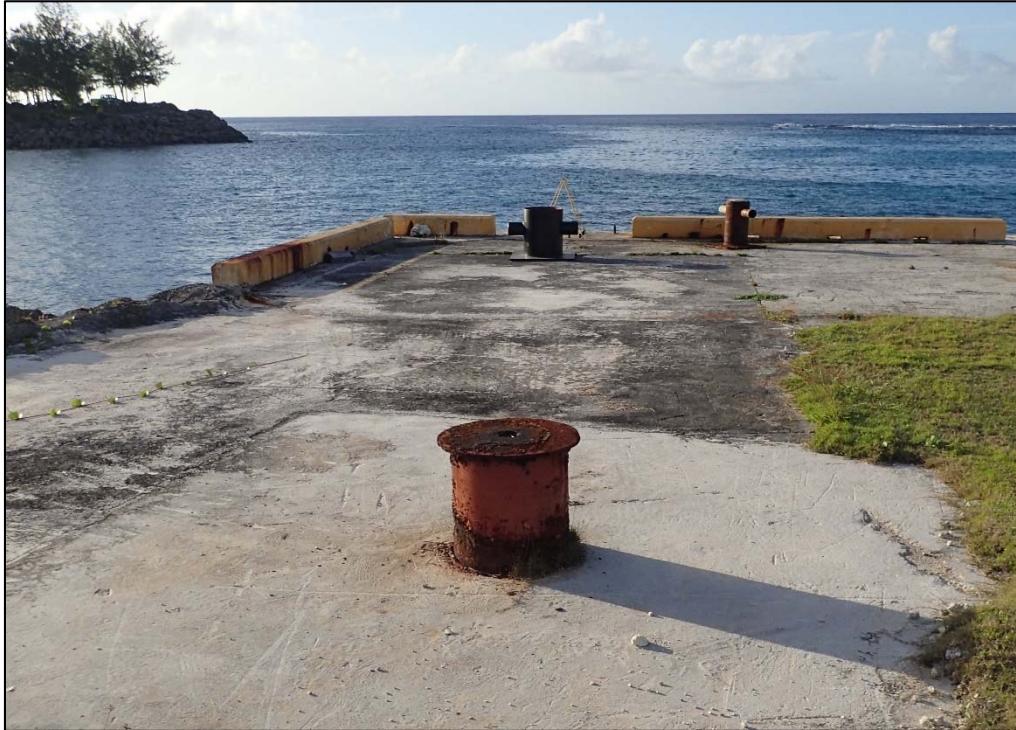
The bollard installed approximately 50-ft behind the southwest corner of Berth 1 (Photo 22), exhibited heavy corrosion around the base. The 18-in. diameter bollard cylinder is anchored in a 20-in. diameter sleeve cast in a 13-ft by 13-ft concrete footing. There is no flashing or grout pad protecting the perimeter of the steel to concrete interface allowing for water intrusion.

Photo 22. An 18-in. diameter bollard approximately 50-ft behind the face of Berth 1.

Short-term repairs are recommended at the bollard cast in concrete footing at Berth 1 (Photo 22) and include the following: Remove corrosion and apply two coats of primer and a corrosion inhibiting topcoat. The interface between the mooring hardware and steel insert foundation should be sealed with a caulking-type sealant around the base.

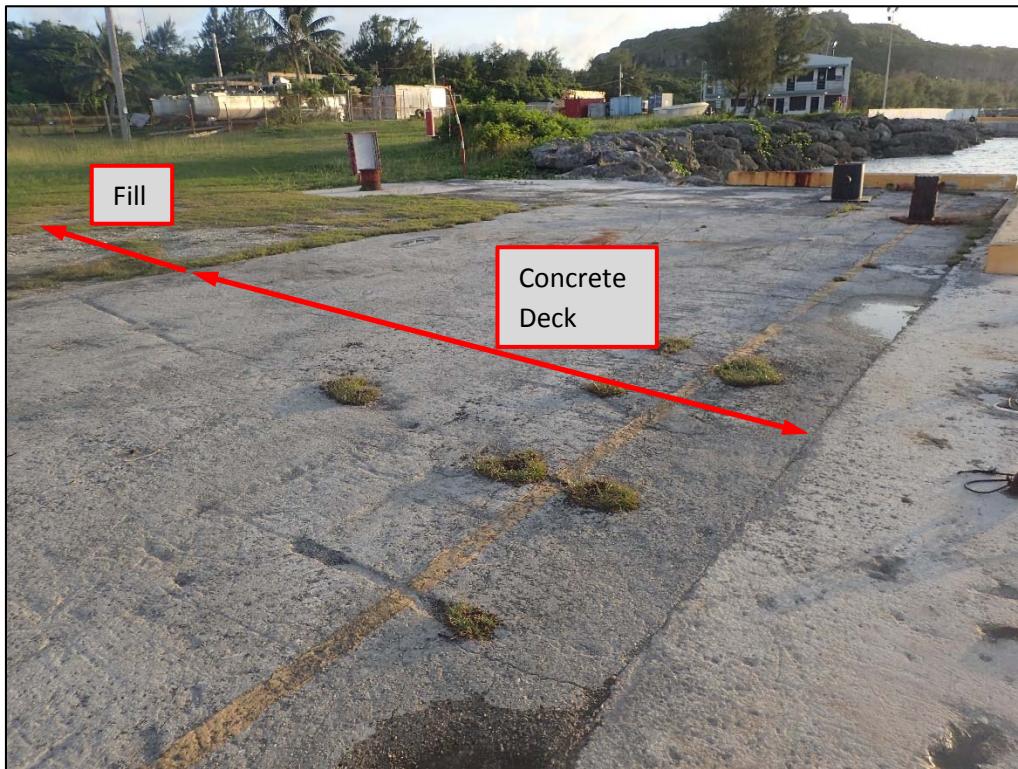
The concrete deck extends from the concrete cap back approximately 20-ft at Berth 1 and from the cap up to the Port Operations Building at Berth 2. The concrete decks are in fair condition. The deck surface at Berth 1 (Photo 25) is heavily worn with minor cracks and subsidence observed. The deck surface at Berth 2 exhibited moderate wear and minor cracks with more prominent subsidence observed and associated cracking (Photo 27).

Photo 25. Concrete deck at Berth 1 looking south.

Recommendation(s) – Repair subsided areas as part of a short-term repair. The following is the recommended repair process: Remove soil and organic matter, saw cut around the perimeter and remove approximately 1-in. thickness of concrete. Place a suitable mortar or concrete, install per manufacturer's recommendation. Monitor areas behind the cap for future ponding and subsidence.

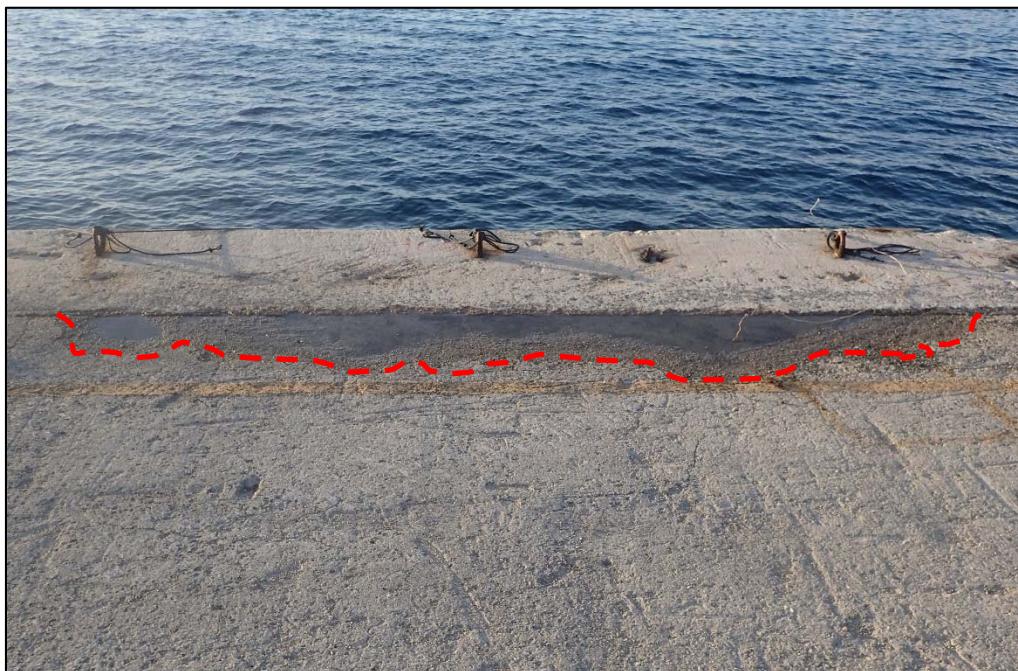
Areas of subsidence were noted directly behind the cap at both piers. Ponding at Berth 1 was noted at Station 0+39 (5' long x 18" wide x 0.5" deep) and Station 0+60. The ponding at Station 0+60 was 15-ft long, 18-in. wide, and 0.5-in. deep and is seen in Photo 26. The area of subsidence at Berth 2 was from Station 0+20 to Station 0+64 and was up to 30-in. wide and 5-in. deep (Photo 28). Subsidence is minor and no evidence of fines percolating through the steel sheet piles was observed. Subsidence is likely a result of compaction over the years.

Photo 26. Ponding from deck surface subsidence noted at Berth 1 Station 0+60.

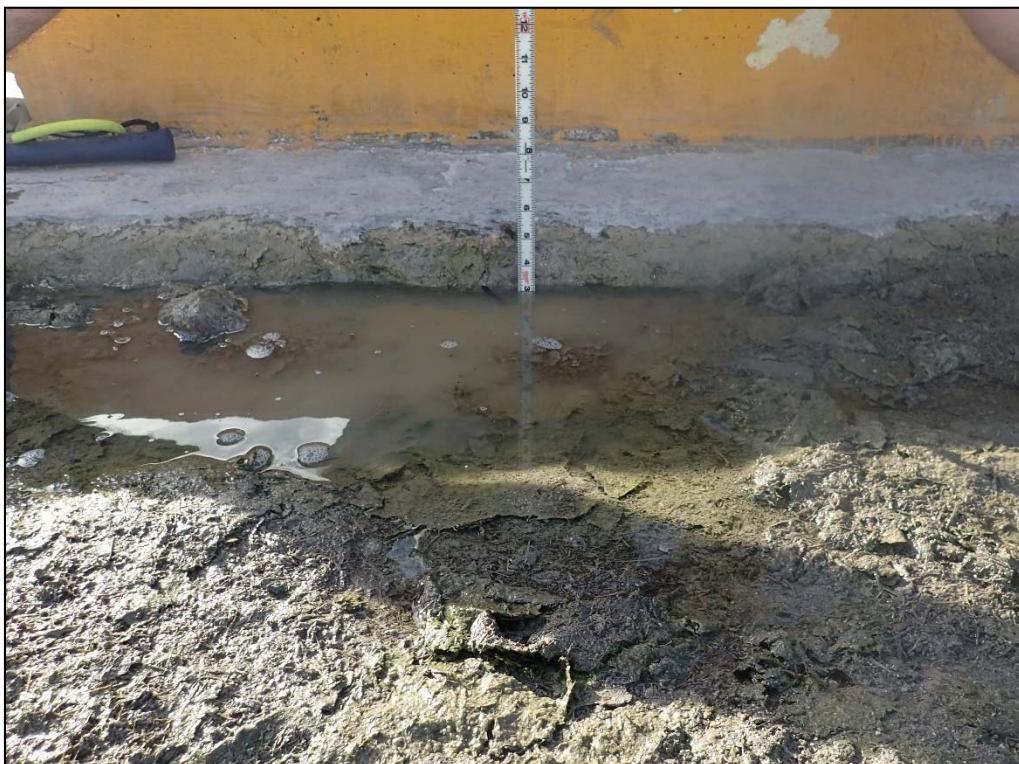
Photo 28. Berth 2. Soil and water collects behind the cap at an area of deck subsidence. The resultant depression is 3-in. deep at Sta. 0+58 and up to 5-in. deep in other areas.

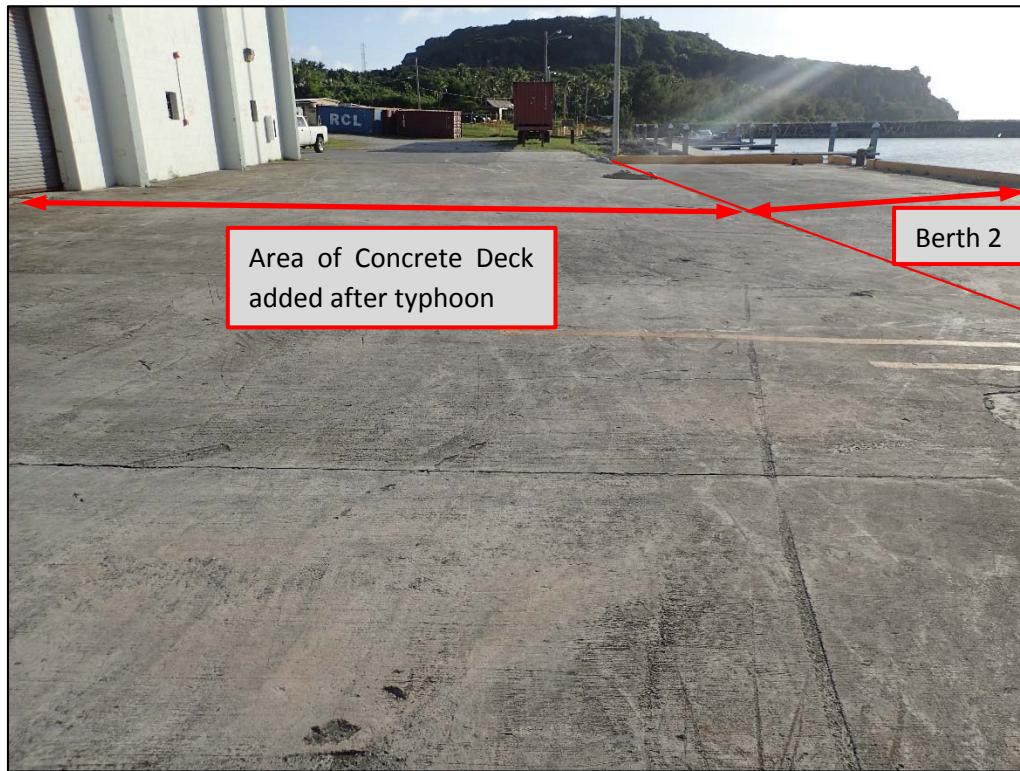
Port personnel indicated that a typhoon washed out the soil behind Berth 2 and in front of the Port Operations Building (10-15 years ago). Repairs included placement of compacted fill and a PCC slab from behind Berth 2 to the building.

Photo 29. Berth 2. Section between Berth 2 and the building which was added after the subsoil was washed out by a typhoon.

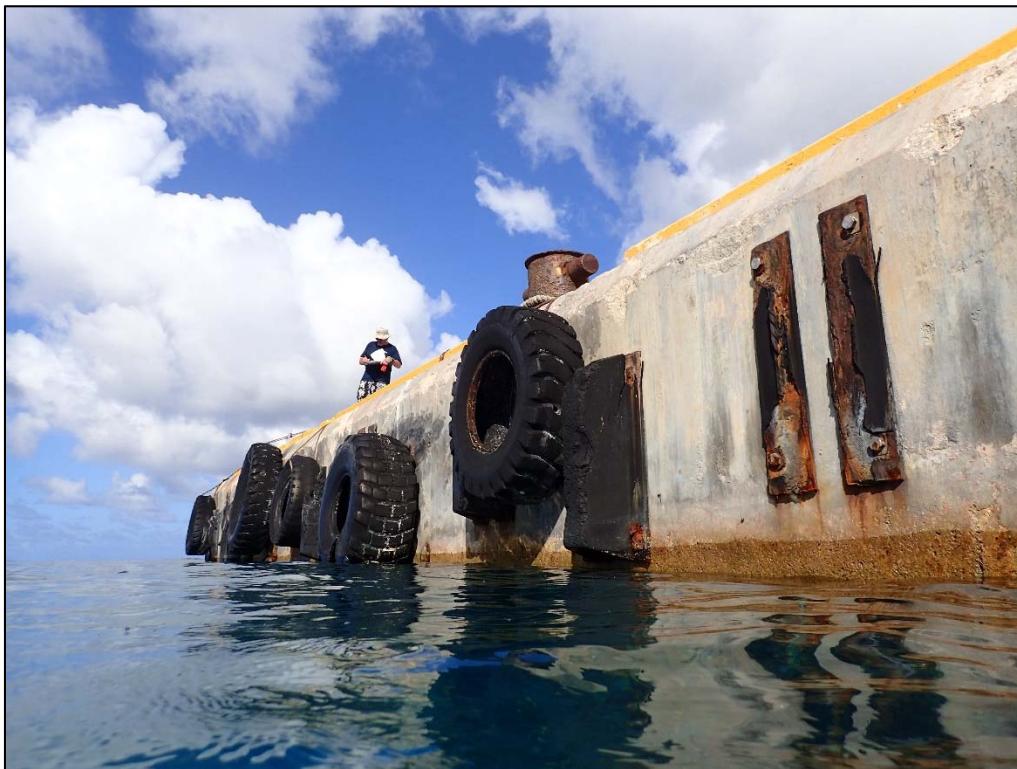
At Berths 1 and 2 makeshift fenders using tires are currently in use, see Photo 33 through Photo 36. The tires are fastened to pad eyes embedded in the top of the concrete cap (Photo 37) and to the concrete curbs (Photo 38) with polypropylene lines, wire rope, or chains. The pad eyes are severely corroded. Significant abrasion damage was observed on the corner of the concrete cap from the wire rope and chains. In some instances, the cap was abraded down to exposed reinforcing steel, see Photo 39. The intent of the fender system is to protect the structure, absorb energy, and protect the hull of the ship. The “spring” provided by the fender system is missing by using the tires, so very little energy is absorbed. The standoff distance provided by the tires also may be inadequate resulting in direct contact of the ship with the concrete cap.

Photo 36. Close up of the V-type fender remnants and suspended tires at Berth 2.

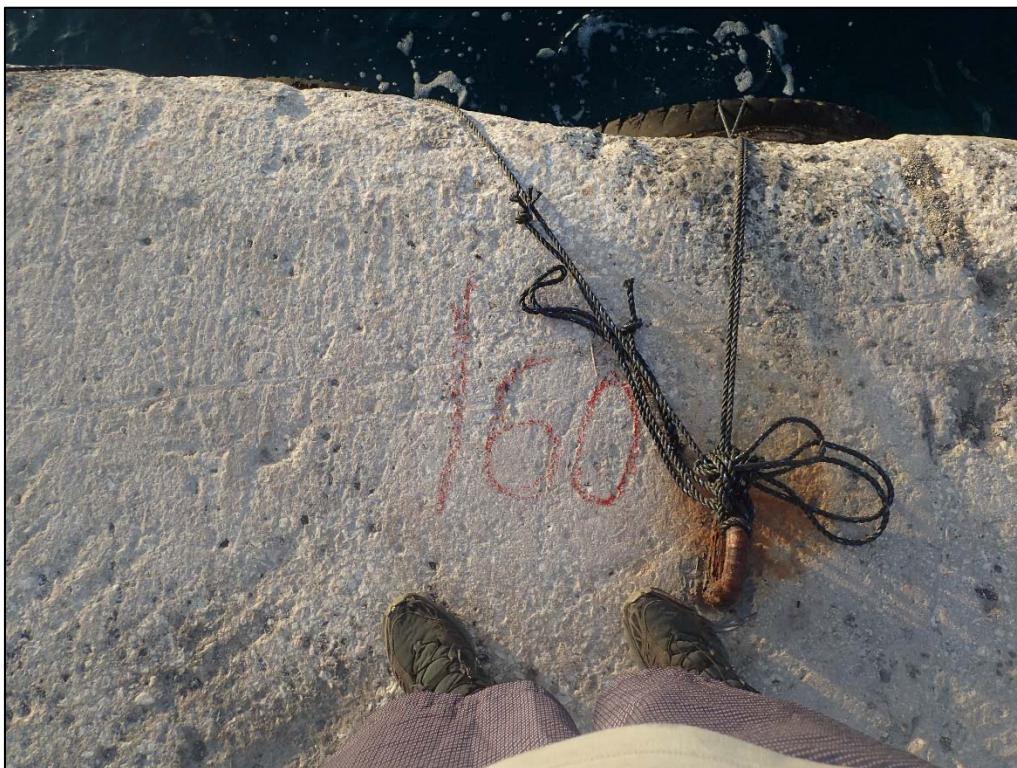
Photo 37. Berth 1 Sta. 0+60. Tires are tied to a pad eye with a polypropylene line.

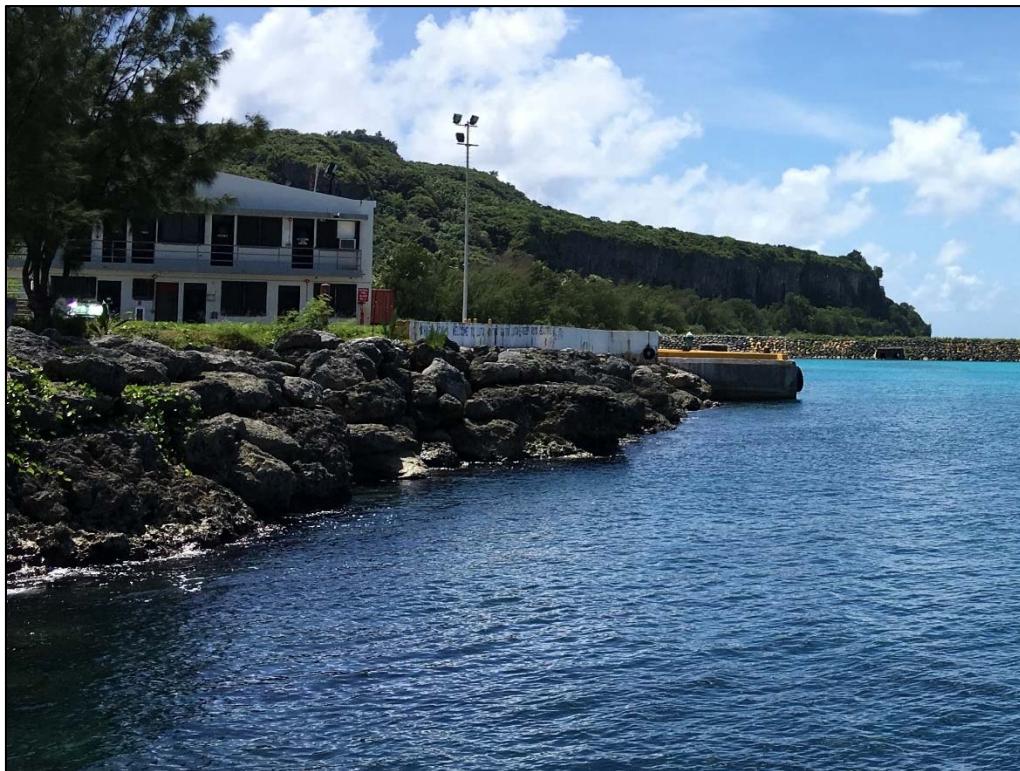
Adjacent to Berth 2 on the north and south sides, voids were observed near the bottom of the rip rap revetment, approximately 4-ft high by 2-ft wide by 6-ft deep and 2-ft high by 4-ft wide by 6-ft deep respectively.

Photo 40. Rock revetment seen from Berth 1 looking south towards Berth 2.

Recommendation(s) – As part of a long-term repair, adding riprap adjacent to the berth should be considered. There are no records or cross-sections available for the installation of riprap. It is assumed the riprap was not part of an engineered design. A study should be performed to determine the proper slope for the existing riprap and how much rock should be added to achieve the desired level of protection. Environmental permitting will be required for the in-water portions of work.

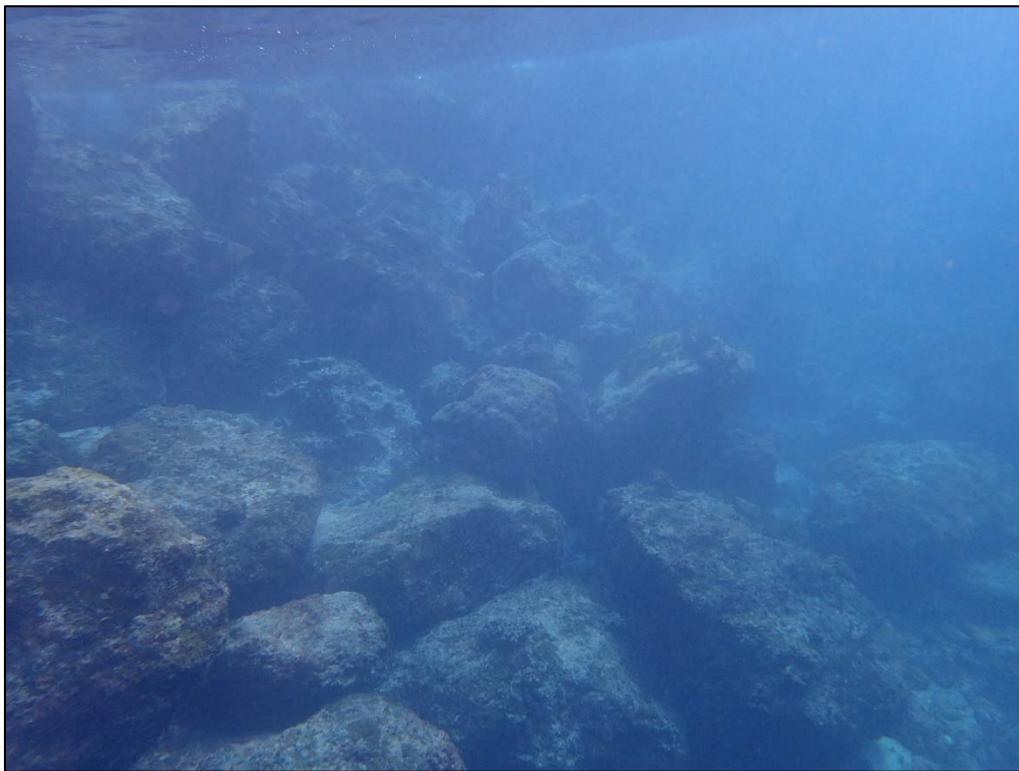
Photo 41. The revetment between Berths 1 and 2 seen below water.

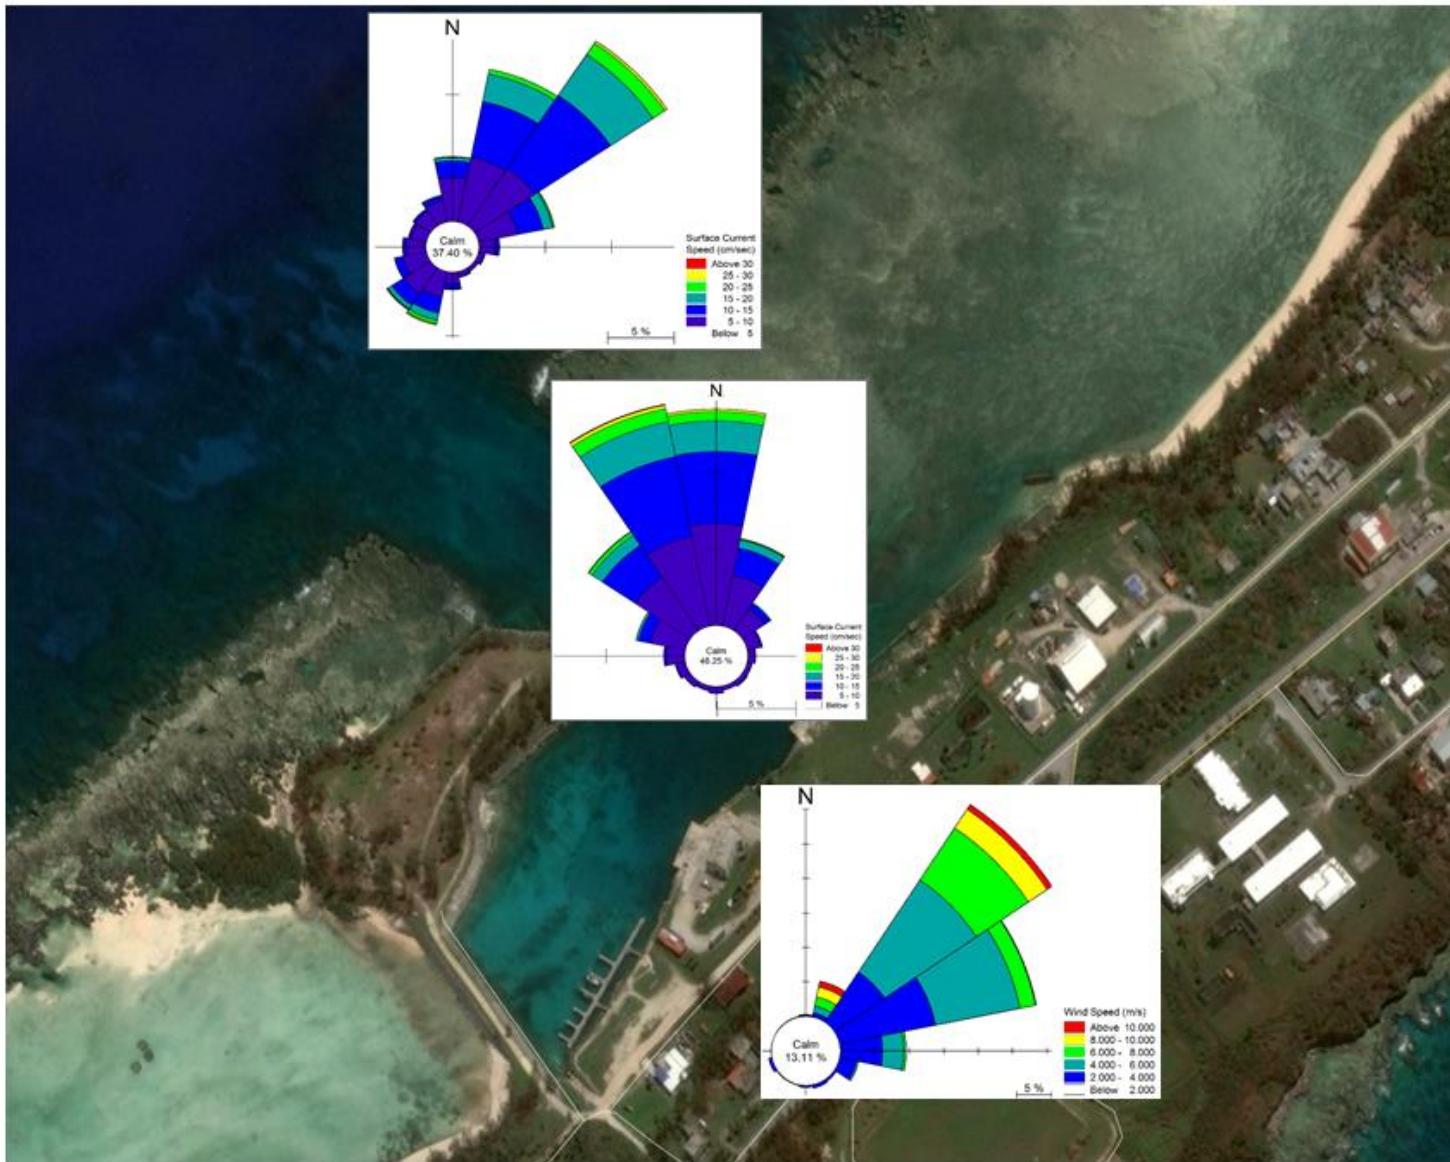
The wind speed of 1-percent exceedance is approximately 10.6 m/sec (21.2 knots). The surface current speeds occurring 1-percent of the time at inshore location are higher than 23.0 cm/sec (0.46 knots). At the turning basin, the vessel is pushed by the winds and currents (see Figure 21).

Figure 21. Wind and Surface Current Conditions at Rota Island Harbor (Dec. 2, 2016 through Mar. 3, 2017)
