ROTA WEST HARBOR MASTER PLAN

Commonwealth Ports Authority

April 2018

Prepared By | Moffatt & Nichol, Honolulu, Hawaii
In Association With | PEGS and Micronesian Environmental Services, Inc.

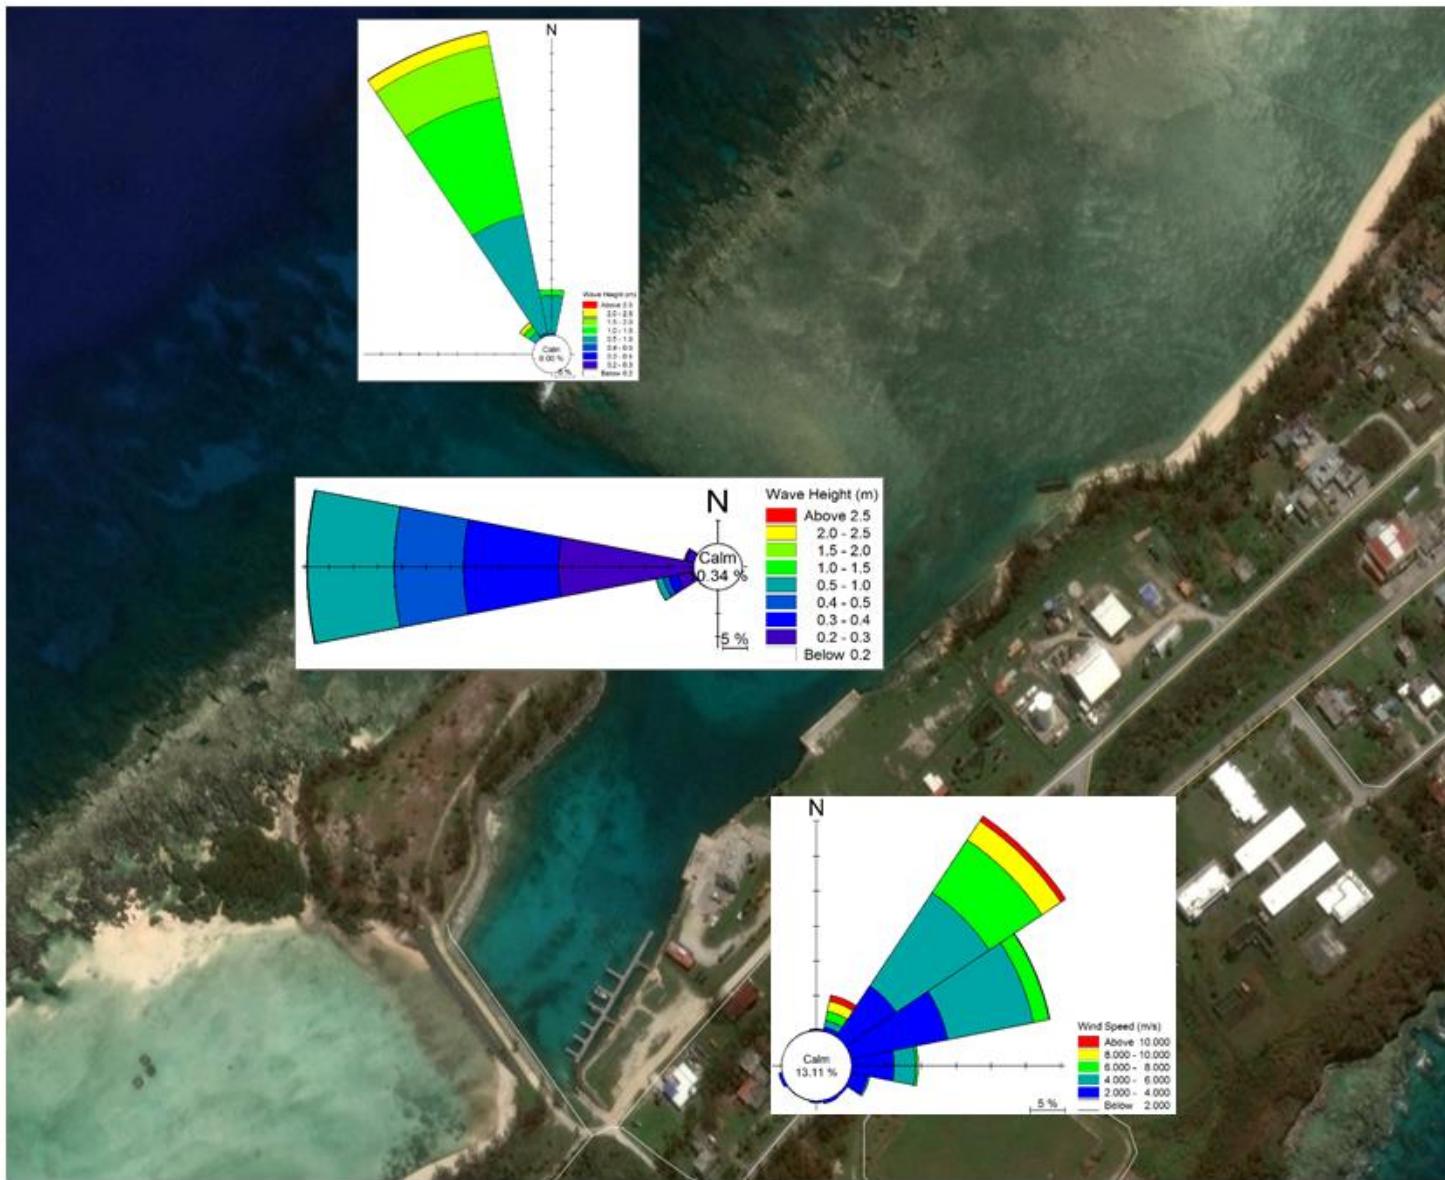
The updated wave data during December 2, 2016 and March 3, 2017 (see Figure 22) indicate that the prevailing waves at offshore location are 0.5 meter to 2.0 meters with wave periods of 8 to 12 seconds, and the prevailing waves at inshore location are 0.2 meter to 0.5 meter with wave periods of 8 to 14 seconds. The wave data at deep water during 1971 and 1980 indicate that the prevailing

waves are 1 meter to 2.5 meters with wave periods of 6 to 9 seconds. The new wave data have longer wave periods compared to the old wave data. The longer wave periods can result ship operation more difficult. The inshore significant wave heights occurring 1-percent of the time are higher than 0.80 m.

Figure 22. Wind and Wave Conditions at Rota Island Harbor (Dec. 2, 2016 through Mar. 3, 2017)

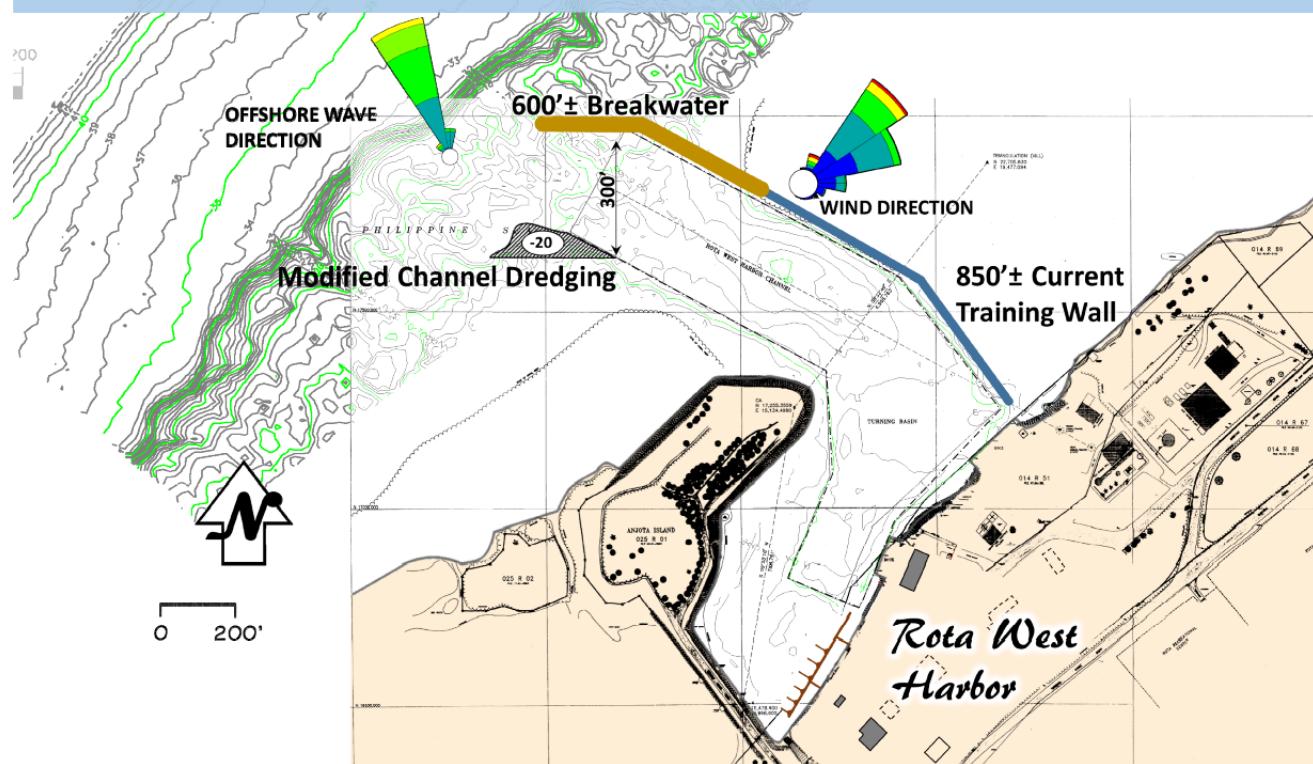
Figure 23. Recommended Rota Island Harbor Improvement

A jetty at northeast side of the Rota Island Harbor is recommended to block the currents. An offshore breakwater near channel entrance is recommended to reduce incident waves at turning basin area and berthing area (see Figure 23).
