Drinking Water and Wastewater Master Plan – Rota, Commonwealth of the Northern Mariana Islands

Prepared for
Commonwealth Utilities Corporation

June 2015

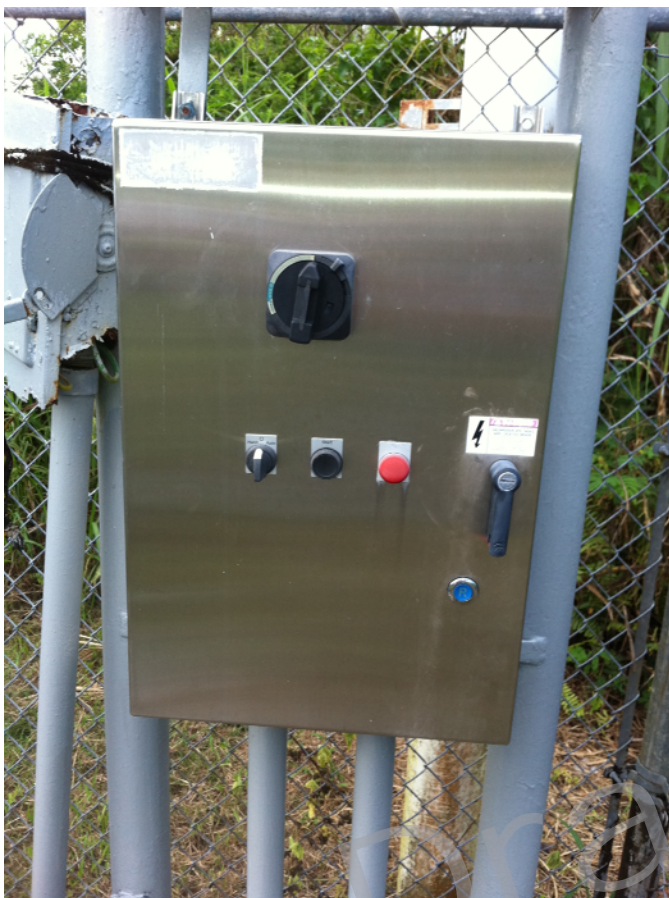
Figure 2.2.2-2. Typical Well Control Panel

Pump controls are provided by a local control panel that has a manual on/off position (see Figure 2.2.2-2). The pumps run based on manual control. There is no automated control system. Upon start up, the well water supplies are manually bled through a bypass valve located along the well discharge manifold.

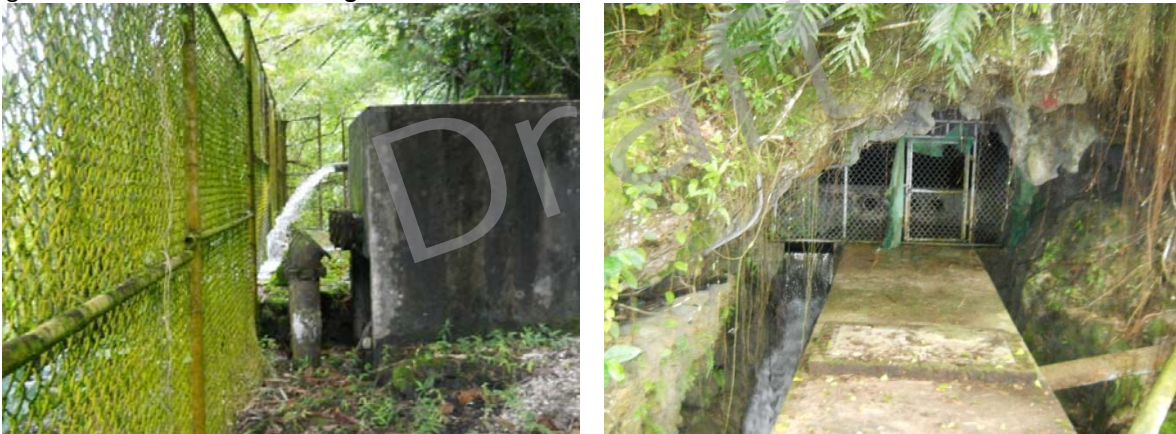
Figure 2.2.2-3. **Main Cave Fencing**

There were no hardened structural enclosures at either of the spring sites. The caves have a fence and gate built into the rock formation to prevent anyone from illegally entering the caves and potentially contaminating the water.

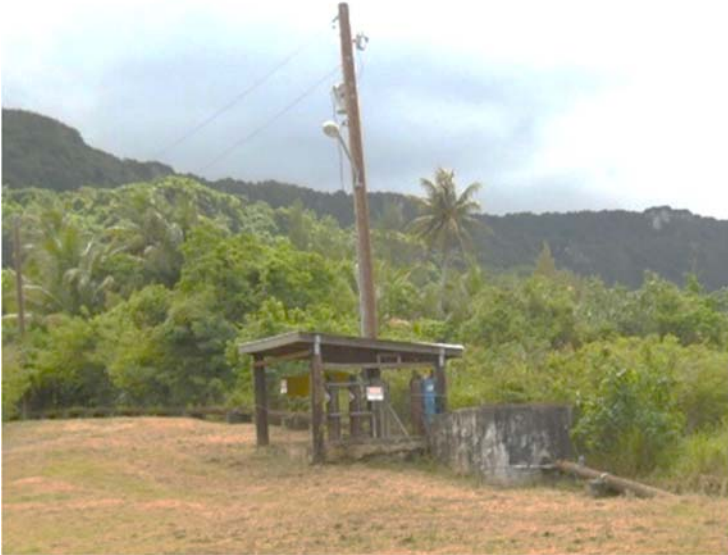
Figure 2.2.2-5. Chlorination System at the Kaan Tank

available during the dry season, this chlorine treatment system is not used during the dry season. Figure 2.2.2-5 is a photo of the chlorination system at the Kaan tank.

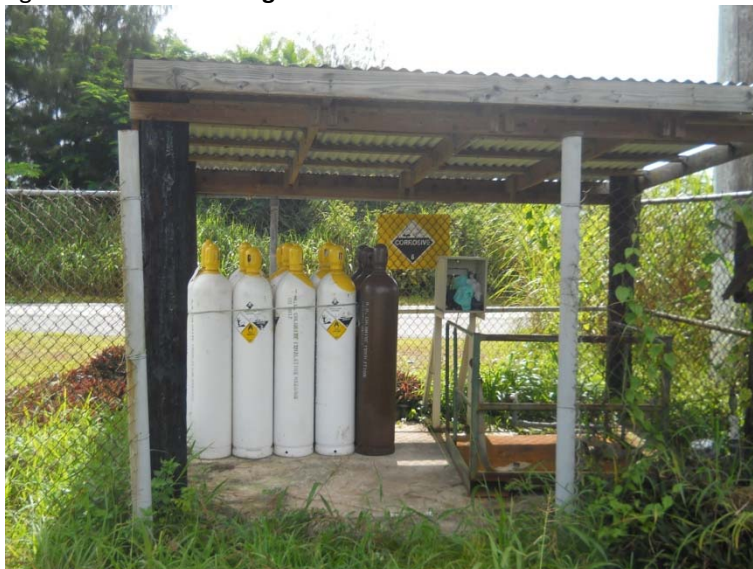
Figure 2.2.2-8. Ginanlangan Tank Site

period. The empty and full cylinders are stored at the Kaan tank, as seen in Figure 2.2.2-7, and at the Ginanlangan tank site, shown in Figure 2.2.2-8.

At both chlorination sites on Rota the chlorine tank is connected to the rotameter through a manifold consisting of a Regal regulator, ejector, and vacuum tubing. Both of the manifold systems were functioning properly at the time of inspection, although the regulators were being operated manually and were not utilizing an automatic chlorine tank switchover. Each of the Rota chlorination sites only had one regulator, which had to be manually switched over once a chlorine tank is empty.

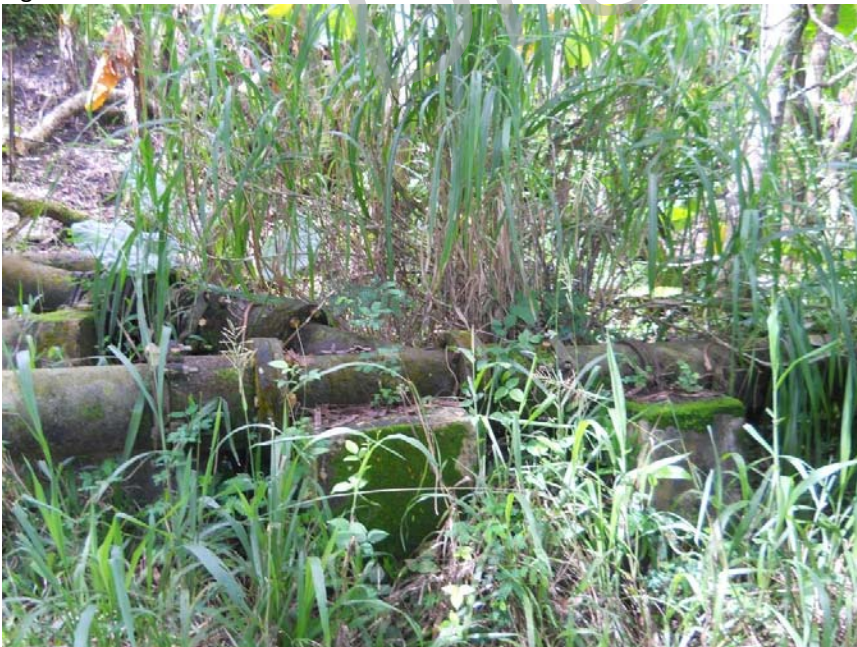
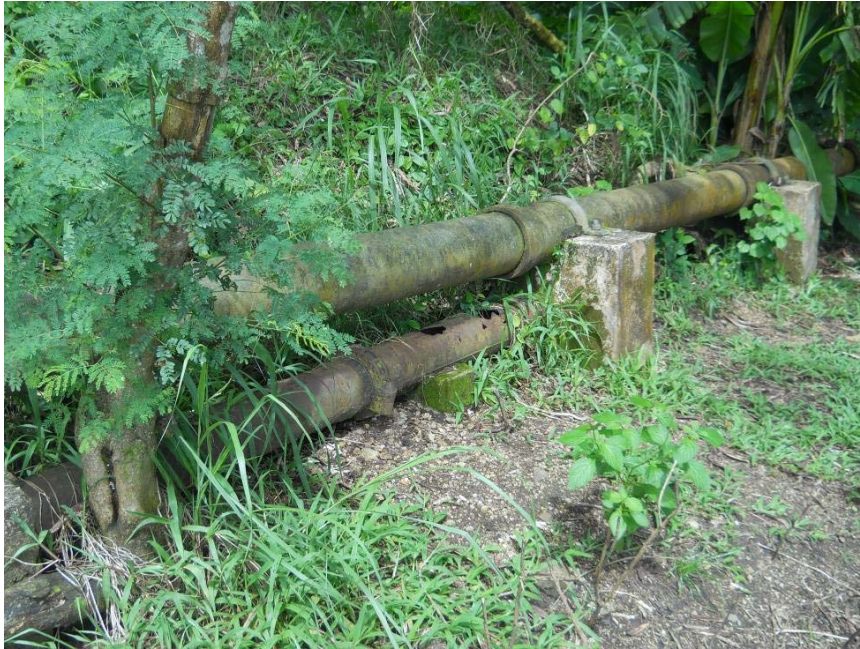
Figure 2.2.2-10. Transmission Line Intersection of the Main and Onan Caves

Figure 2.2.2-11. Abandoned Transmission Line Shown Below New 10-Inch Line

The concrete pedestals that the transmission lines are secured to show signs of root intrusion. CUC conducts routine clearing around these pedestals to control the root intrusion.

- Continue to conduct routine clearing around the concrete pedestals that support aboveground transmission pipelines to control the root intrusion.
- Routine painting of the site piping is recommended.

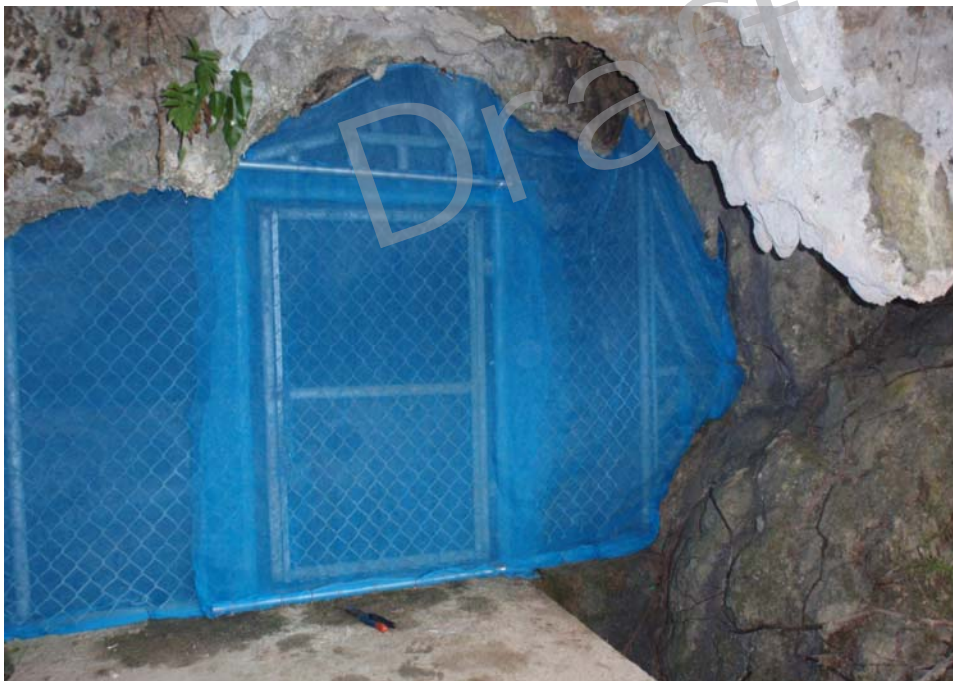
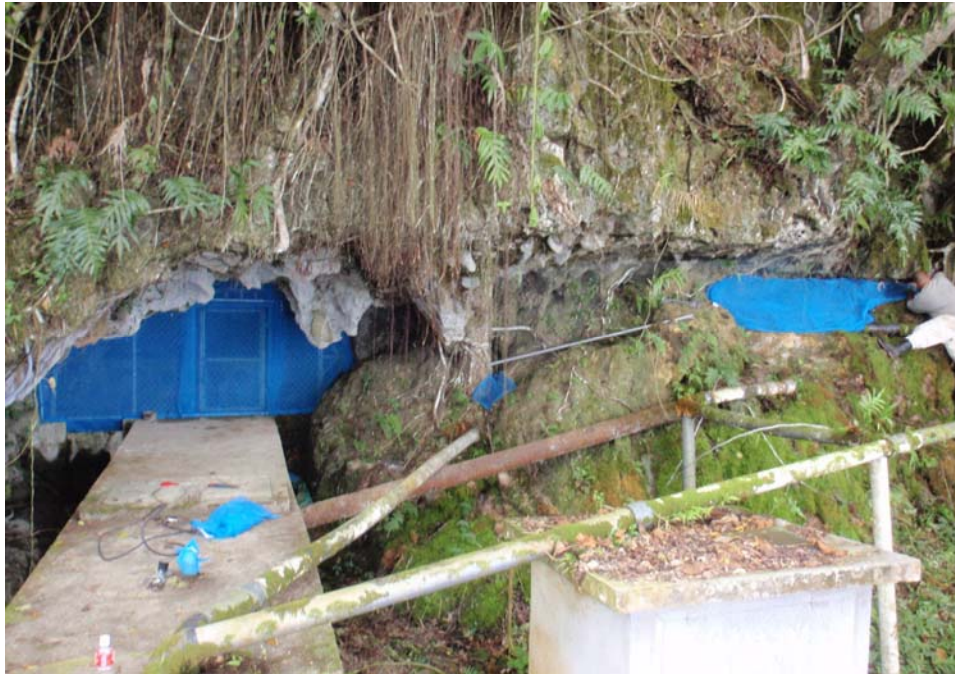
For 9 months of the year, the primary water supplies for Rota are the Onan Cave and Main Cave, which are natural springs fed by rain falling on the highest parts of the island. These springs are protected sources in that there are no unsewered areas within the watershed. There is a concern that there may be a direct influence on water quality during storm events from surface runoff and potential contamination entering the Main Cave and Onan Cave entrances because they are not properly sealed. The CNMI DEQ selected the Main Cave for the study, understanding that both caves when properly sealed would have similar influences from stormwater run-off. In anticipation of the GWUDI evaluation, the CUC staff temporarily sealed off the cave with insect screens as shown in Figures 2.2.2-12 and 2.2.2-13. A project in the CUC Water Master Plan 20-year Capital Improvements Plan (CIP) has been identified to seal the Main Cave with a more permanent structure. The Rota GWUDI online water quality monitoring (OWQM) station and weather station were located downstream of the Main Cave at the Kaan Tank. The raw water flows directly through a steel pipeline from the Main Cave to the Kaan Tank and is sampled prior to storage and chlorine disinfection.

Figure 2.2.2-12. **Main Cave Temporary Insect Screen Photo 1**

Figure 2.2.2-13. Main Cave Temporary Insect Screen Photo 2

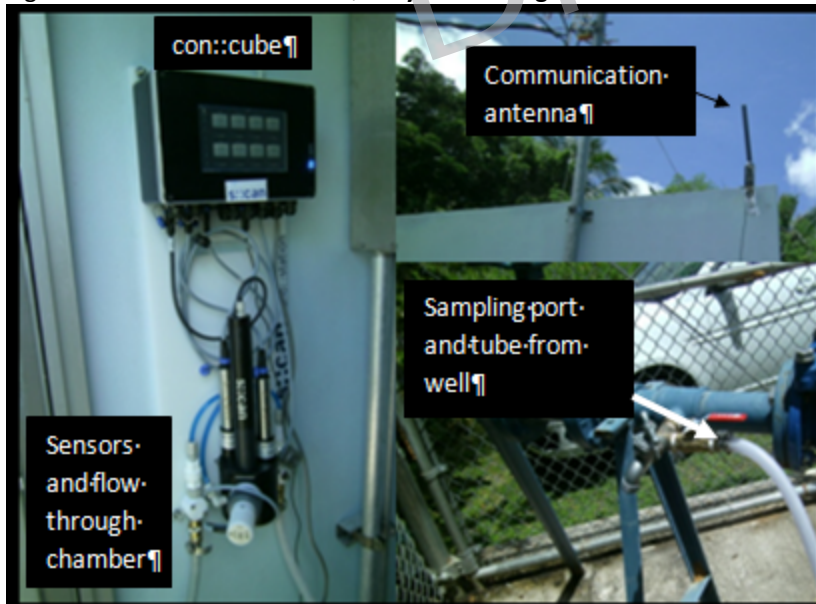
Figure 2.2.2-14. Online Water Quality Monitoring Station

The sensors were connected through a cable into a controller unit known as the con::cube. The con::cube communicates wirelessly through a digital cellular communication system and data can be retrieved from a Web-enabled dashboard that allows real-time OWQM trend analysis and sensor health evaluation. A photo of the station labeled with its various parts is shown in Figure 2.2.2-14. The tubing shown in the figure is the original braided tubing that was initially installed but was later replaced with copper tubing due to pressure problems.

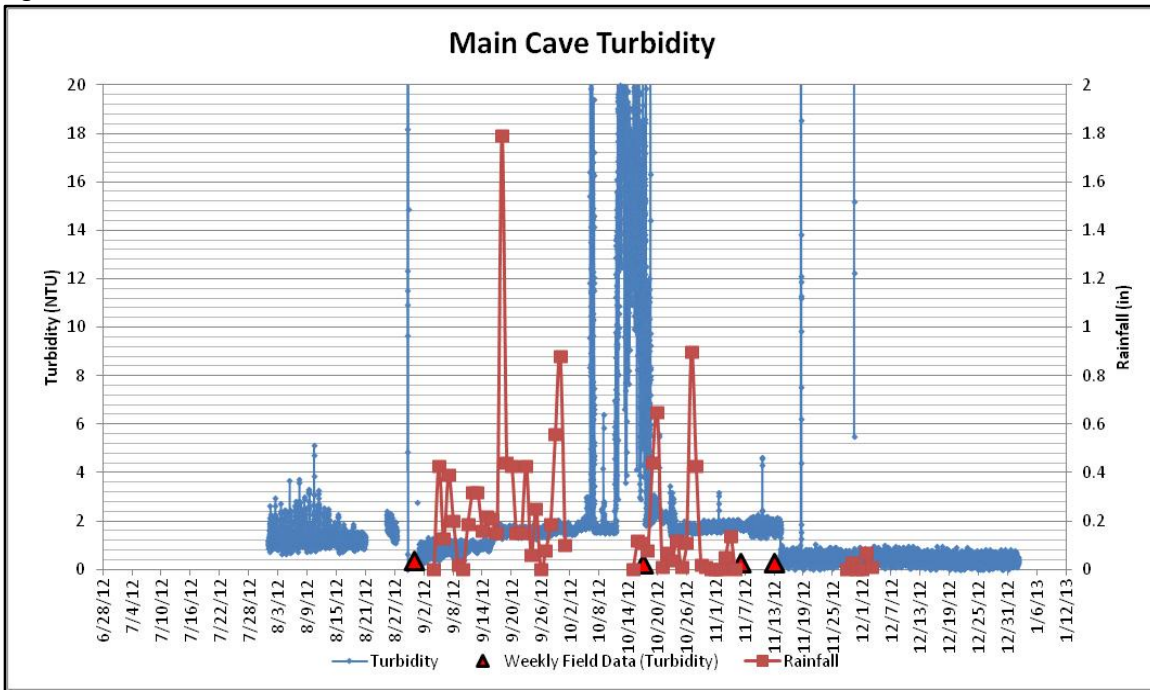
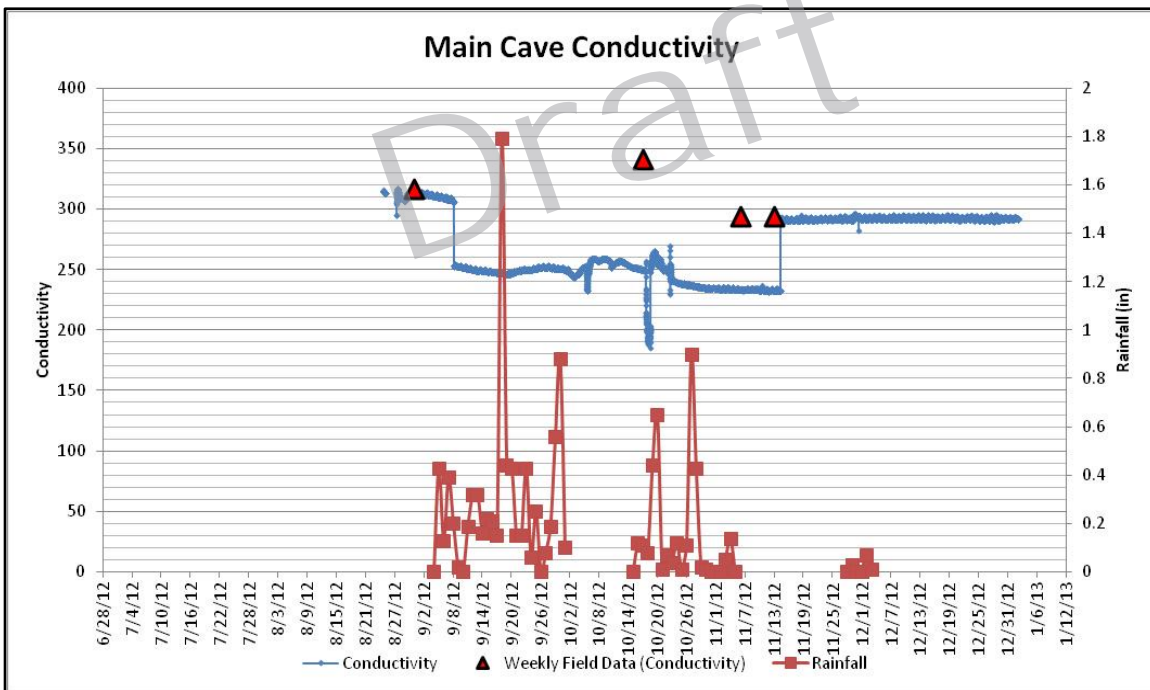
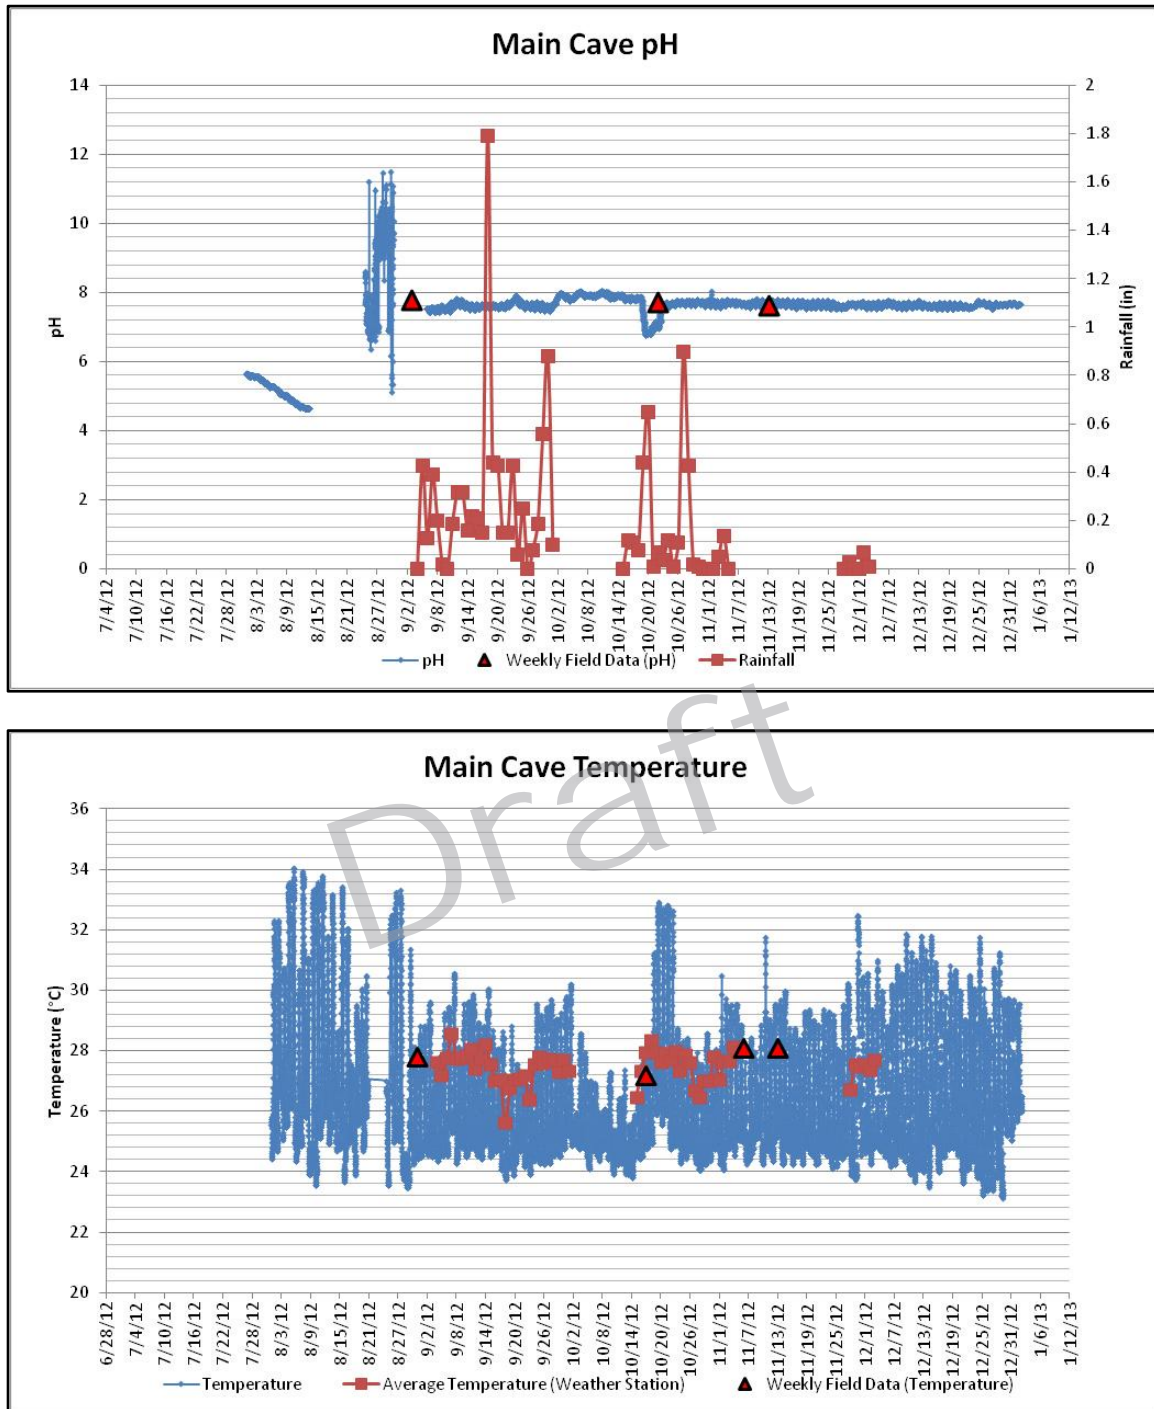
Figure 2.2.2-15. Overall OWQM Data for Main Cave

OWQM and Rainfall Data. The CUC Rota Team installed a PRV to improve the pressure issues that were affecting the OWQM sensors, increased the sensor cleaning frequency, and purchased field-testing equipment to allow for more frequent calibrations of the sensors. The data obtained after mid-November show a dramatic improvement in the online turbidity measurement and a close correlation to the field QA/QC calibrations (see Figure 2.2.2-15). The only problem observed was the impact of entrained air being released after the PRV installation, which increased noise in the turbidity measurement.

Maintenance Log. Maintenance performed on the instrumentation at the Main Cave site was logged and is presented in Table 2.2.2-8. Transportation to Rota can be difficult and therefore regular maintenance was not completed as often as it was at stations on Saipan. Regular maintenance includes the removal of biofilm and recalibration of the sensors as the growth of biofilm on the sensor elements causes a drift in the turbidity, as shown in Figure 2.2.2-18. Maintenance point B shows the effects of cleaning as the turbidity drops down to around 0.5 NTU, but quickly drifts up due to biofilm growth. Although the sensors were cleaned at point C, incorrect calibration led to readings that were greater than 1.0 NTU.

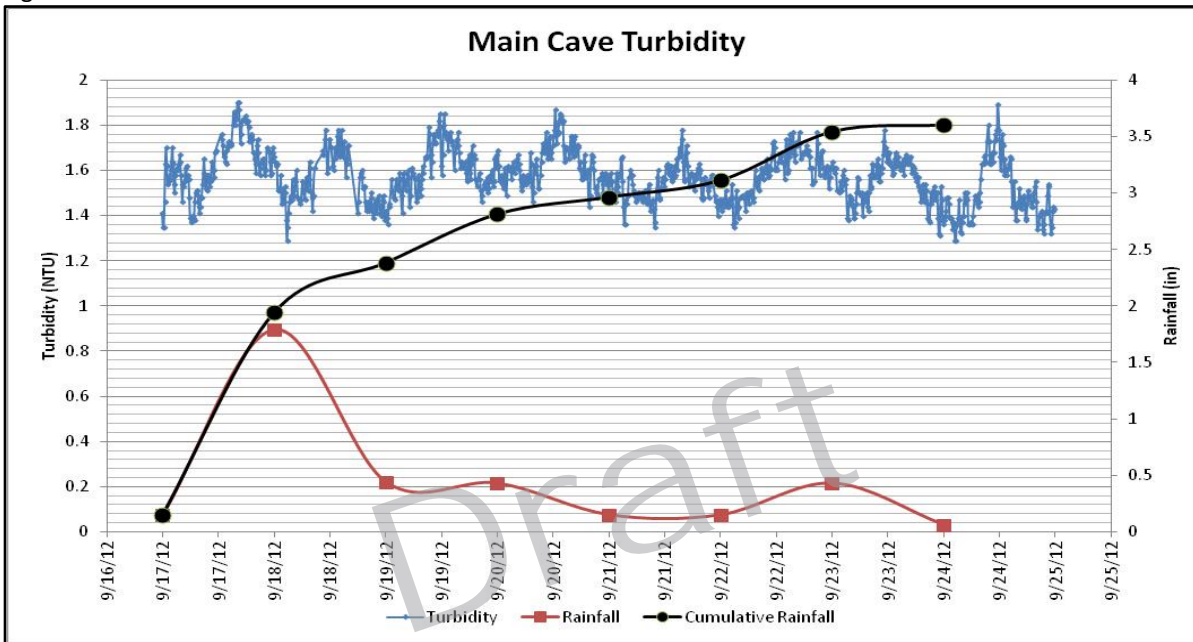
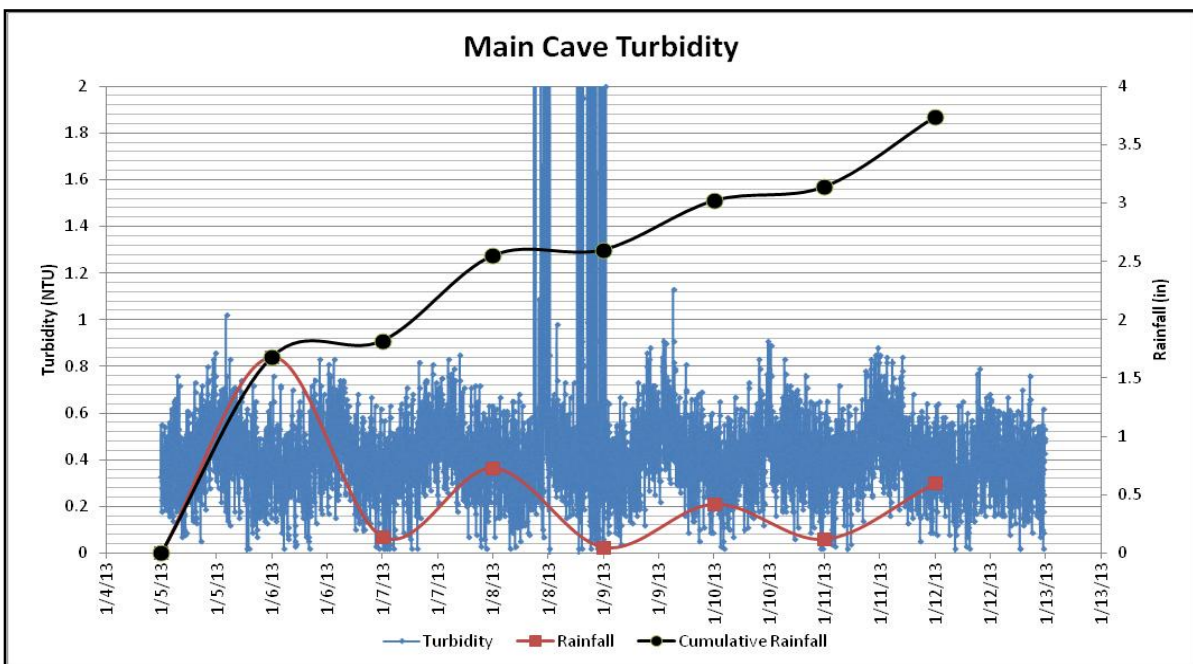
Figure 2.2.2-16. Rainfall Events at Main Cave

Rainfall Events. Two significant rainfall events were captured at the Kaan Tank site during the Phase I GWUDI Study as shown in Figure 2.2.2.16. Below is a discussion of each of the two events:

- September 17, 2012 Event.** The rainfall event that occurred on September 17 - 18th, 2012 had a combined total rainfall near the GWUDI study's threshold of 2". The baseline turbidity, although slightly elevated, did not have any unusual spiking following the event.

- January 6, 2013 Event.** The rainfall event on January 5-6, 2013 was similar to the previous one, but was also followed by a number of smaller rain events during the week. During the week of monitoring the i:scan cleaning brush stuck, blocking the turbidity sensor light pathway. The result was erroneous data. Similar to the earlier event, the turbidity did not demonstrate any unusual spikes associated with the rainfall event.
- MPA Sample.** The baseline MPA sample collected on November 16, 2012 had an overall low risk assigned as shown in Table 2.2.2-9. The groundwater source is considered low risk for surface water influence. The team was unable to travel to Rota in time to collect a storm related MPA sample.

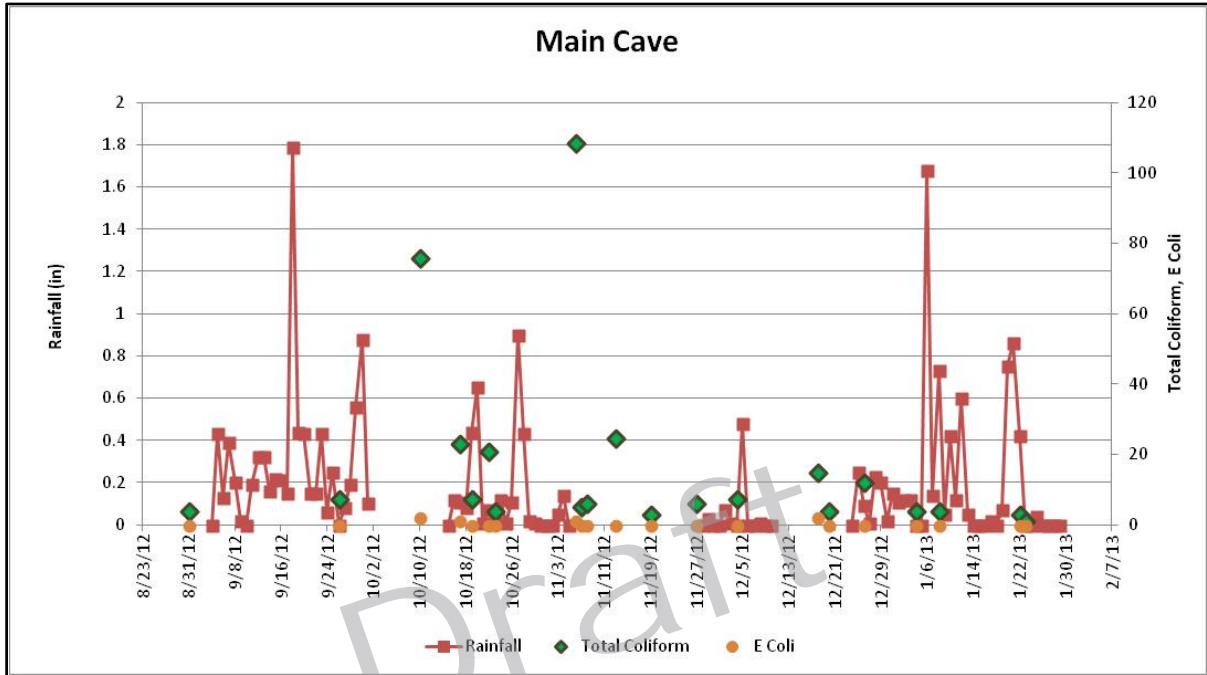
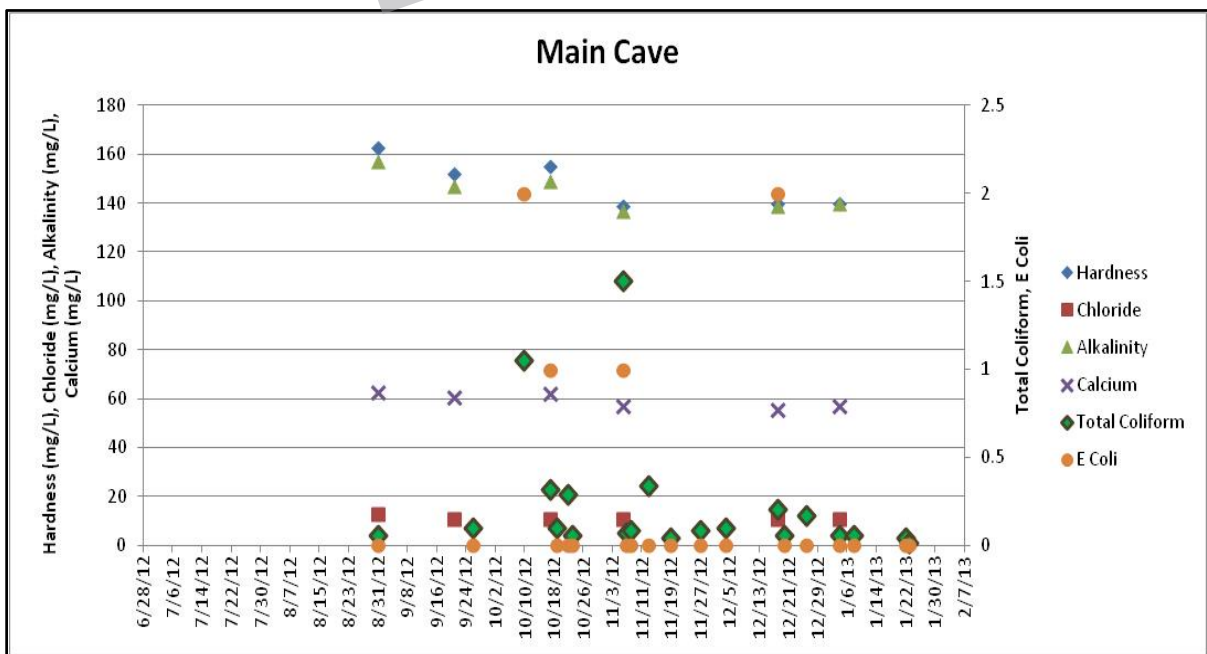
Figure 2.2.2-17. Laboratory Data for Main Cave

Laboratory Data. Laboratory data for the Main Cave are shown in Figure 2.2.2-17. Water quality parameters such as calcium, hardness, etc. remained consistent throughout the measurement period and were not directly affected by rainfall events. Microbe data, on the other hand, shows small spikes in total coliform during some of the sample periods. Because of instrument failure, it is difficult to determine whether the spikes occurred directly following a rainfall event.

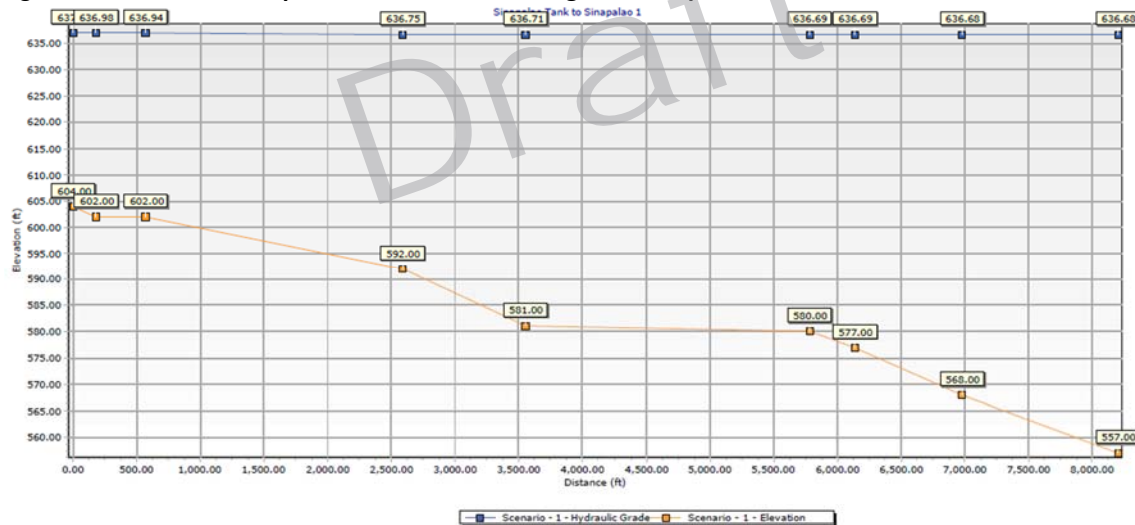
Figure 2.2.3-7. Model Output of HGL from Ginanlangan to Sinapalo

The profile for the HGL immediately east the Ginanlangan tank is shown in Figure 2.2.3-7. The pressure in this area is set at 20, below the recommended pressure set forth in this Master Plan. This is the maximum HGL that can be set and is done so by keeping the Ginanlangan tank full at all times through constant overflowing of this tank to maintain 20 psi in the areas east of the tank.

- Repair the altitude valve at the Ginanlangan Tank.
- Relocate and upgrade the booster pump and increase its service area to include the areas east of the Ginanlangan Tank.

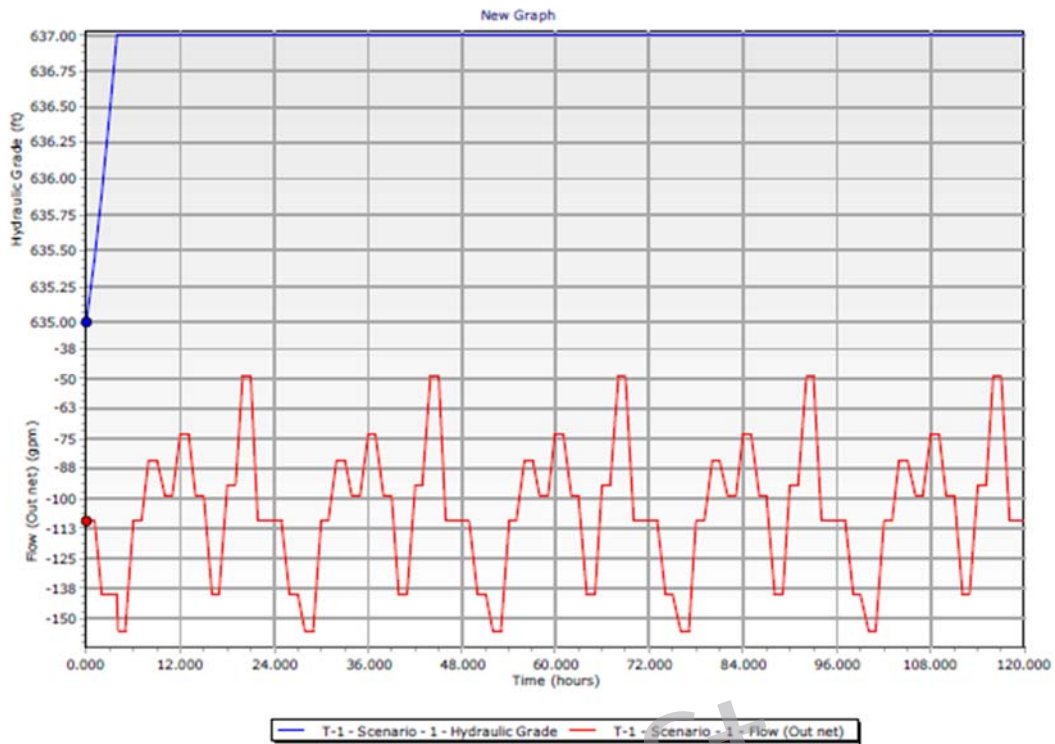
Figure 2.2.3-9. Ginanlangan Tank Hydraulic Grade and Inflow/Outflow

The HGL of the Ginanlangan tank tops off at 637 (see Figure 2.2.3-9). The finished grade of this tank is 604. The observed condition in the field is shown in the photograph of the overflow (Figure 2.2.3-10).

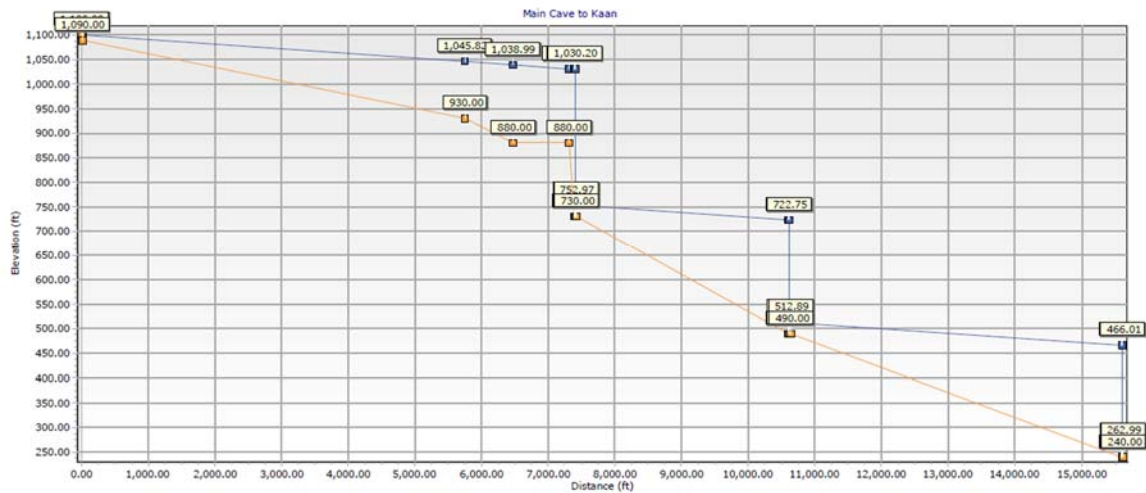
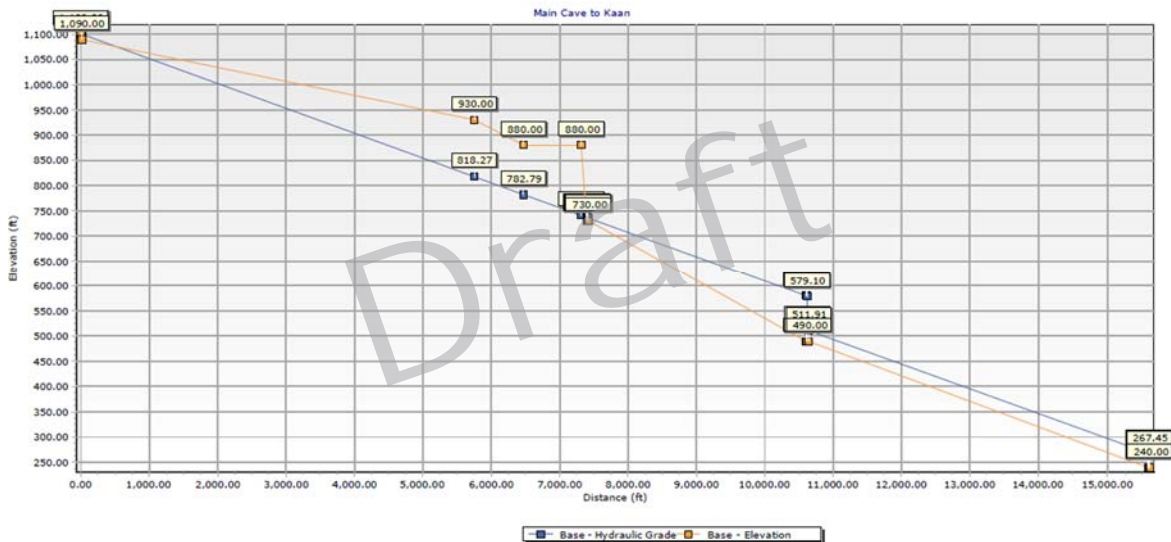
The Main Cave to the Kaan tank transmission line is approximately 15,400 feet of 8-inch, ductile iron pipe. According to the as-builts for this transmission line, three PRVs are used to reduce the head. The elevation of the main cave is 1090 feet and the finished grade of the Kaan tank is 225, an 865-foot drop in grade or the equivalent of 374 psi. The PRVs along this transmission line are not in working order based on information provided by CUC personnel. This is why the Kaan Tank is allowed to constantly overflow. The profiles shown in Figures 2.2.3-12 and 2.2.3-13 present the design/ideal condition of this transmission line and the current operating condition of the Kaan tank overflowing.

The existing condition profile reflects a negative pressure from stations 10+00 to 70+00. This can be the case if the Kaan tank is allowed to overflow. This is a modeled condition and must be verified in the field. It is recommended that CUC personnel inspect between these stations to confirm if a vacuum is present. If a vacuum is present, then modification to the operating condition, such as using the Ginanlangan Tank to serve all of Rota, should be done.

Repairing or replacing the PRVs along the Main Cave to Kaan Tank transmission line and repairing/replacing the altitude valve at the Kaan tank will restore this transmission and tank operating to its initial design state, correcting the overflow.

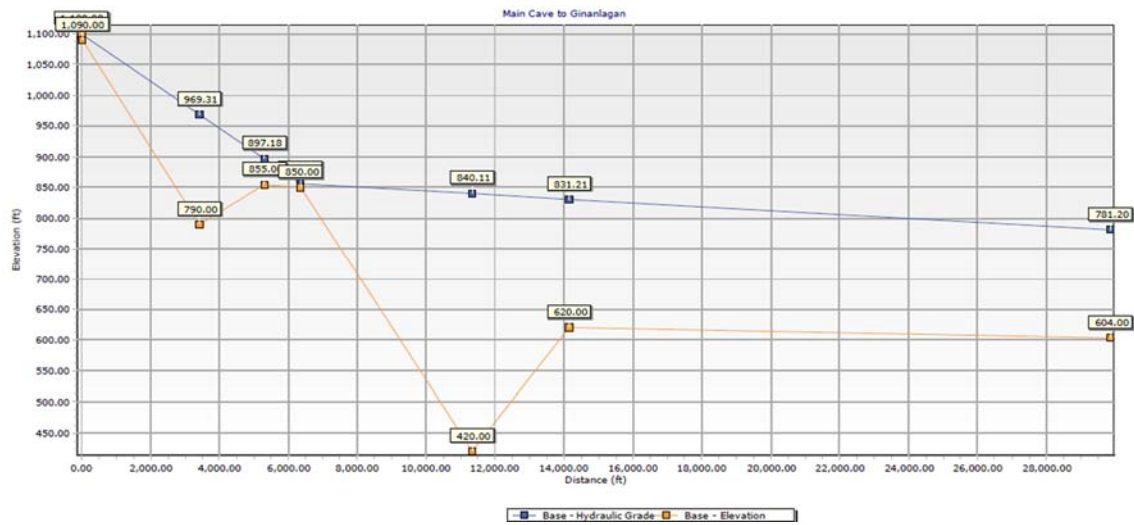
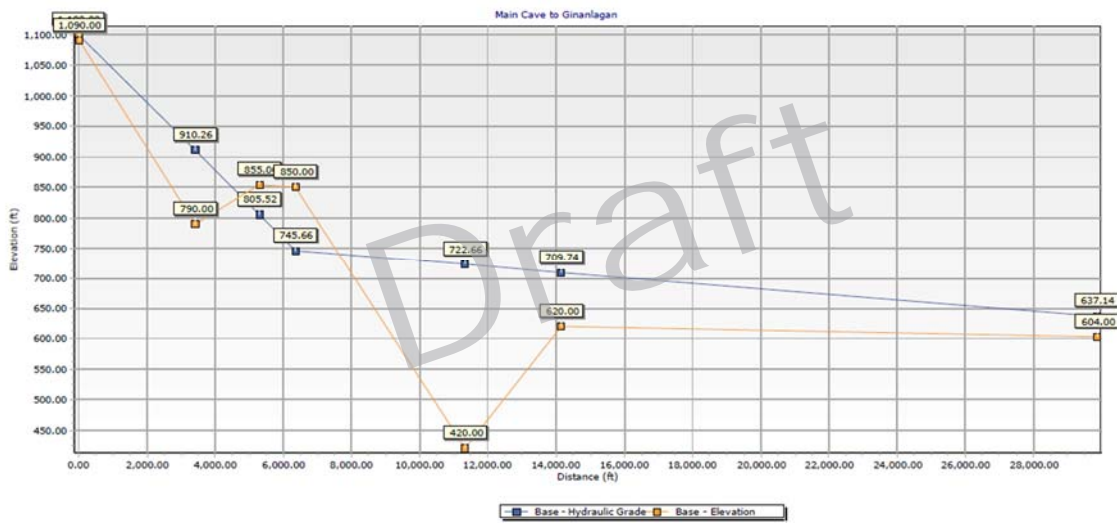
The profiles presented as Figures 2.2.3-14 and 2.2.3-15 show the HGL from Main Cave to the Ginanlangan Tank. The first profile presents the design condition; the second profile presents the existing operating condition where the Ginanlangan Tank is allowed to overflow.

Based on the existing condition profile of the Main Cave to Ginanlangan Tank transmission line, there is negative pressure from stations 50+00 to 70+00. This is also the location where CUC Operations have installed the chlorination system. This chlorination system relies on the pressure differential between a gate valve to activate the chlorinator. This modeled condition must be verified in the field. It is recommended that CUC personnel inspect between these stations to confirm a vacuum is present; if so, a modification to operations should be done. This modification may be to repair the existing altitude valve supplying the tank. The recommended correction to this is to relocate and upgrade the Sinapalo pump station so that it can serve the larger Sinapalo area, allowing allow the Ginanlangan tank level to fluctuate with the daily demand.
