2022
Commonwealth of the Northern Mariana Islands
305(b) and 303(d)
Water Quality Assessment Integrated Report

Bureau of Environmental and Coastal Quality
SEPTEMBER 2022

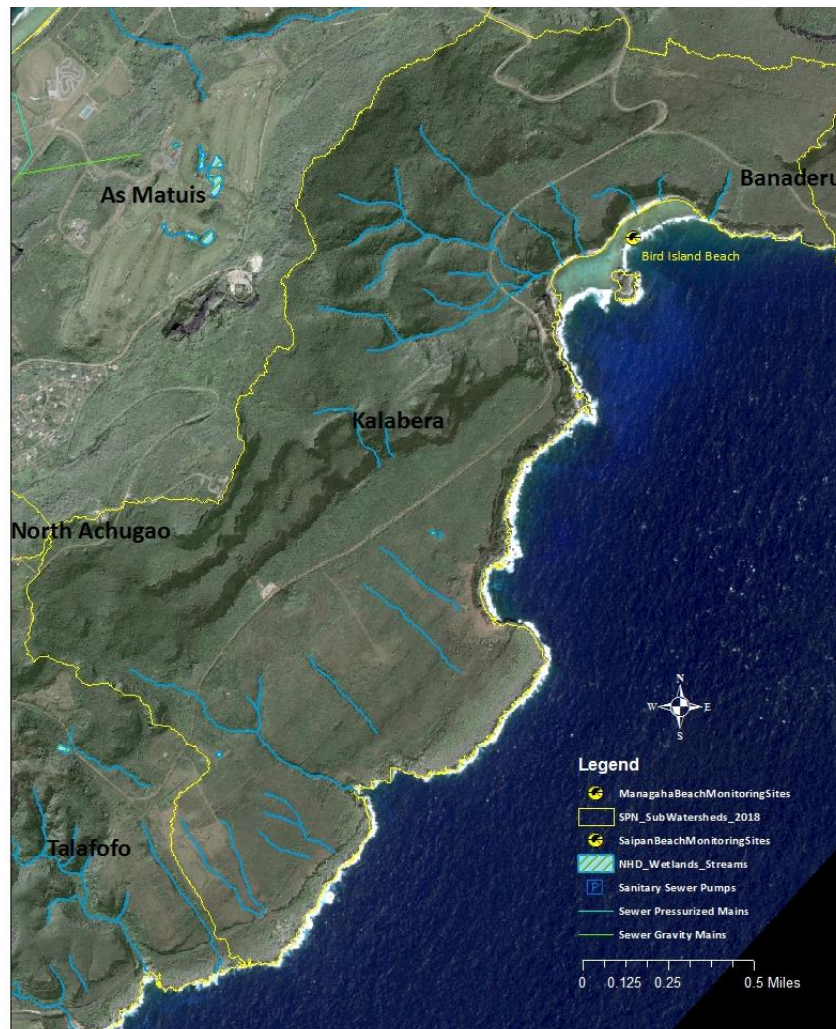
FIGURE C-9. Kalabera Watershed (Segment 12)

Kalabera Watershed is the northernmost watershed on Saipan's east coast. It is rural in nature, with few roads or impervious land cover, as seen in Figure C-9. Kalabera has only one long-term BEACH monitoring site, which is located next to Bird Island Beach's shoreline.

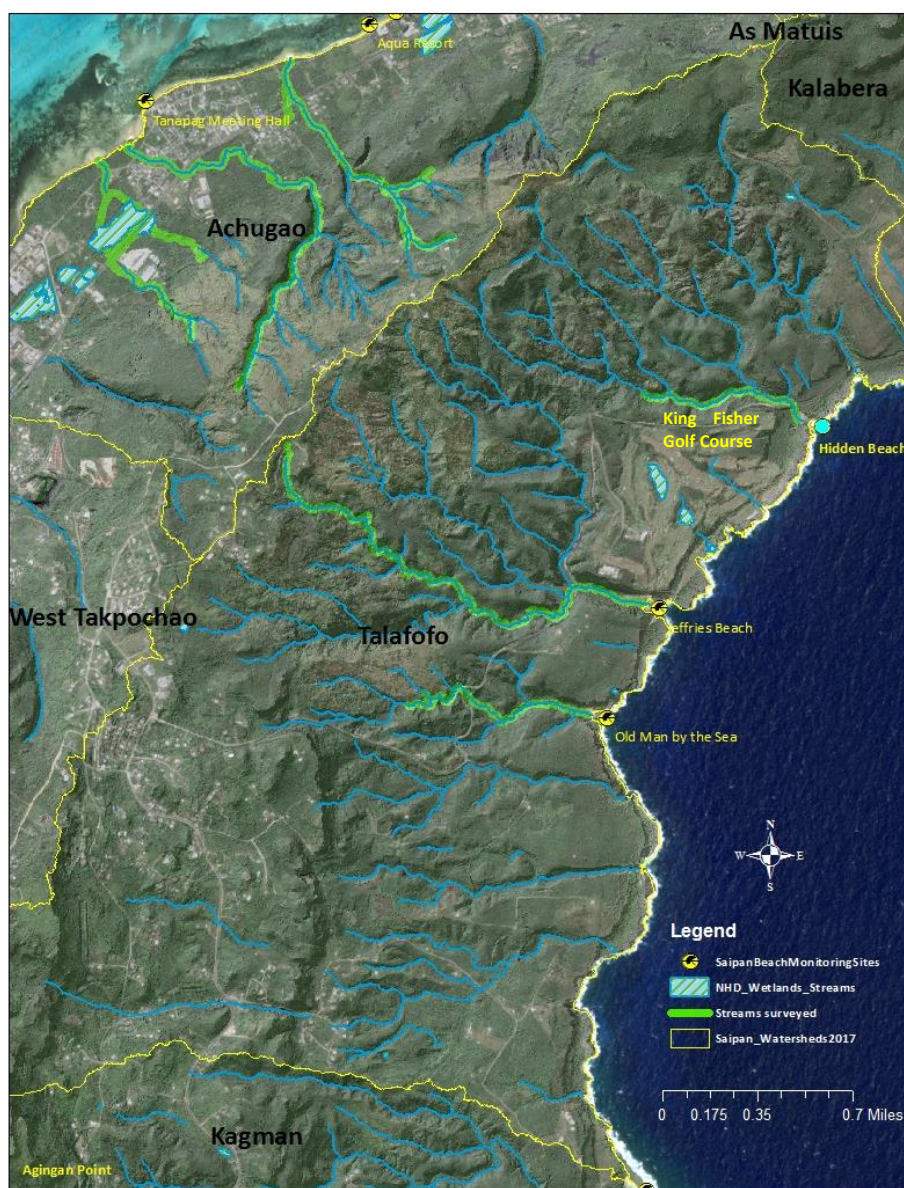
FIGURE C-10. Talofofo Watershed (Segment 13)

Talofofo Watershed's long-term BEACH monitoring sites are located in the waters surrounding three remote beaches: Hidden, Jeffrey's, and Old Man by the Sea, as shown in Figure C-10.

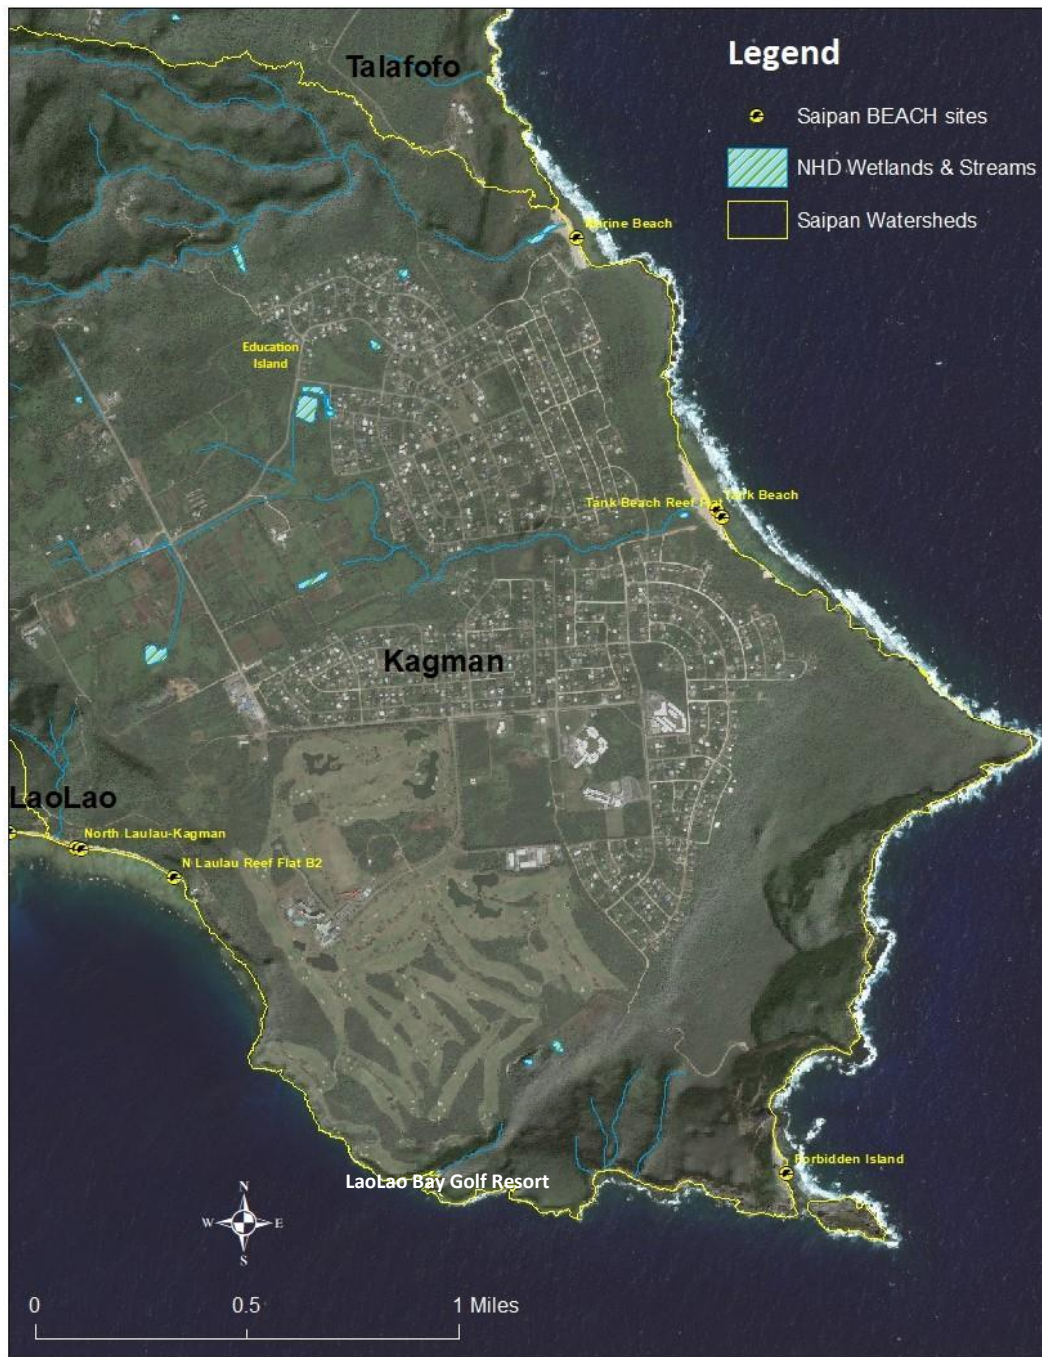
FIGURE C-11. Kagman Watershed (Segment 14)

The Kagman Watershed borders LaoLao Bay and contains the LaoLao Bay Golf Resort, shown in Figure C-11.

It has four long-term BEACH monitoring sites located in the waters surrounding Marine, and Tank, and Forbidden Island, and North LaoLao beaches. In addition, there are also three LaoLao ARRA water quality sites, and two biological monitoring reef flat sites used to assess Kagman's coastal waters. These sites are adjacent to LaoLao's northern beach, one of Saipan's most popular dive sites.

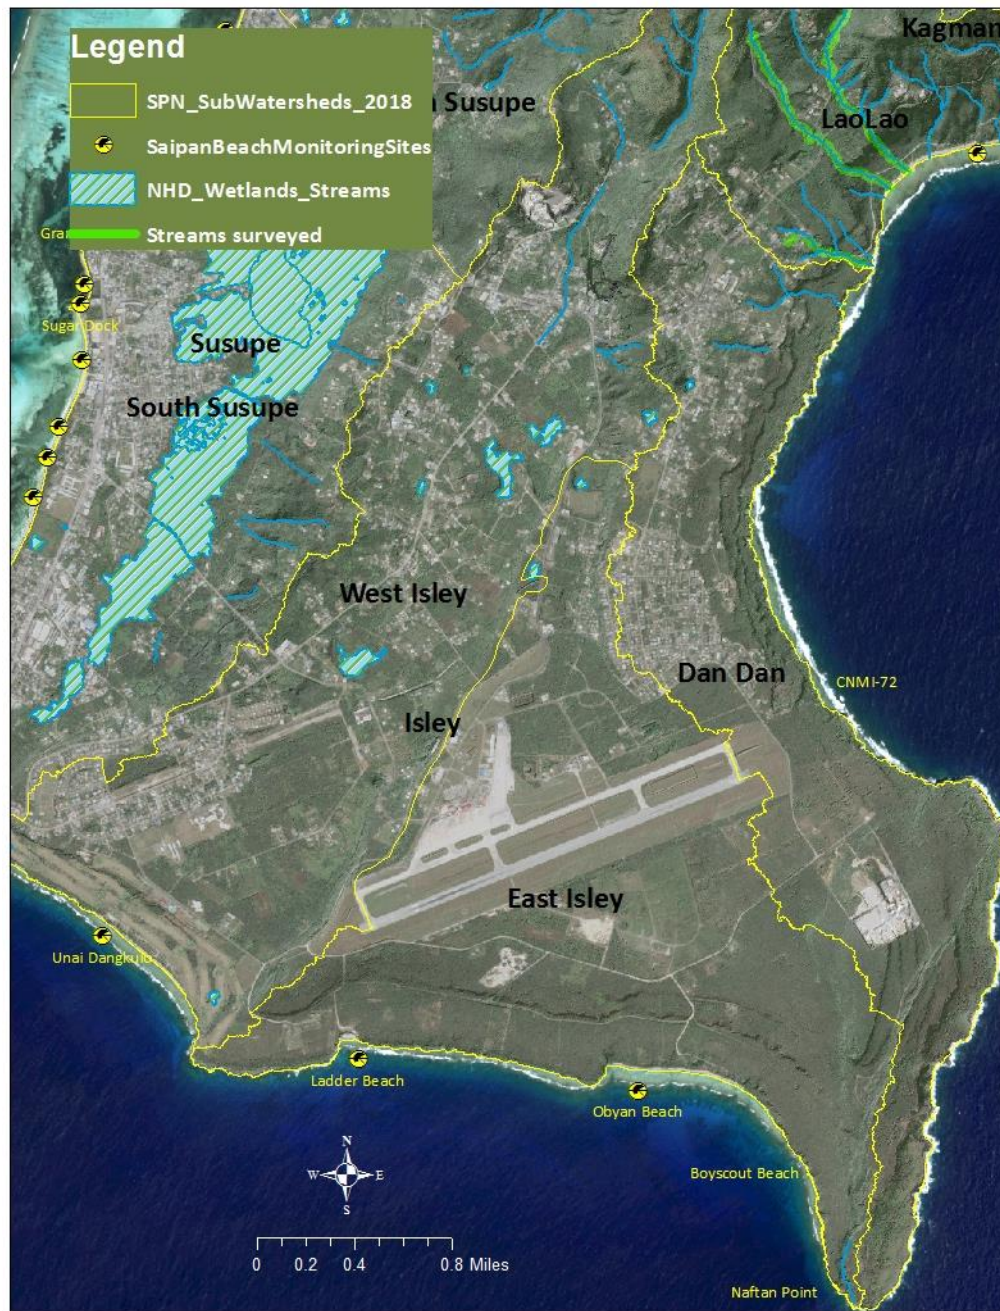
FIGURE C-16. Isley Watershed (Segment 17A and 17B)

The Isley Watershed (Figure C-16) is divided into sub-watersheds, East Isley (17B) and West (17A). Isley's headwaters start at the centrally located peak of Mt. Takpochau at 1554 feet. Mt. Takpochau's surface waters flow from its ridge by subterranean transport to the south coast.

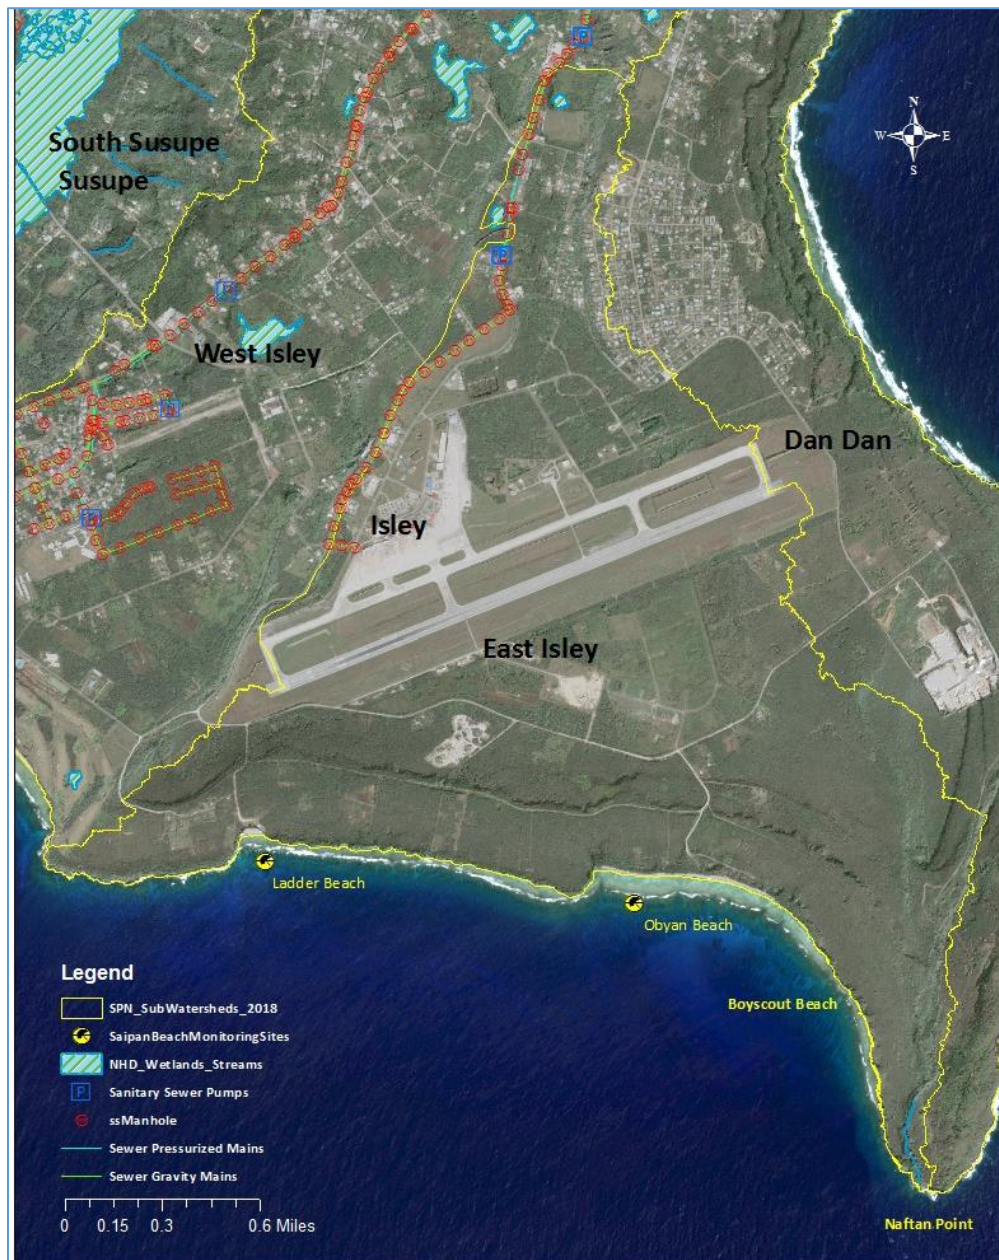
FIGURE C-17. East Isley Watershed (Segment 17B)

East Isley's Watershed (Figure C-17.) contains Saipan's present day, Francisco C. Ada International Airport; constructed over a Formerly Used Defense Site (FUDS). A WWII military dumpsite is located in East Isley at Naftan Point. There is PFOS and FPOA contamination of ground water here associated with wartime activities, and airport firefighting drills.

The East Isley watershed is sparsely populated with a few homes compared to West Isley. There are two long-term BEACH monitoring sites located at Obyan and Ladder beaches, one reef flat site off Ladder Beach, and another biological monitoring site at Boy Scout Beach.

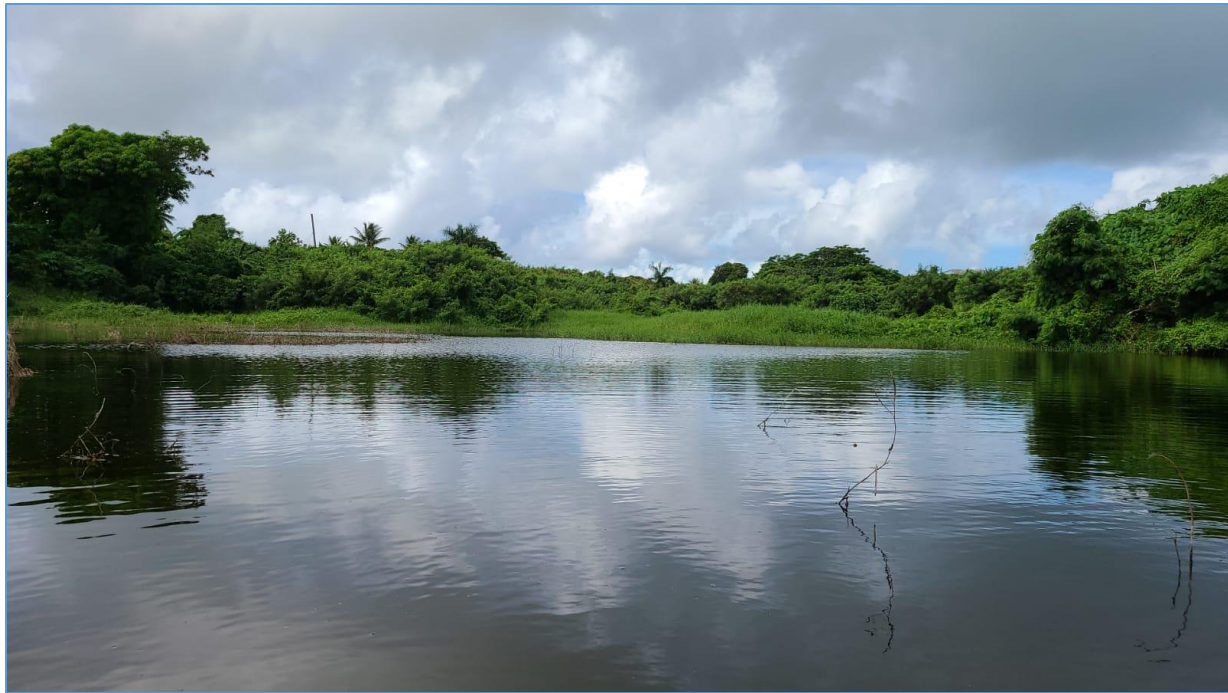
FIGURE C-21. Flores Pond in August 2021 – 2021 NWCA

The most recent NHD, and Wetlands and Streams GIS data layers show significant natural emergent wetlands, or marsh areas that have been tilled for agriculture in the mid and upper West Isley watershed, a constructed mitigation wetland, and Flores Pond (Figure C-21).

These wetlands exist due to the clay geology, which acts as an aquitard and holds the freshwater longer than in other places on Saipan. Information gathered during the 2021 NWCA found that Flores Pond does not contain standing water year-round that would support fish, but it is home to many aquatic invertebrates when flooded, e.g., water striders, aquatic beetles and other insects. The Pond is an important migratory bird habitat and for the endangered Mariana Moorhen. Therefore, West Isley's wetlands support the *Propagation of Aquatic (Invertebrate) Life* DU, but they also have had altered habitats.

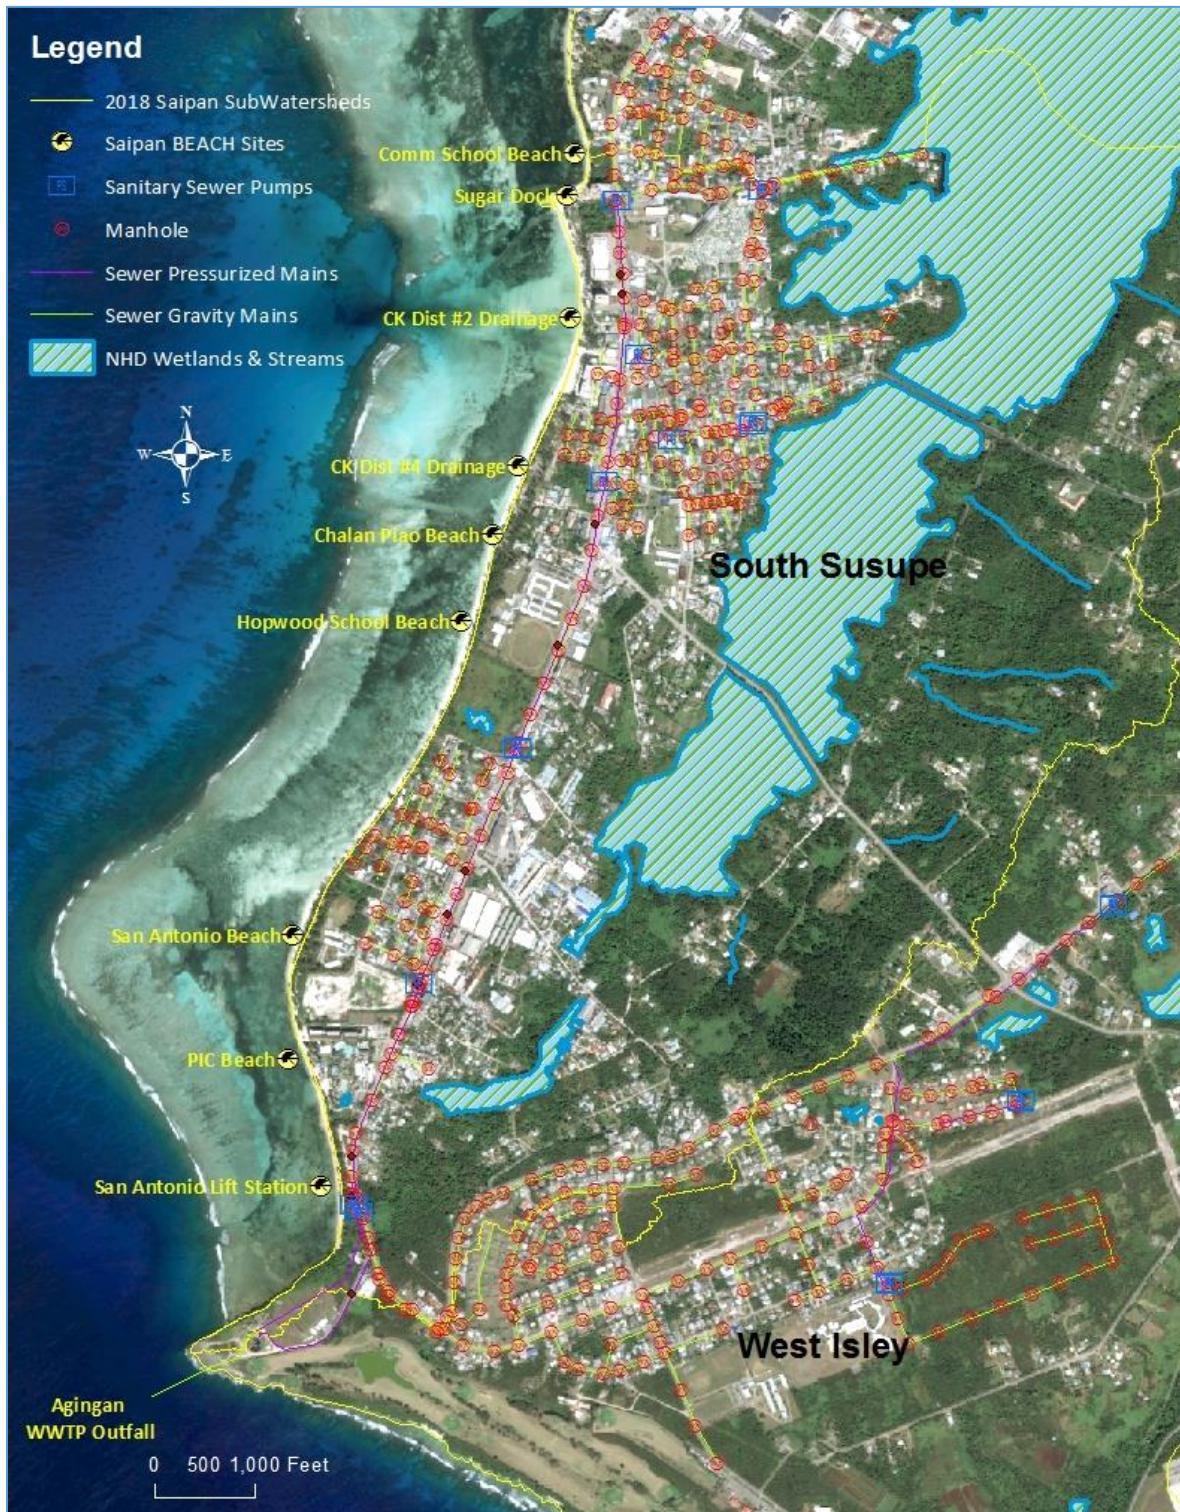
FIGURE C-23. South Susupe Watershed (Segment 18B)

The 2016 heavy metal sediment study conducted by Denton, et.al, found exceedances of DEQ's screening levels for Cu, Pb, and Zn in soils taken from the former 'Agingan Point' dump, which was used for ocean disposal of ammunition after WWII, and for civilian wastes up into the 1970s.

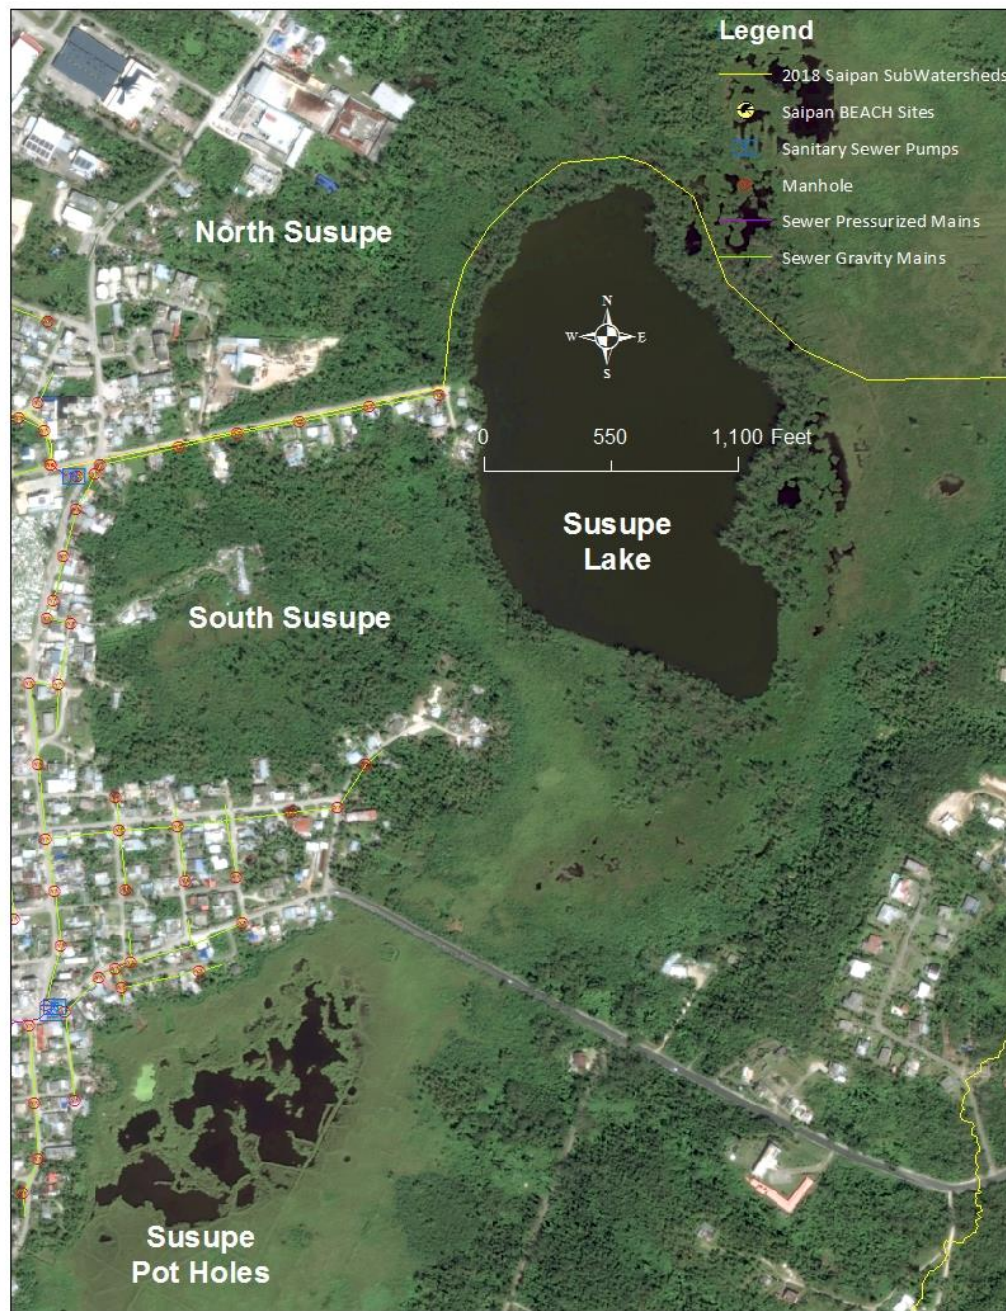
FIGURE C-25. Susupe Lake and the Surrounding Wetlands and Chalan Kanoa Potholes

Lake - Saipan’s only lake, the 40-acre “Susupe Lake” resides in the South Susupe watershed (Figure C-25). Lake water quality is tested every two weeks. The most recent study by Environet, Inc., entitled “*Assessment of Toxicity and Water Quality of Lake Susupe*”, concluded in 2006 that Susupe Lake “consists primarily of rainfall with minimal groundwater influence” and is “isolated from surrounding groundwater and seawater systems”.

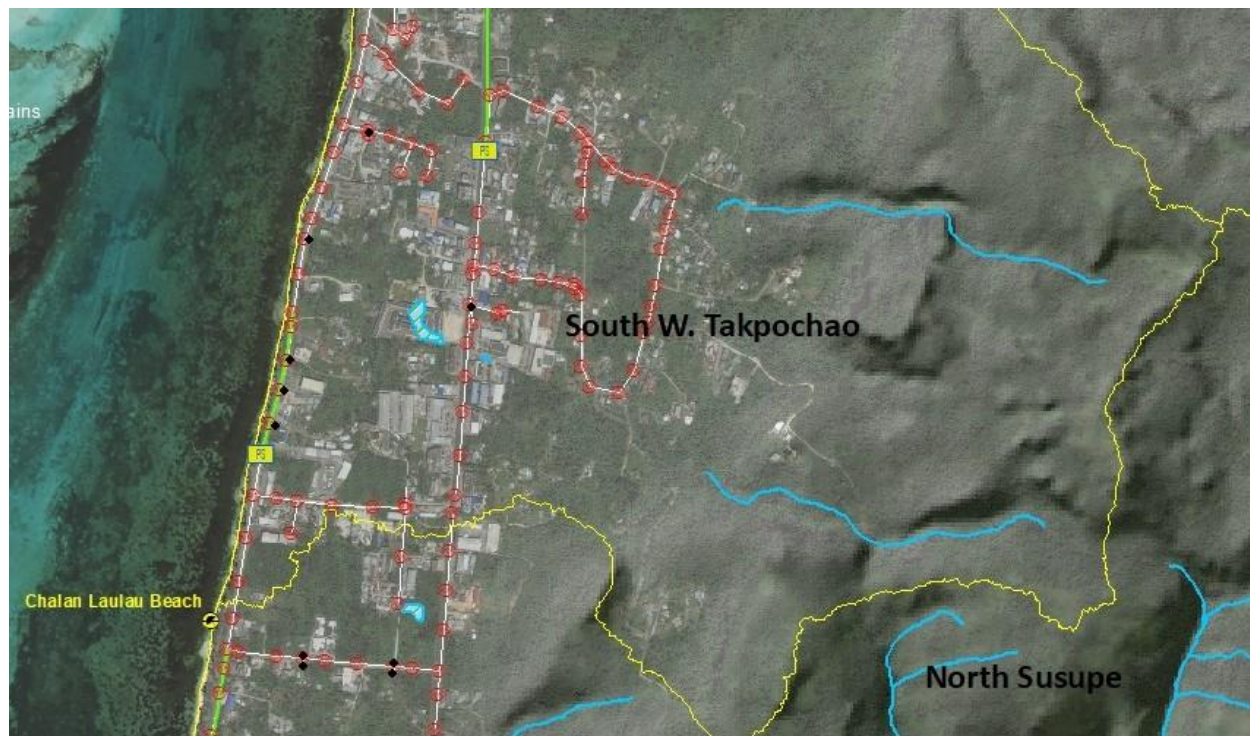
FIGURE C-31. South W. Takpochau Streams (Segment 19STRC)

There are two ephemeral streams in the South West Takpochau watershed as seen in the latest NHD, and Wetlands and Stream GIS data layers. The streams' headwaters start at the ridge separating North Susupe from the South West Takpochau watershed. The streams flow on the surface from the steep upper watershed in the west, then subterranean through the lower watershed that discharges through groundwater seeps into Saipan Lagoon.

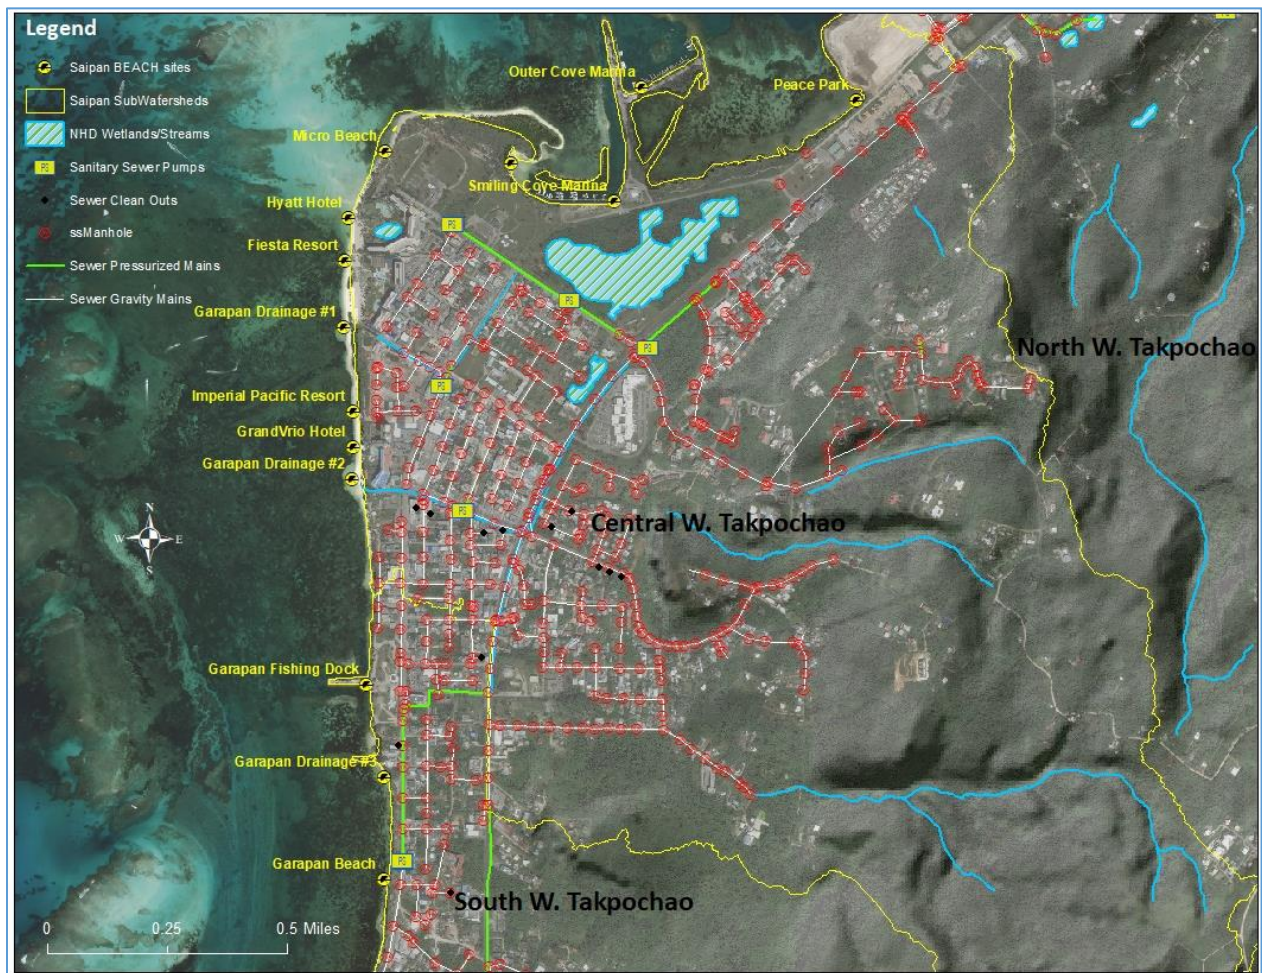
FIGURE C-32. Central W. Takpochau Watershed (Segment 19B)

Saipan's Beach Path winds its way along the Central West Takpochau's shoreline into Saipan's "industrial area". The coastal waters surrounding the industrial area have been designated as Class A waters. As was discussed previously in Section B.1.4.2, these coastal waters contain Smiling Cove and Outer Cove Marinas.

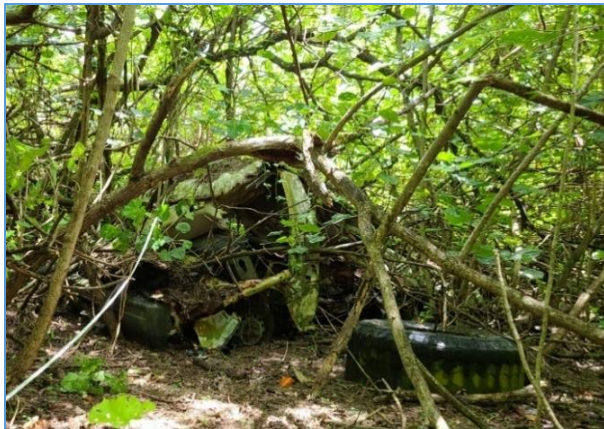
FIGURE C-36. 2021 NWCA Site Lower Base Wetland

WQS/NPS field crew visited several wetland sites in the North West Takpochau watershed during the 2021 NWCA. One lacustrine Hibiscus

forested wetland located in Lower base southwest of JG Sablan repair shop had mounds of fill and WWII era debris at the wetland boundaries (Figure C-36).

The mounds of fill surrounding the wetland were used to redirect water flow and prevent flooding. Old tires, junk vehicles, trash, and a CUC water meter line and other infrastructure were observed within the wetland. Coral roadways surround the wetland, as do invasive vines.

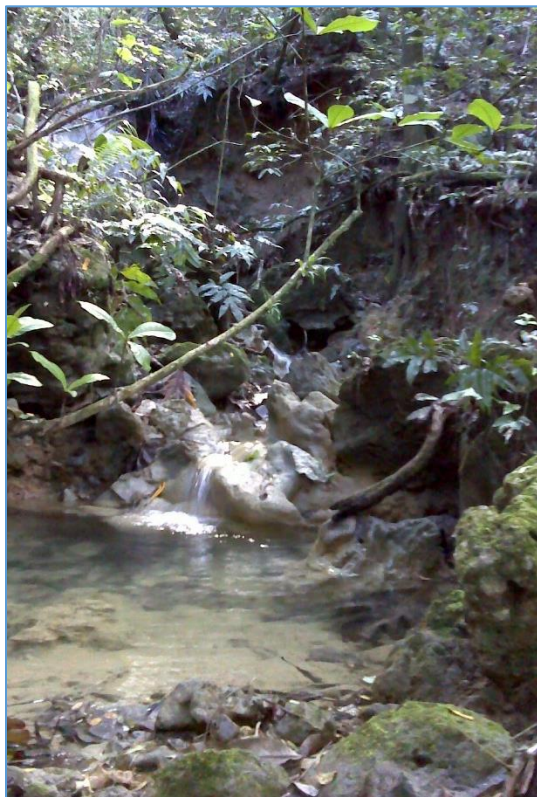
FIGURE C-45. Achugao Stream

A SVAP assessment of Achugao Stream was completed this reporting cycle. This stream’s headwaters begin at Wireless Ridge and flows through the pristine upper watershed through a small cluster of homes in the mid watershed, and out to Saipan Lagoon.

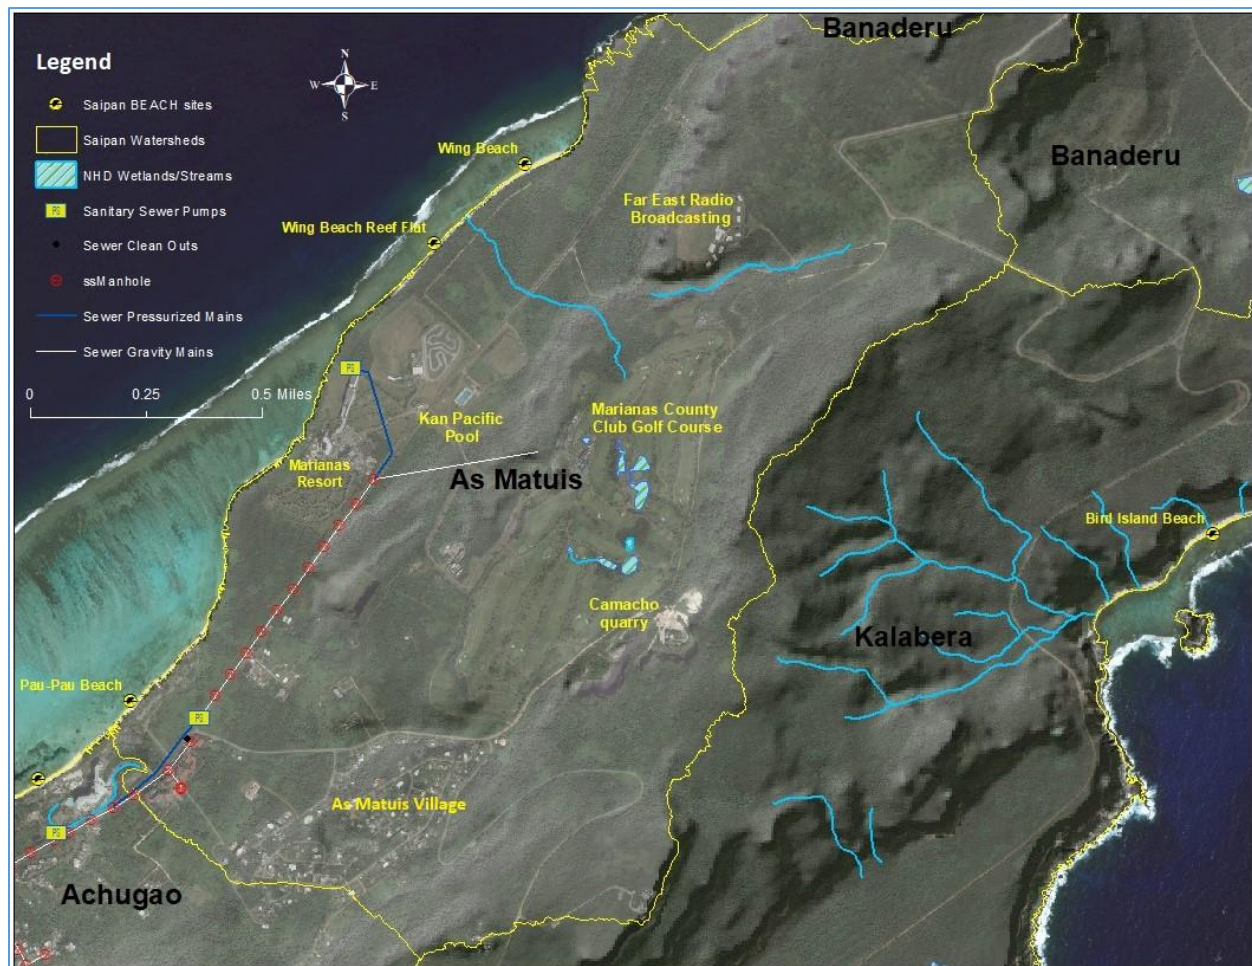
FIGURE C-47. As Matuis Watershed (Segment 21)

relies, on IWDS for wastewater collection and treatment. The SR-2 lift station upgrade near PauPau Beach was completed this reporting cycle.

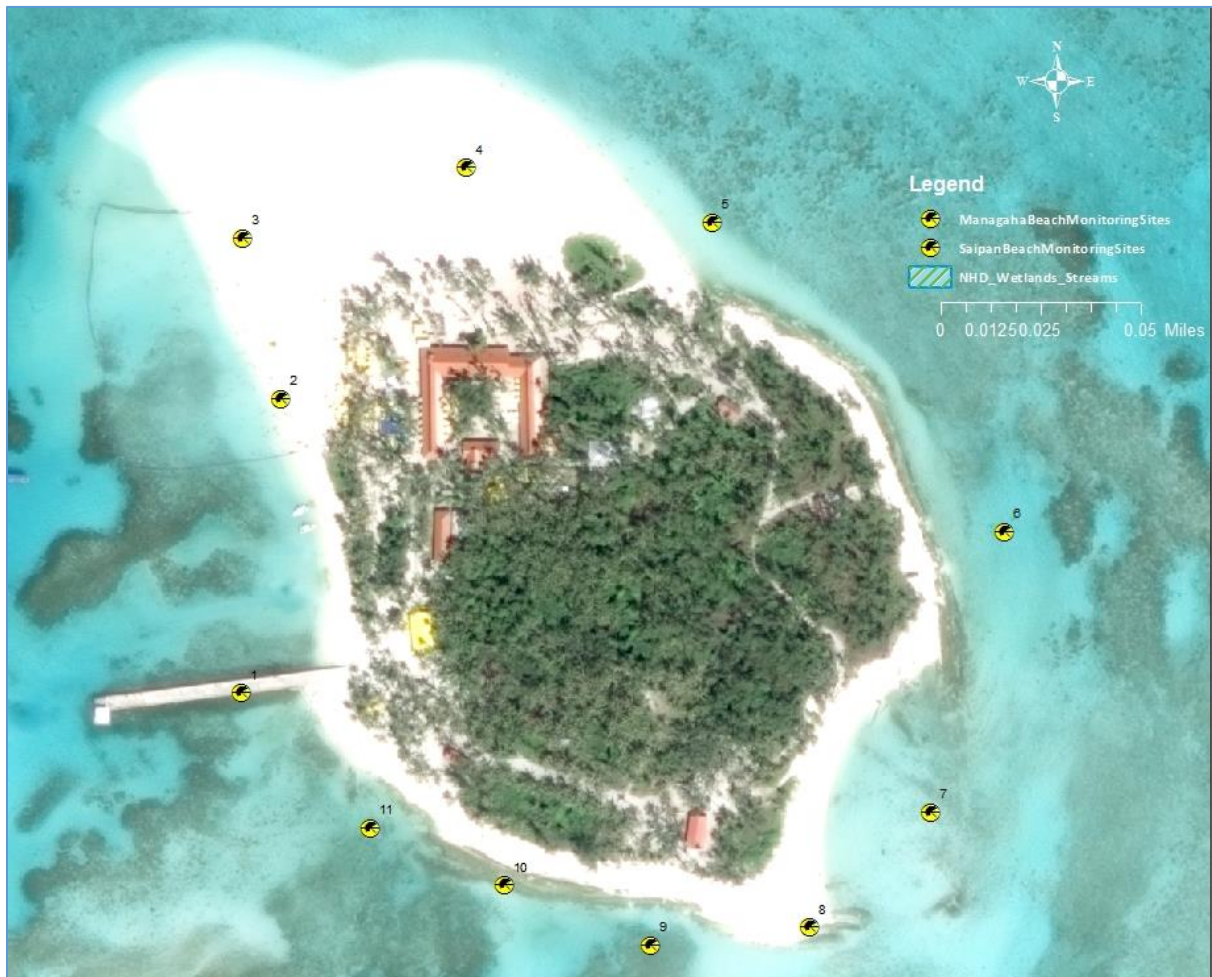
FIGURE C-51. Mañagaha (Segment 23)

The cay has insufficient precipitation, topographical and geological features to support any surface waters. Precipitation flows directly overland or by subterranean transport from land to sea.

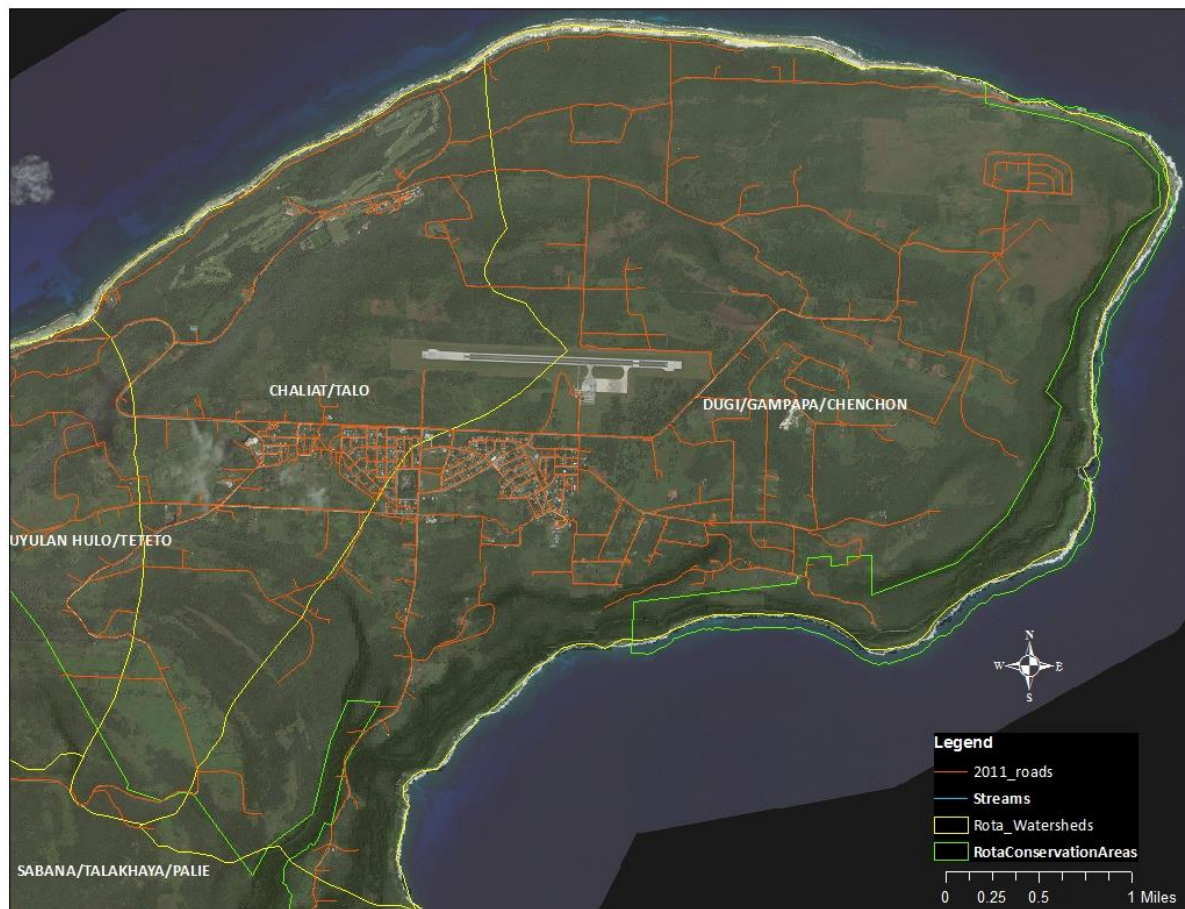
FIGURE C-54. Dugi/Gampapa/Chenchon (Segment 1)

The Dugi/Gampapa/Chenchon watershed does not contain paved roads or any consistently well-maintained trails to allow easy access to the remote coastline for regular water quality monitoring. Therefore, there is not an established long-term BEACH monitoring site for this watershed. The rugged cliff line drops off to deep water, with panoramic views and extremely hazardous surf most of the year. This has resulted in very limited water quality data as samples may only be collected by boat during calm weather, which is usually done in conjunction with biological monitoring of reef flat sites.

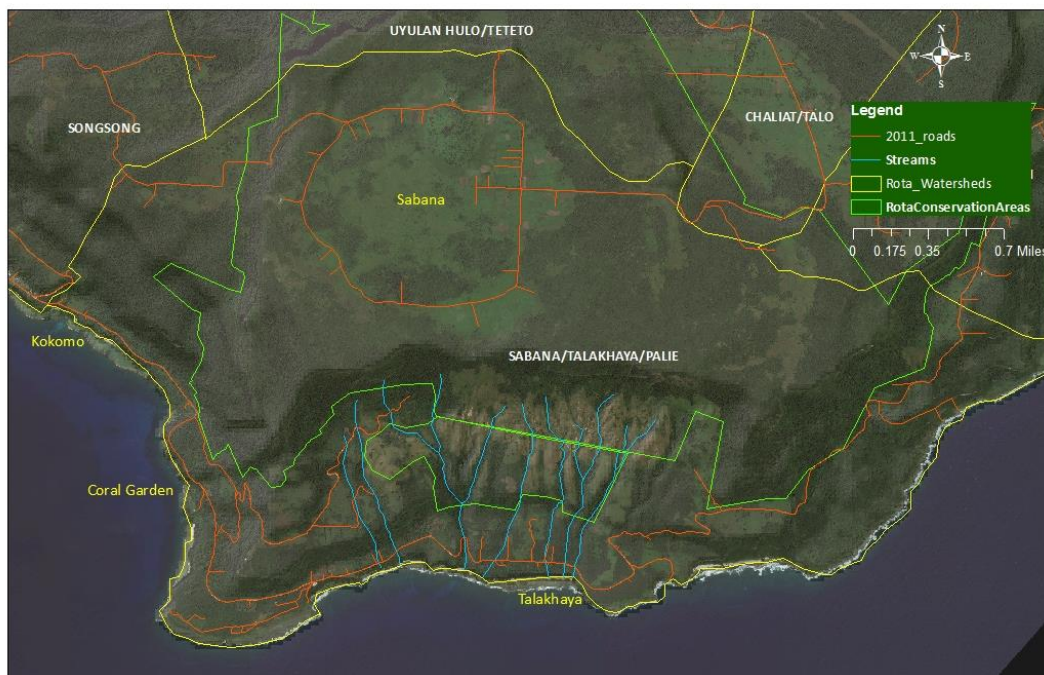
FIGURE C-55. Sabana/Talakhaya/Palie (Segment 2)

The Sabana/Talakhaya/Palie watershed is steeply sloped with barren badlands in Talakhaya's upper watershed as shown in Figure C-55.

This is the result of vast clear cutting for agriculture, which began during the Japanese occupation. Clearings above Rota's primary potable water source, the Water Cave, have continued in recent years for new agricultural plots.

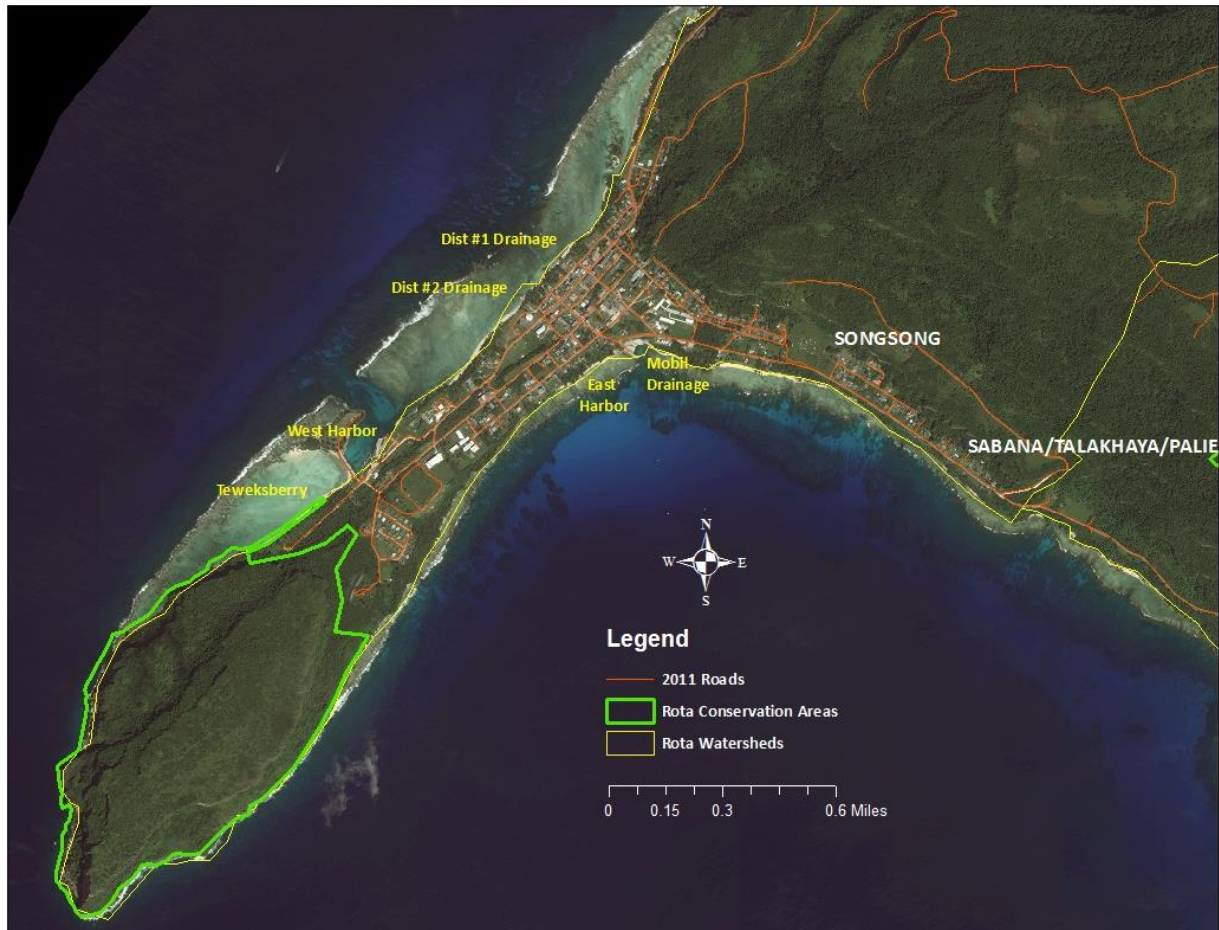
FIGURE C-57. Songsong (Segment 3)

The Songsong watershed has insufficient precipitation, topographical and geological features to support stream systems. Precipitation flows through subterranean transport from land to sea.

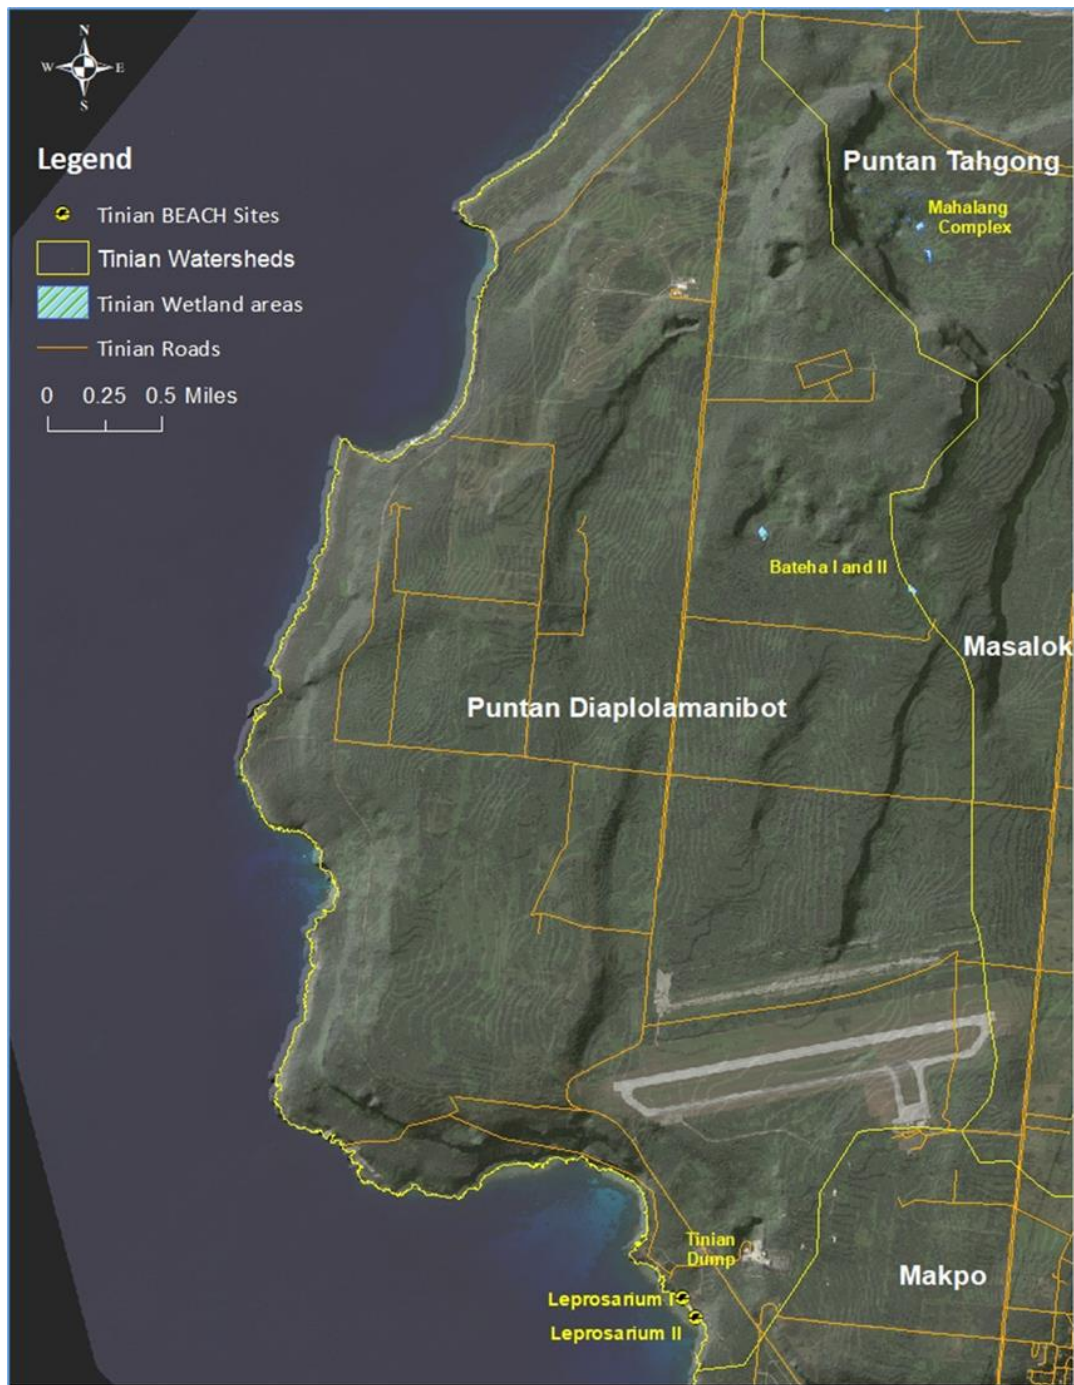
FIGURE C-68. Puntan/Diapolamanibot (Segment 10)

These calm shallow beach areas are protected by a shallow fringing reef. Cuts were made into the reef for supply boats to access the beach and to bring provisions to the colony. The cuts are still visible today, but are no longer used for boat landing. However, the beach sites may be easily reached by using a secondary coral road.

monitoring sites at Leprosarium I and II beaches. These beaches were used during the Spanish occupation to provide a distant location to quarantine a Leprosy colony (see Figure C-68).

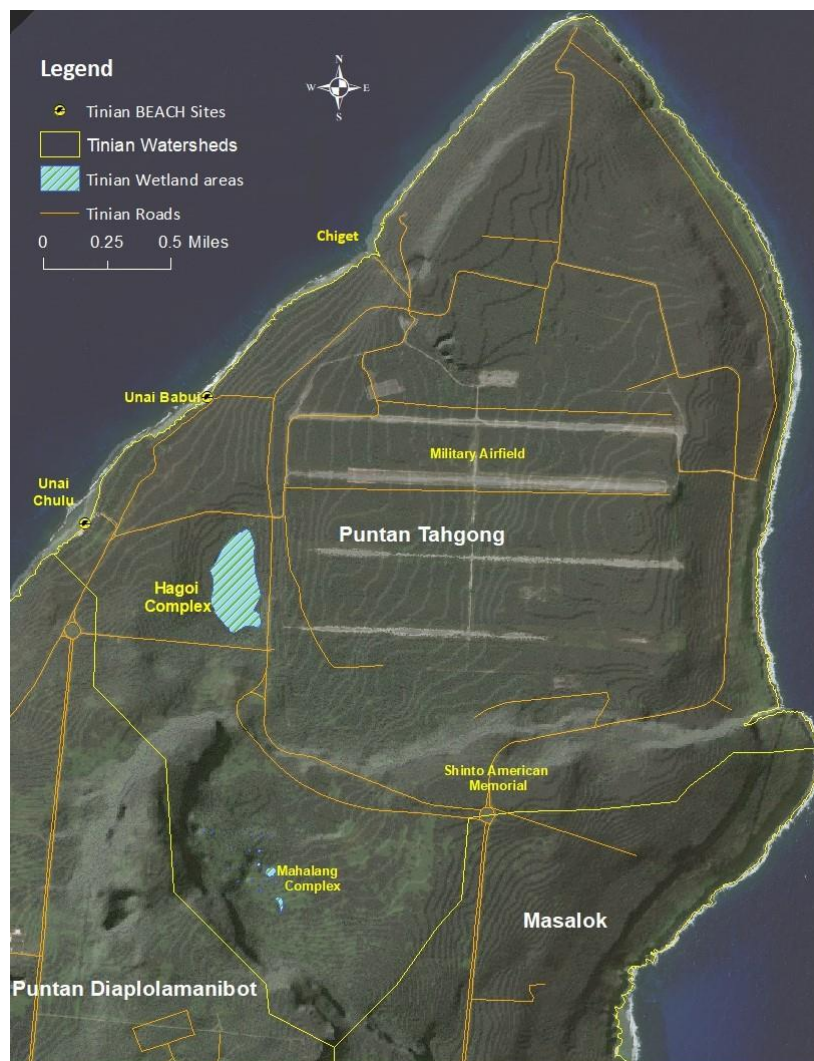
FIGURE C-70. Puntan/Tahgong (Segment 11)

It is contained in the US Military leased land area, and contains two long-term BEACH monitoring sites, including Unai Babui (“Pig Beach”) and Unai Chulu beaches (see Figure C-70 above).
