2022
Commonwealth of the Northern Mariana Islands
305(b) and 303(d)
Water Quality Assessment Integrated Report

Bureau of Environmental and Coastal Quality
SEPTEMBER 2022

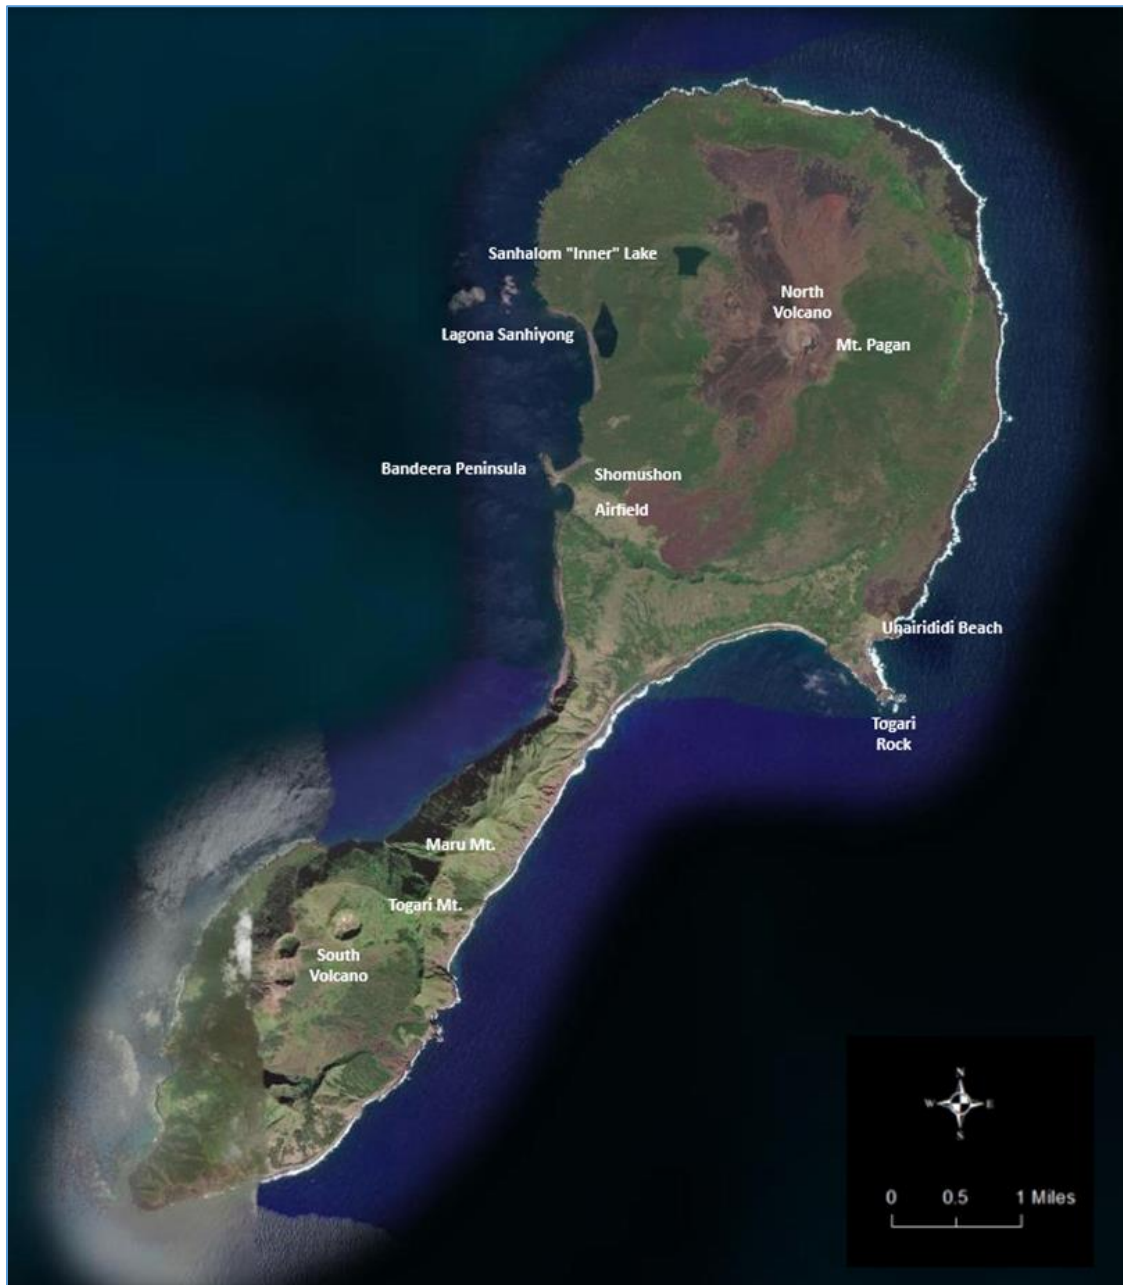
FIGURE C-80. Pagan – Earthstar Geographics Powered by ESRI imagery (Segment 29)

Mt. Pagan, at 1,870 feet (Smithsonian VDP), lies within a caldera in the north. This volcano is separated by a narrow isthmus (a strip of land surrounded by marine waters on either side) from three volcanoes in a caldera in the south. The isthmus is also “composed of another volcanic center (the highest point is Togari Mountain...) at 579 m above sea level.

According to the Smithsonian GVP, Pagan is one of the largest and most active of the Northern volcanic Islands, with 28.2 miles of coastline. Trusdell stated that it is the second most active after FDP and is “made up of a string of volcanoes originating from three volcanic centers..., distinguishing the island from the rest of the Mariana Islands.”, (2009. Gillespie). See Figure C-80., on the following page.
