Commonwealth of the Northern Mariana Islands

Standard State Mitigation Plan
August 2018

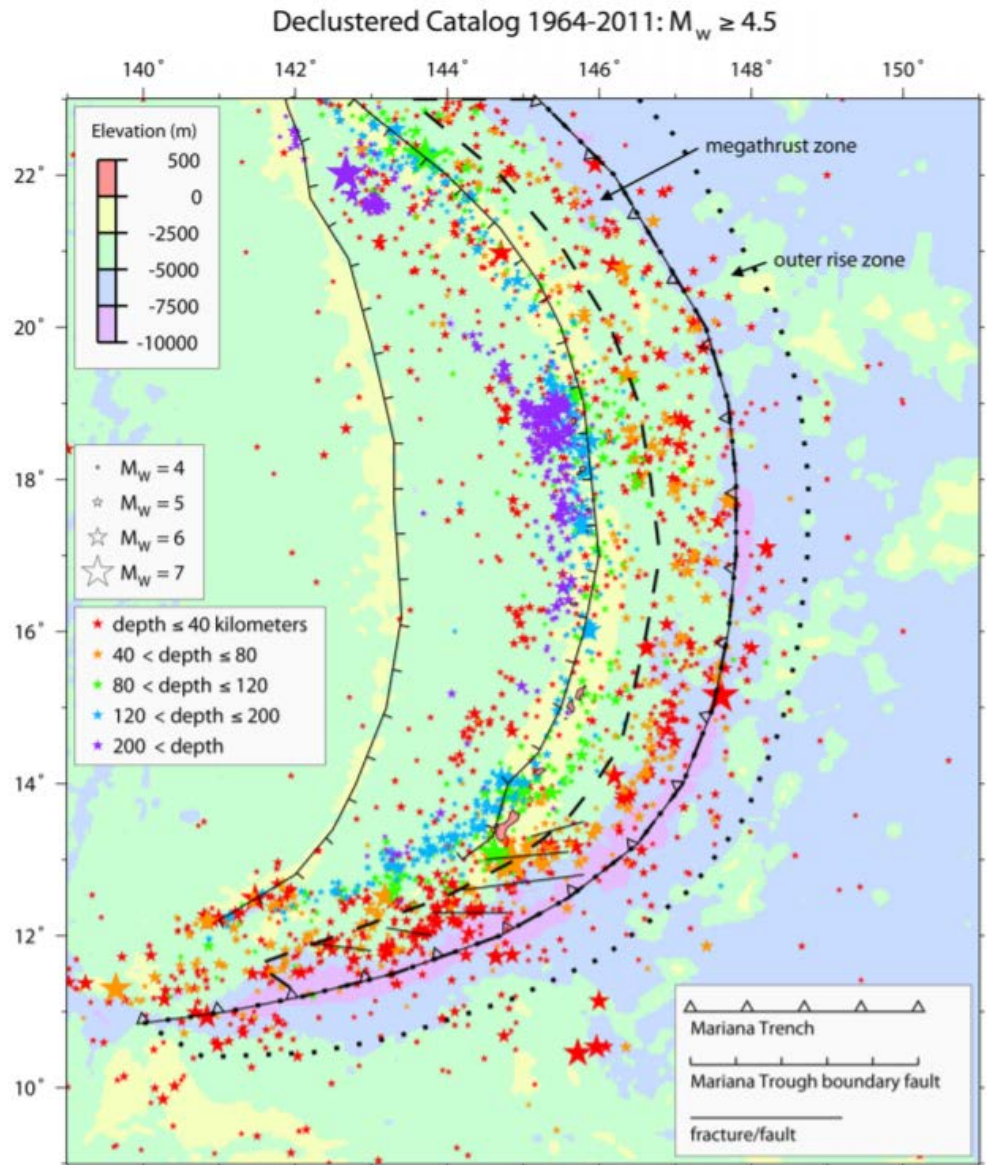
Figure 5-3: Declustered Seismicity Catalog Earthquakes 1964-2011 $MW > 4.5$
Source: USGS

The epicenters of most earthquakes are located on the Pacific Ocean floor and intensities generally diminish before reaching the Mariana Islands. The earthquake history of Saipan since 1800 records two major events, one in 1849 and the other in 1902, (actual magnitudes are not known). In April 1990 an underwater earthquake measuring 7.5 on the Richter Scale was recorded as occurring 225 miles East of Saipan. This caused a small Tsunami which did not exceed 24 cm.

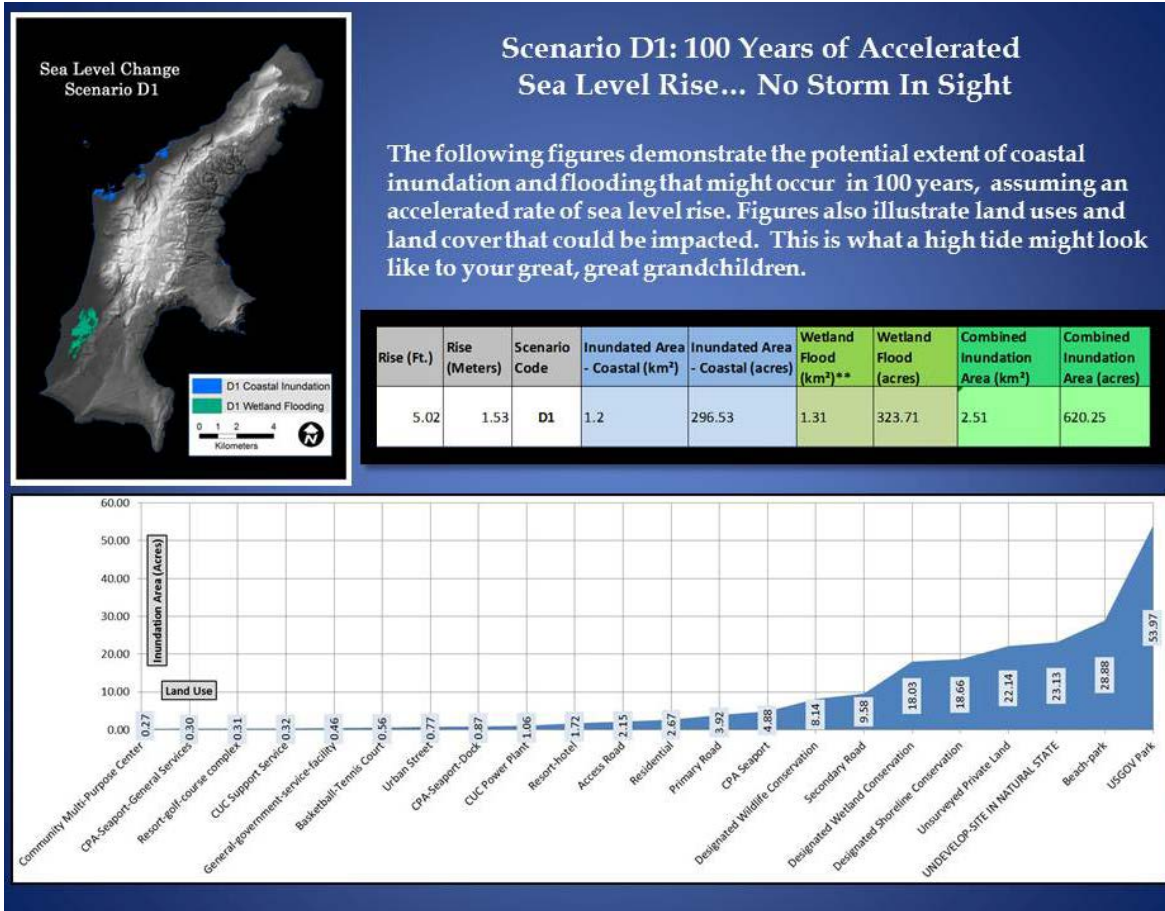
Figure 5-11: Normal Conditions in 100 Years

Scenario D1 is an extreme scenario built upon the upper end of SLR projections for the 21st century, but regardless of probability, such an increase in sea level remains within the realm of possible futures, and therefore merits consideration. The scenario is also of interest due to the similarities it shares with scenario A1. D1 illustrates conditions in which the extent of coastal inundation during high tide by the end of the century (D1) exceeds that of a large typhoon at the beginning of the century (A1). The axiom “today’s flood is tomorrow’s high tide” is embodied in this scenario.
